Detailed Unexploded Ordnance (UXO) Threat Assessment

Project Name	73 – 75 Avenue Road		
Client	GEA Limited		
Site Address	73 – 75 Avenue Road, London, NW8 6HP		
Report Reference	2111AT01	Revision	01
Date	3 rd February 2015		
Originator	AT

Detailed Unexploded Ordnance Threat Assessment
73 – 75 Avenue Road
GEA Limited

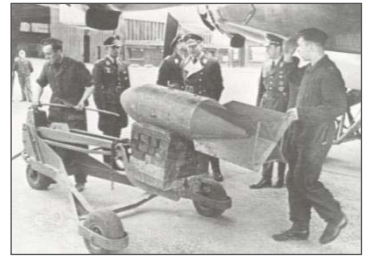
SC 250kg

Bomb Weight	245-256kg (540-564lb)
Explosive Weight	125-130kg (276-287lb)
Fuze Type	Electrical impact/mechanical time delay fuze.
Bomb Dimensions	1640 x 512mm (64.57 x 20.16in)
Body Diameter	368mm (14.5in)
Use	Against railway installations, embankments, flyovers, underpasses, large buildings and below-ground installations.
Remarks	It could be carried by almost all German bomber aircraft, and was used to notable effect by the Junkers Ju-87 Stuka (Sturzkampfflugzeug or dive-bomber).

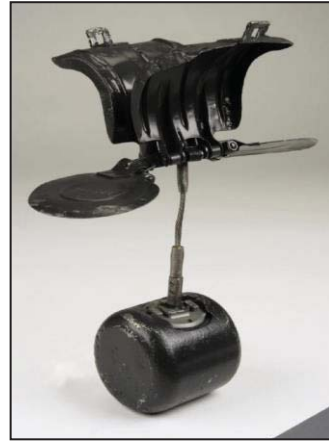
SD2 Butterfly Bomb

Bomb Weight	2kg (4.41lb)
Explosive Weight	7.5oz (212.6 grams) of TNT surrounded by a layer of bituminous composition.
Fuze Type	41 fuze (time), 67 fuze (clockwork time delay) or 70 fuze (anti-handling device)
Bomb Dimensions	Length 240 mm Width 140 mm Height 310 mm
Body Diameter	3in (7.62 cm) diameter, 3.1in (7.874) long
Use	It was designed as an anti-personnel/fragmentation weapon. They were delivered by air, being dropped in containers that opened at a predetermined height, thus scattering the bombs.
Remarks	The smallest and most common conventional German bomb. Nearly 70% of bombs dropped on the UK were 50kg.

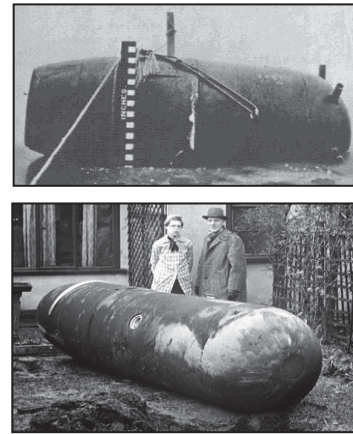
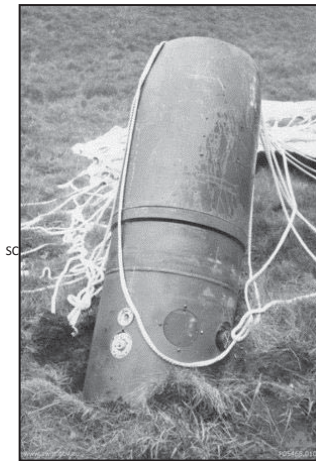
Parachute Mine (Luftmine B / LMB)

Bomb Weight	987.017kg (2176lb)
Explosive Weight	125-130kg (276-287lb)
Fuze Type	Impact/ Time delay / hydrostatic pressure fuze
Bomb Dimensions	1640 x 512mm (64.57 x 20.16in)
Body Diameter	368mm (14.5in)
Use	Against civilian, military and industrial targets. Designed to detonate above ground level to maximise damage to a wider area.
Remarks	Parachute Mines were normally carried by HE 115 (Naval operations), HE 111 and JU 88 aircraft types. Deployed a parachute when dropped in order to control its descent.

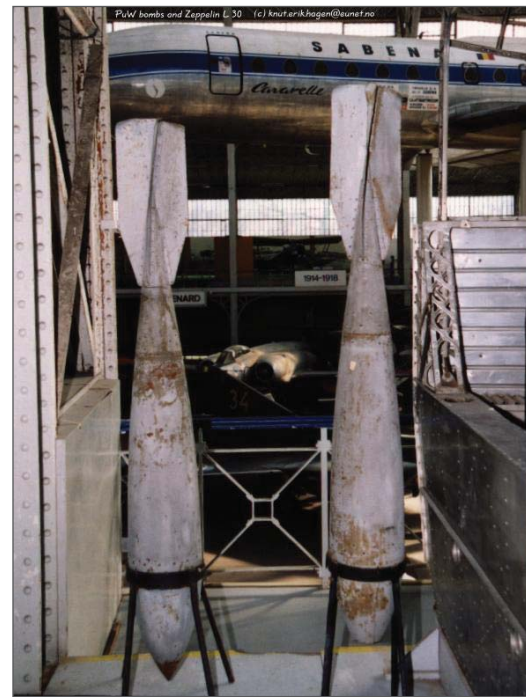
Examples of 50 and 100kg German WWI bombs

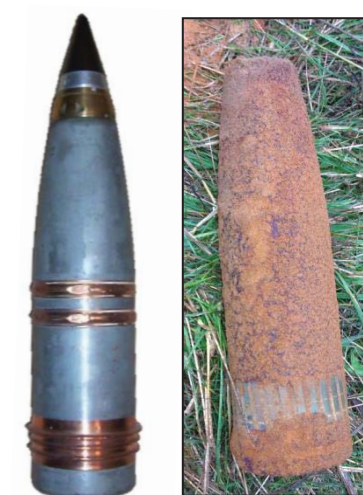
QF 3.7 Inch WWII Anti-Aircraft Projectile

Projectile Weight	28lb (12.6 kg)
Explosive Weight	2.52lbs
Fuze Type	Mechanical Time Fuze
Dimensions	3.7in x 14.7in (94mm x 360mm)
Rate of Fire	10 to 20 rounds per minute
Use	High Explosive Anti-Aircraft projectile. 4.5in projectiles were also used in this role.
Ceiling	30,000ft to 59,000ft

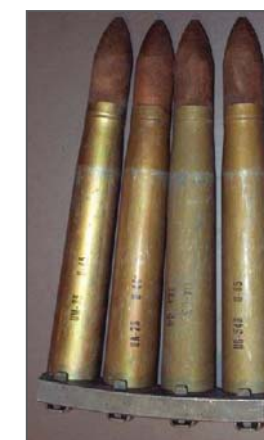
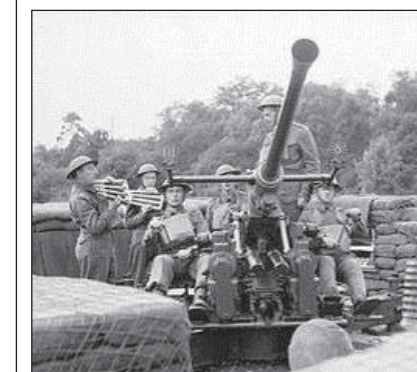
40mm Bofors Projectile

Projectile Weight	1.96lb (0.86kg)
Explosive Weight	300g (0.6lb)
Fuze Type	Proximity and Mechanical Time Fuze
Rate of Fire	120 rounds per minute
Projectile Dimensions	40mm x 310mm (1.6in x 12.2in)
Ceiling	23,000ft (7000m)

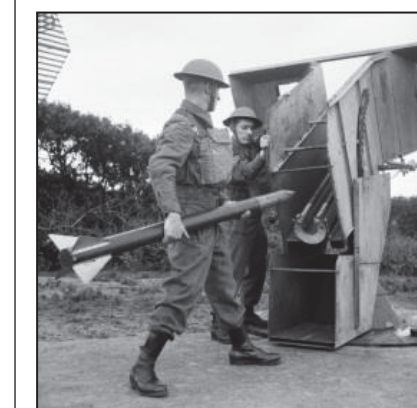
Unrotated Projectile (UP) – Z Battery

Projectile Weight	84lb (24.5kg)
Warhead Weight	4.28lb (1.94kg)
Warhead	Aerial Mine with a No. 700 / 720 fuze
Filling	High Explosive
Dimensions	1930mm x 82.6mm (76 x 3.25in)
Use	As a short range rocket-firing anti-aircraft weapon developed for the Royal Navy. It was used extensively by British ships during the early days of World War II. The UP was also used in ground-based single and 128-round launchers known as Z Batteries.
