ADDENDUM D&A STATEMENT

Hatton Square

Information to support S73 application for minor changes as a result of detailed design development

Document number: 203-A-REP-PC-03_01

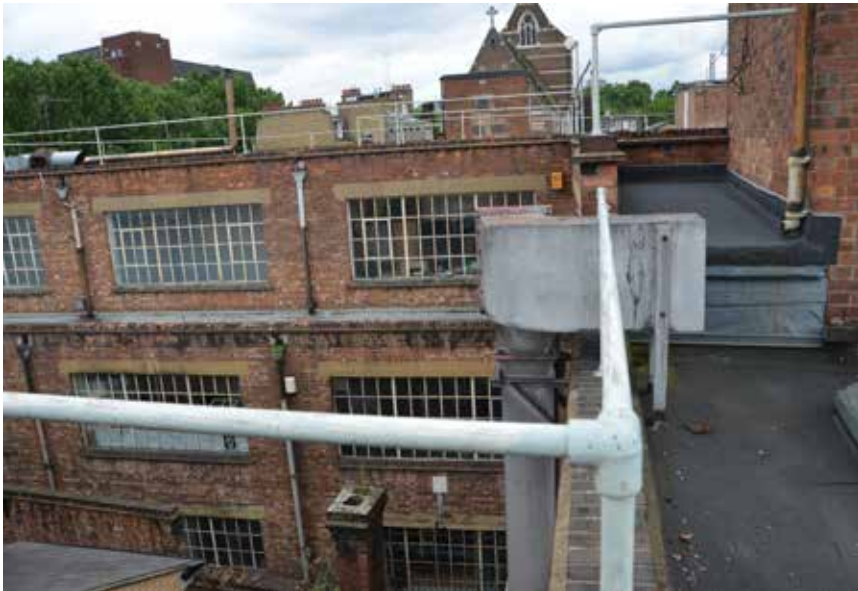
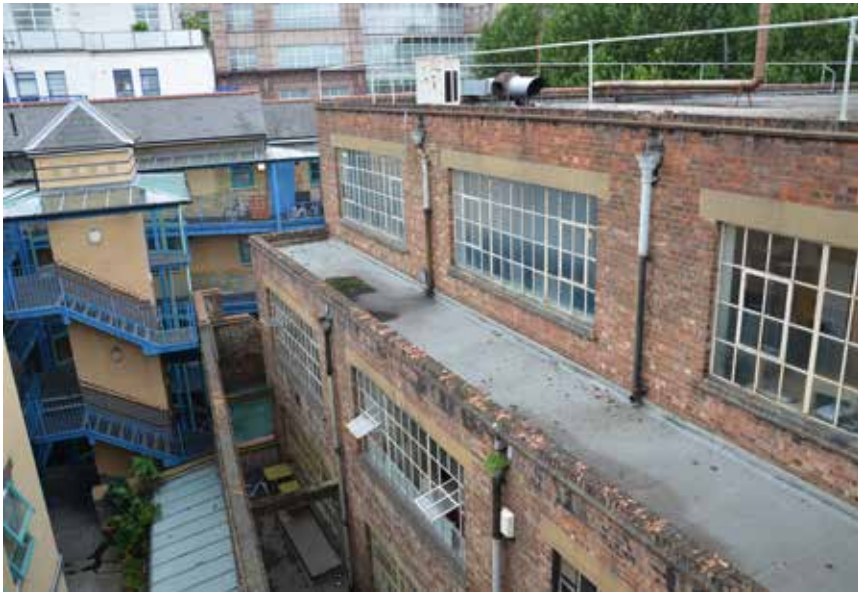
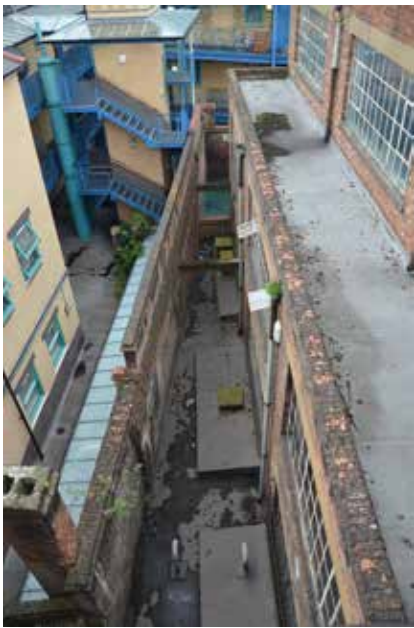
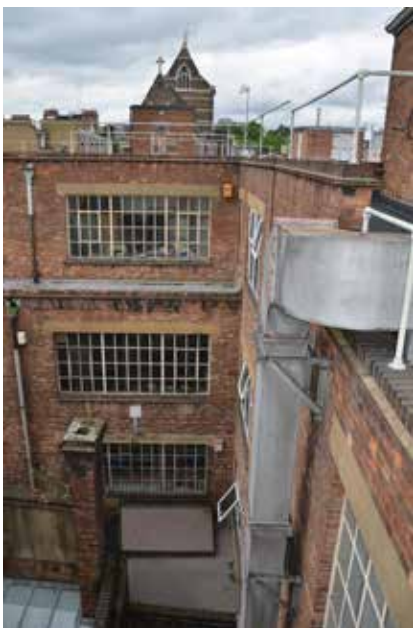
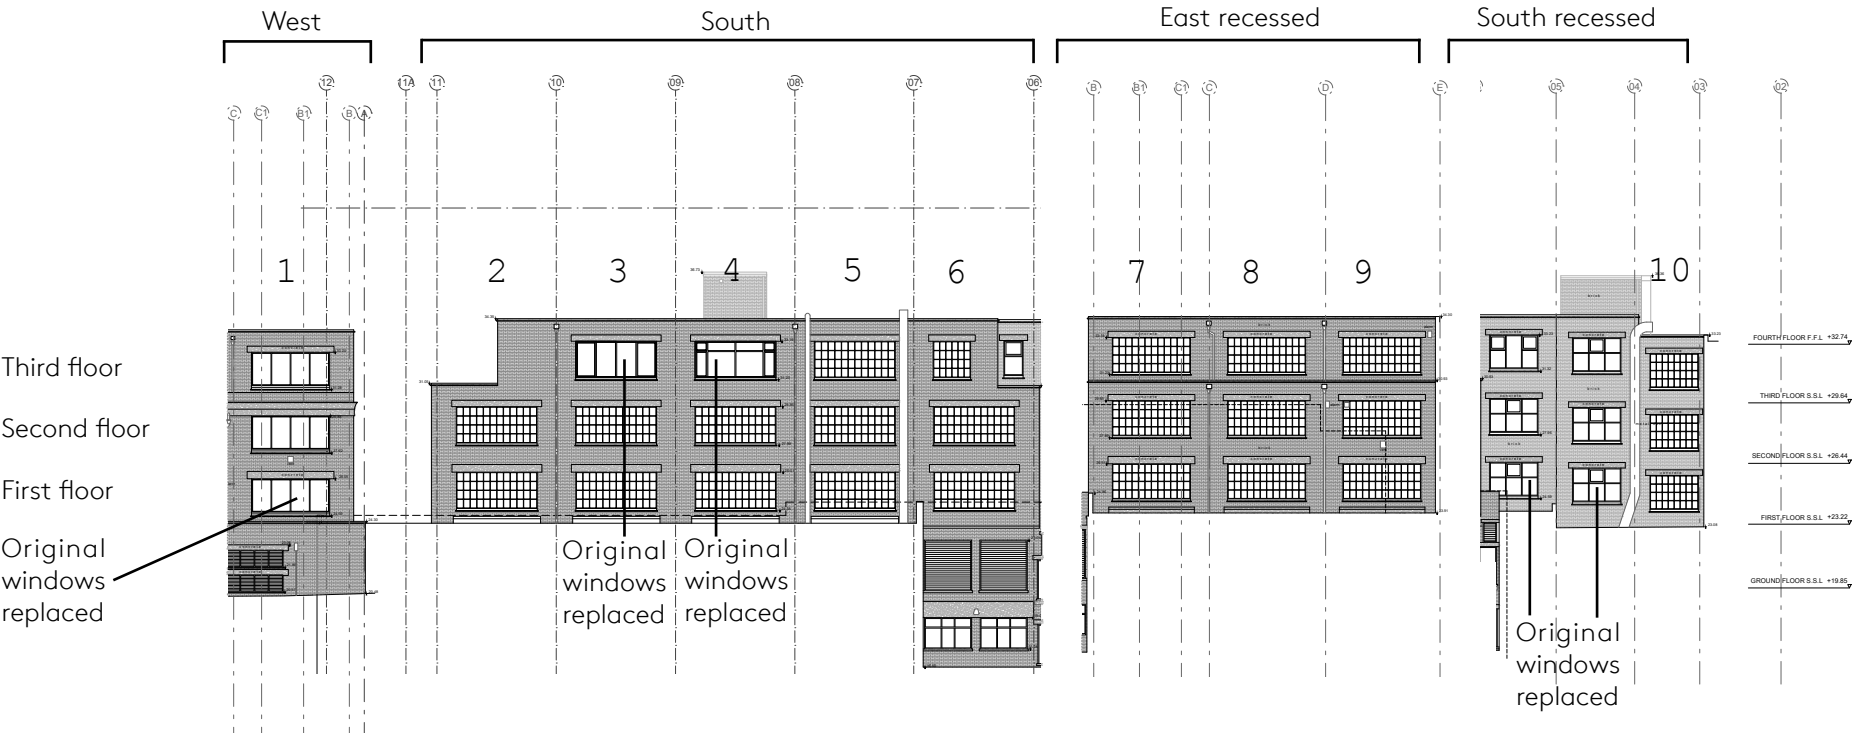
Location of existing windows in retained elevation

The existing windows to the rear and side elevations are a mixture of old single glazed multi-panel metal frame windows and later aluminium/PVC replacements - see overleaf for photographic survey.

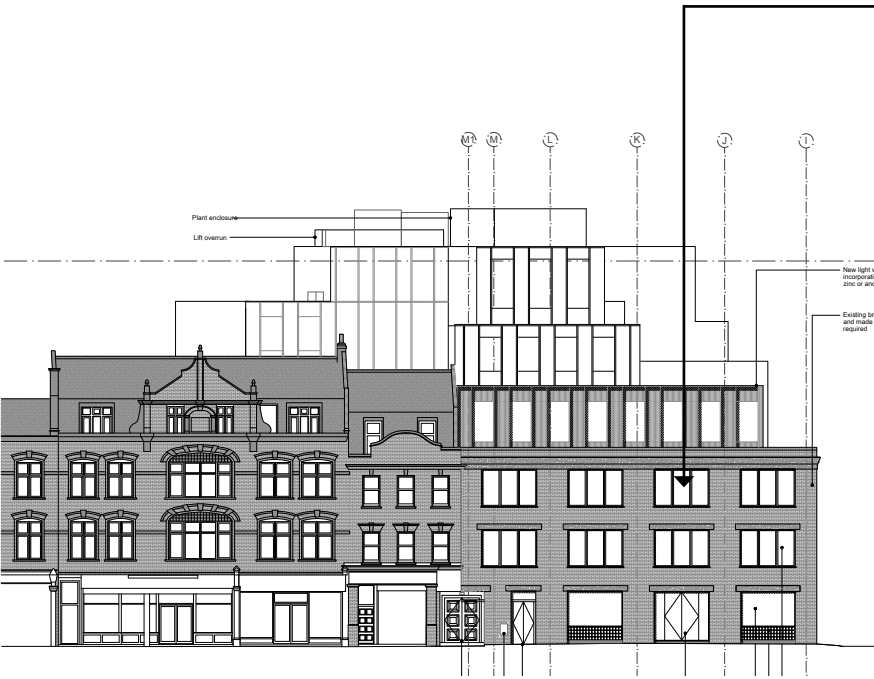
EAST ELEVATION - LEATHER LANE

Existing & new window openings - all proposed (and consented) with high performance double-glazed composite windows with an aluminium outer face; finish natural anodised

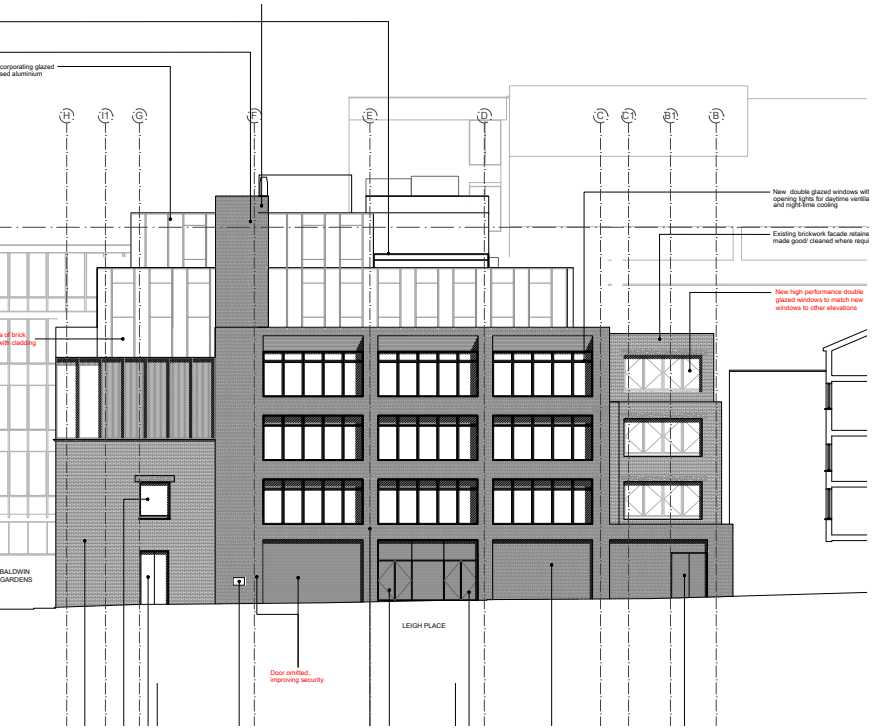
WEST ELEVATION - LEIGH PLACE

Highlighted areas indicate openings where the existing crittall-type windows are proposed to be replaced with a matching window specification to the rest of the building - improving thermal performance and creating a more unified visual appearance

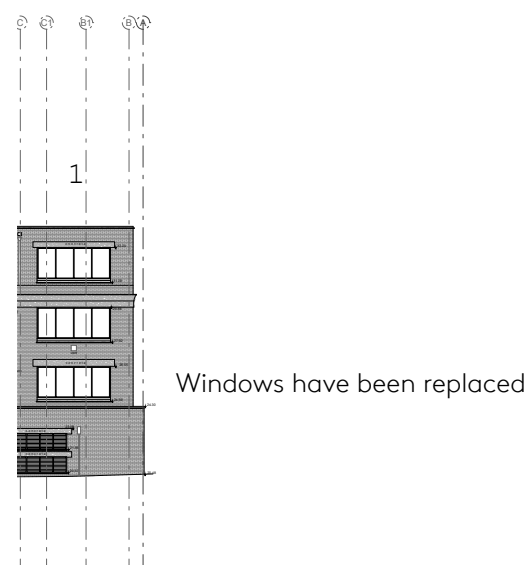
WEST ELEVATION

Window Studies: condition of existing frames

The frames of the existing windows have degraded to a poor quality over time, making them difficult to repair fully.

The frame depths of the windows are too thin to be able to replace the existing glass with new double glazing, limiting the level of improvement to thermal performance that can be made.
