# Basement Impact Assessment

| <b>Site</b> | 55 Greencroft Gardens<br>South Hampstead<br>NW6 3LL |
| <b>Our Ref</b> | BIA/5352 |

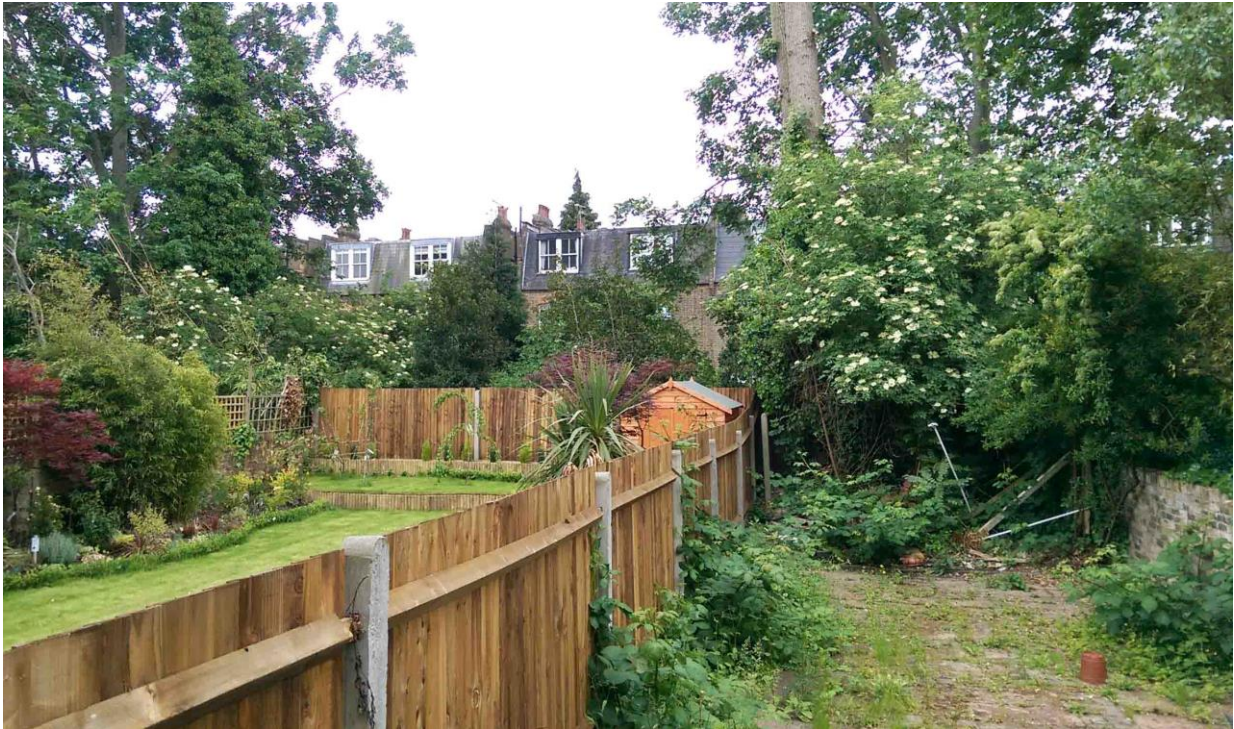
**Photo 3:** The rear garden to Flat 2 No.55 is surfaced with paving slabs, and is bounded by a brick wall to the west, and by wooden fences to the east and south. Overall the garden falls gently southwards, however a slight rise in level can be seen at its southern boundary with No.71 Aberdare Gardens.
