8.1.2 Proposed Basement

The proposed works require the insertion of a new basement beneath the main building, extension and rear garden include one light well and glass roof light.

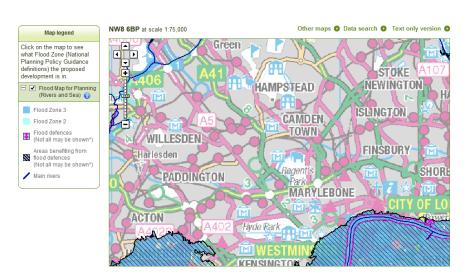
Figure 44: Flood map for planning (Environment Agency)

The site is within Zone 1, a low probability flood risk area.

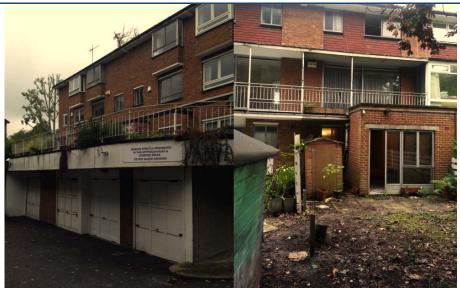
Figure 50: Rear and front of the property

In the unlikely event of surface water flooding in the vicinity, the likelihood of the water entering and accumulating in or the basement is low. This is because the site is on a slope and water will continue to flow downhill, away from the property.
