**Job Number: 15-139**  
**Date: 24 June 2015**

## Basement Structural Method Statement

Planning Application for 269 Goldhurst  
Terrace, London, NW6 3EP

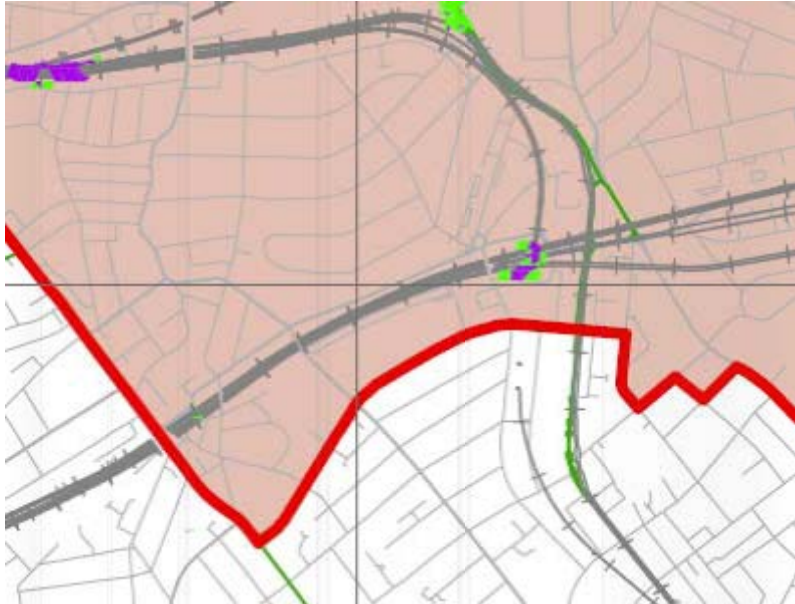
Figure 9: Figure 16 of Arup's report showing slope angle

**No.** The slope of the wider hillside setting is as per the property, less than 7°. From Figure 16 the slope angle is shown less than 7°

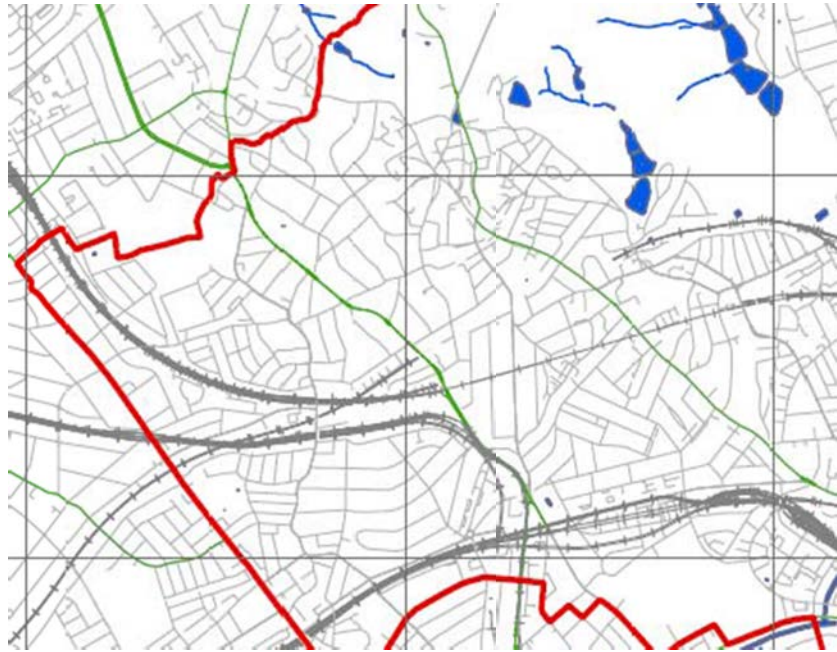
Figure 12: Extract from Camden Surface water features map (Arup's report, Fig 12)

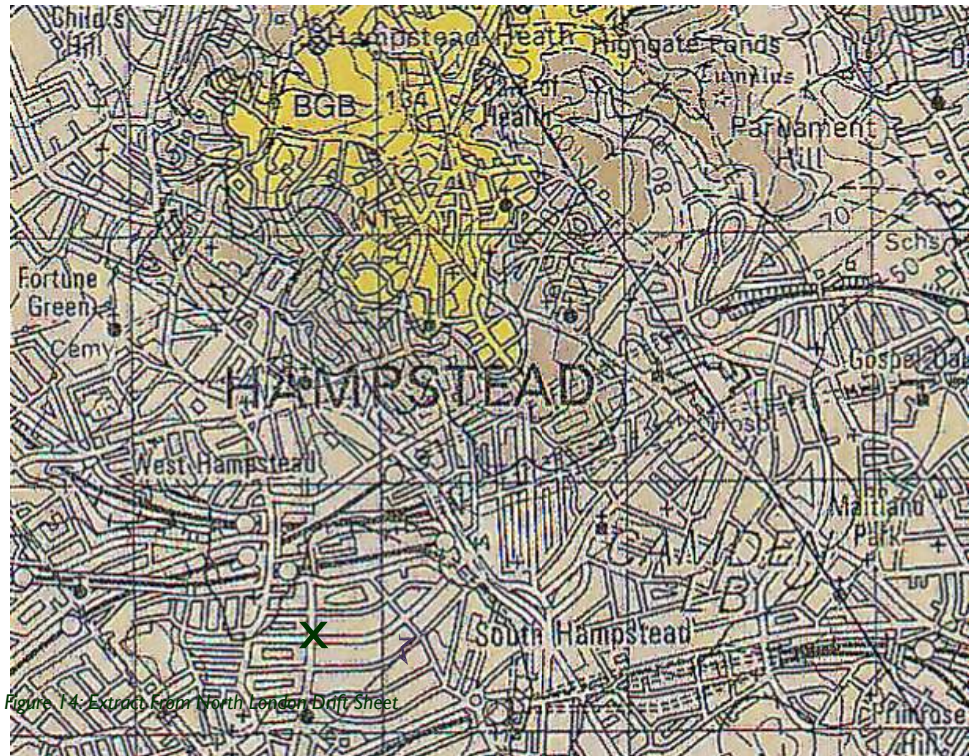
Figure 14- Extract from North London Drift Sheet

The North London Geological Maps Indicates the site is underlain by London Clay. This is as expected in the area. A soil investigation has confirmed this.

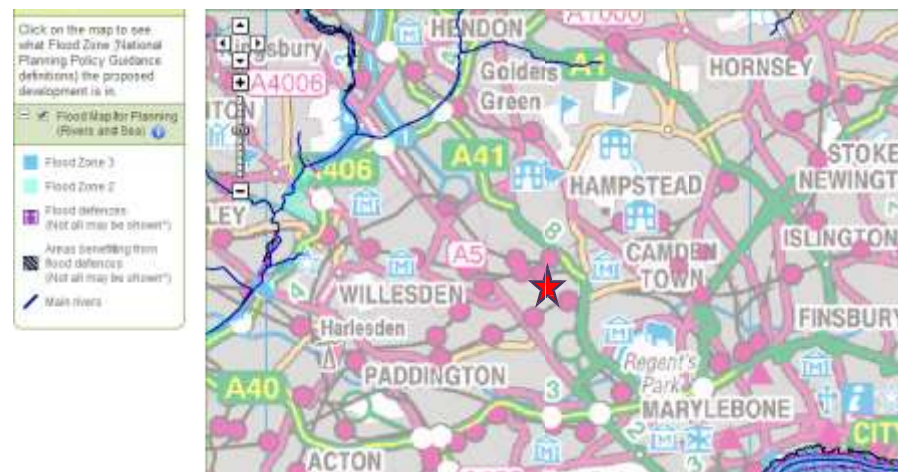
Figure 25: Flood map for planning (Environment Agency)

The site is within Zone I, a low probability flood risk area. However, Camden Panning Guidance CPG4 'Basements and Lightwells requires

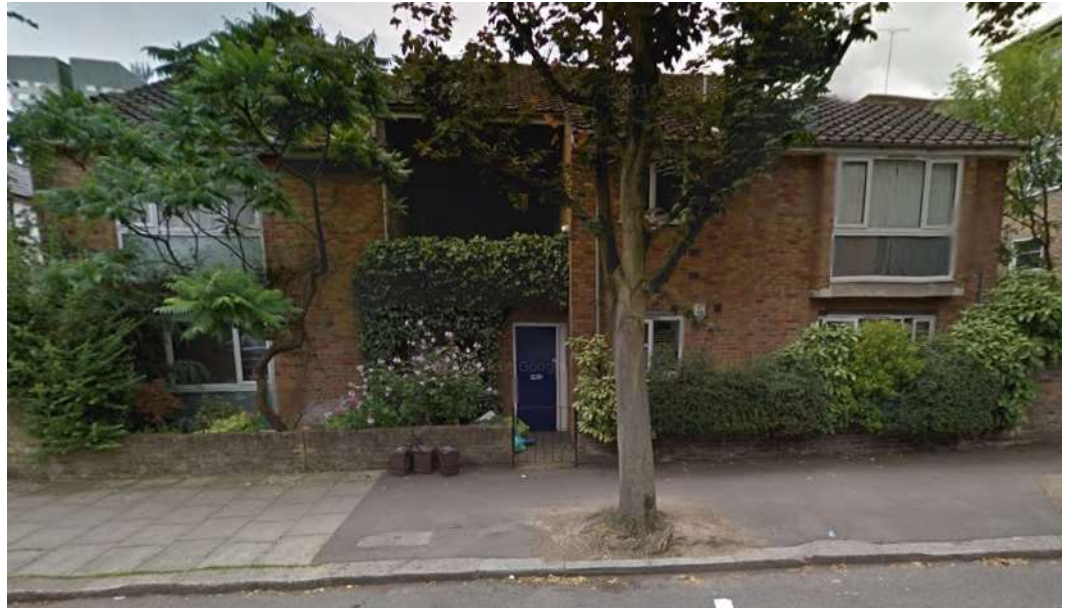
- Excess flow from Goldhurst Terrace may accumulate in the road in front of the site.
- This flow would travel in the direction away from the front elevation of the property owing to the site being on a slightly higher level than the opposite side of the street, and the raised level of the pavement above the road (see photo below).

*Figure 26: Street level view showing kerb raised above road*

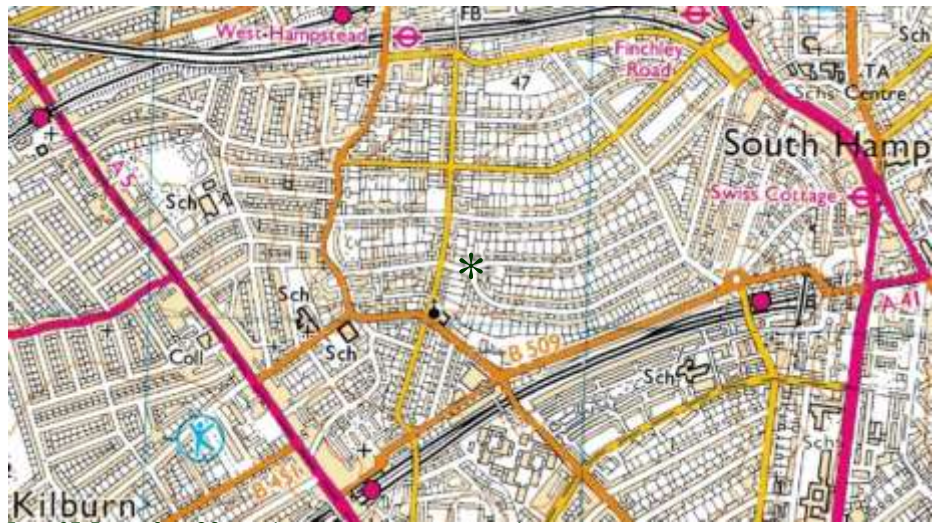
Figure 27: Extract from OS map showing proximity to nearest railways
