**Grove Lodge, Admirals Walk,  
London**  
*Ground Movement Assessment*

August, 2015

Reference	CG/09013	Revision 1	Issue Date August 2015

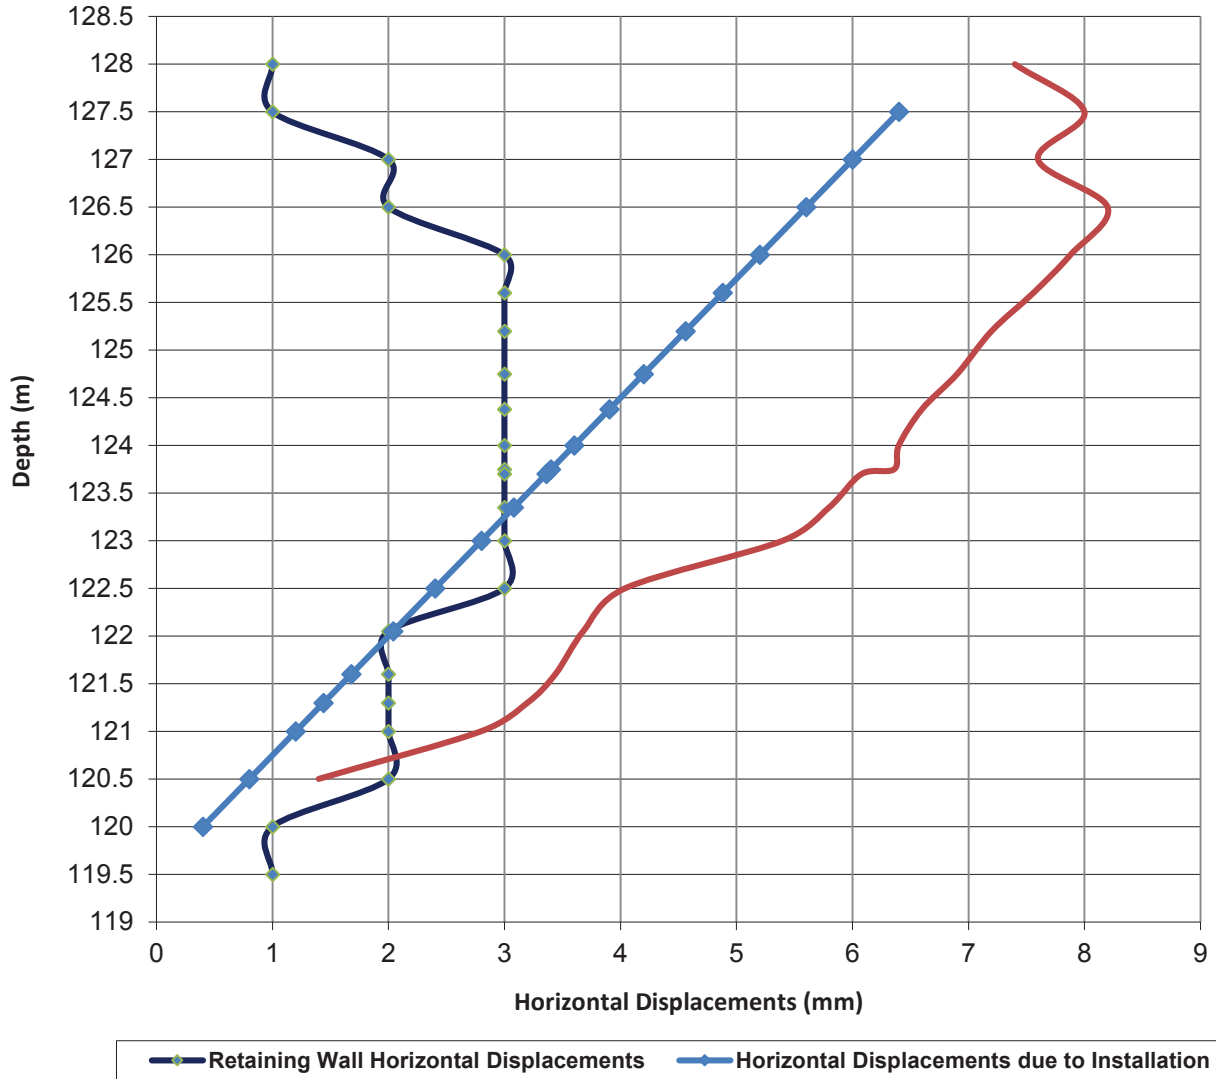
<p>Title</p> <p><b>Horizontal Ground Movements</b></p>	<p><b>Figure 8</b></p>

Retaining Wall Horizontal Displacements (Grove Lodge)

Figure 8 shows the combined lateral movement of the piled wall due to pile installation and deflection. The maximum lateral deflection of the piled wall at the level of Grove Lodge foundations (125m AOD) is predicted to be 3mm. Adding the horizontal movement due to installation, results in a total horizontal movement of 7.4mm which corresponds to a horizontal strain of 0.062% (calculated over a total building length of 12m).
