PROJECT TITLE:  
**SOAS INTO SENATE HOUSE  
 MALET STREET  
 LONDON, WC1E 7HU**

DRAWING TITLE:  
**COURTYARD  
 LG.09 LOWER GROUND  
 ELEVATIONS**

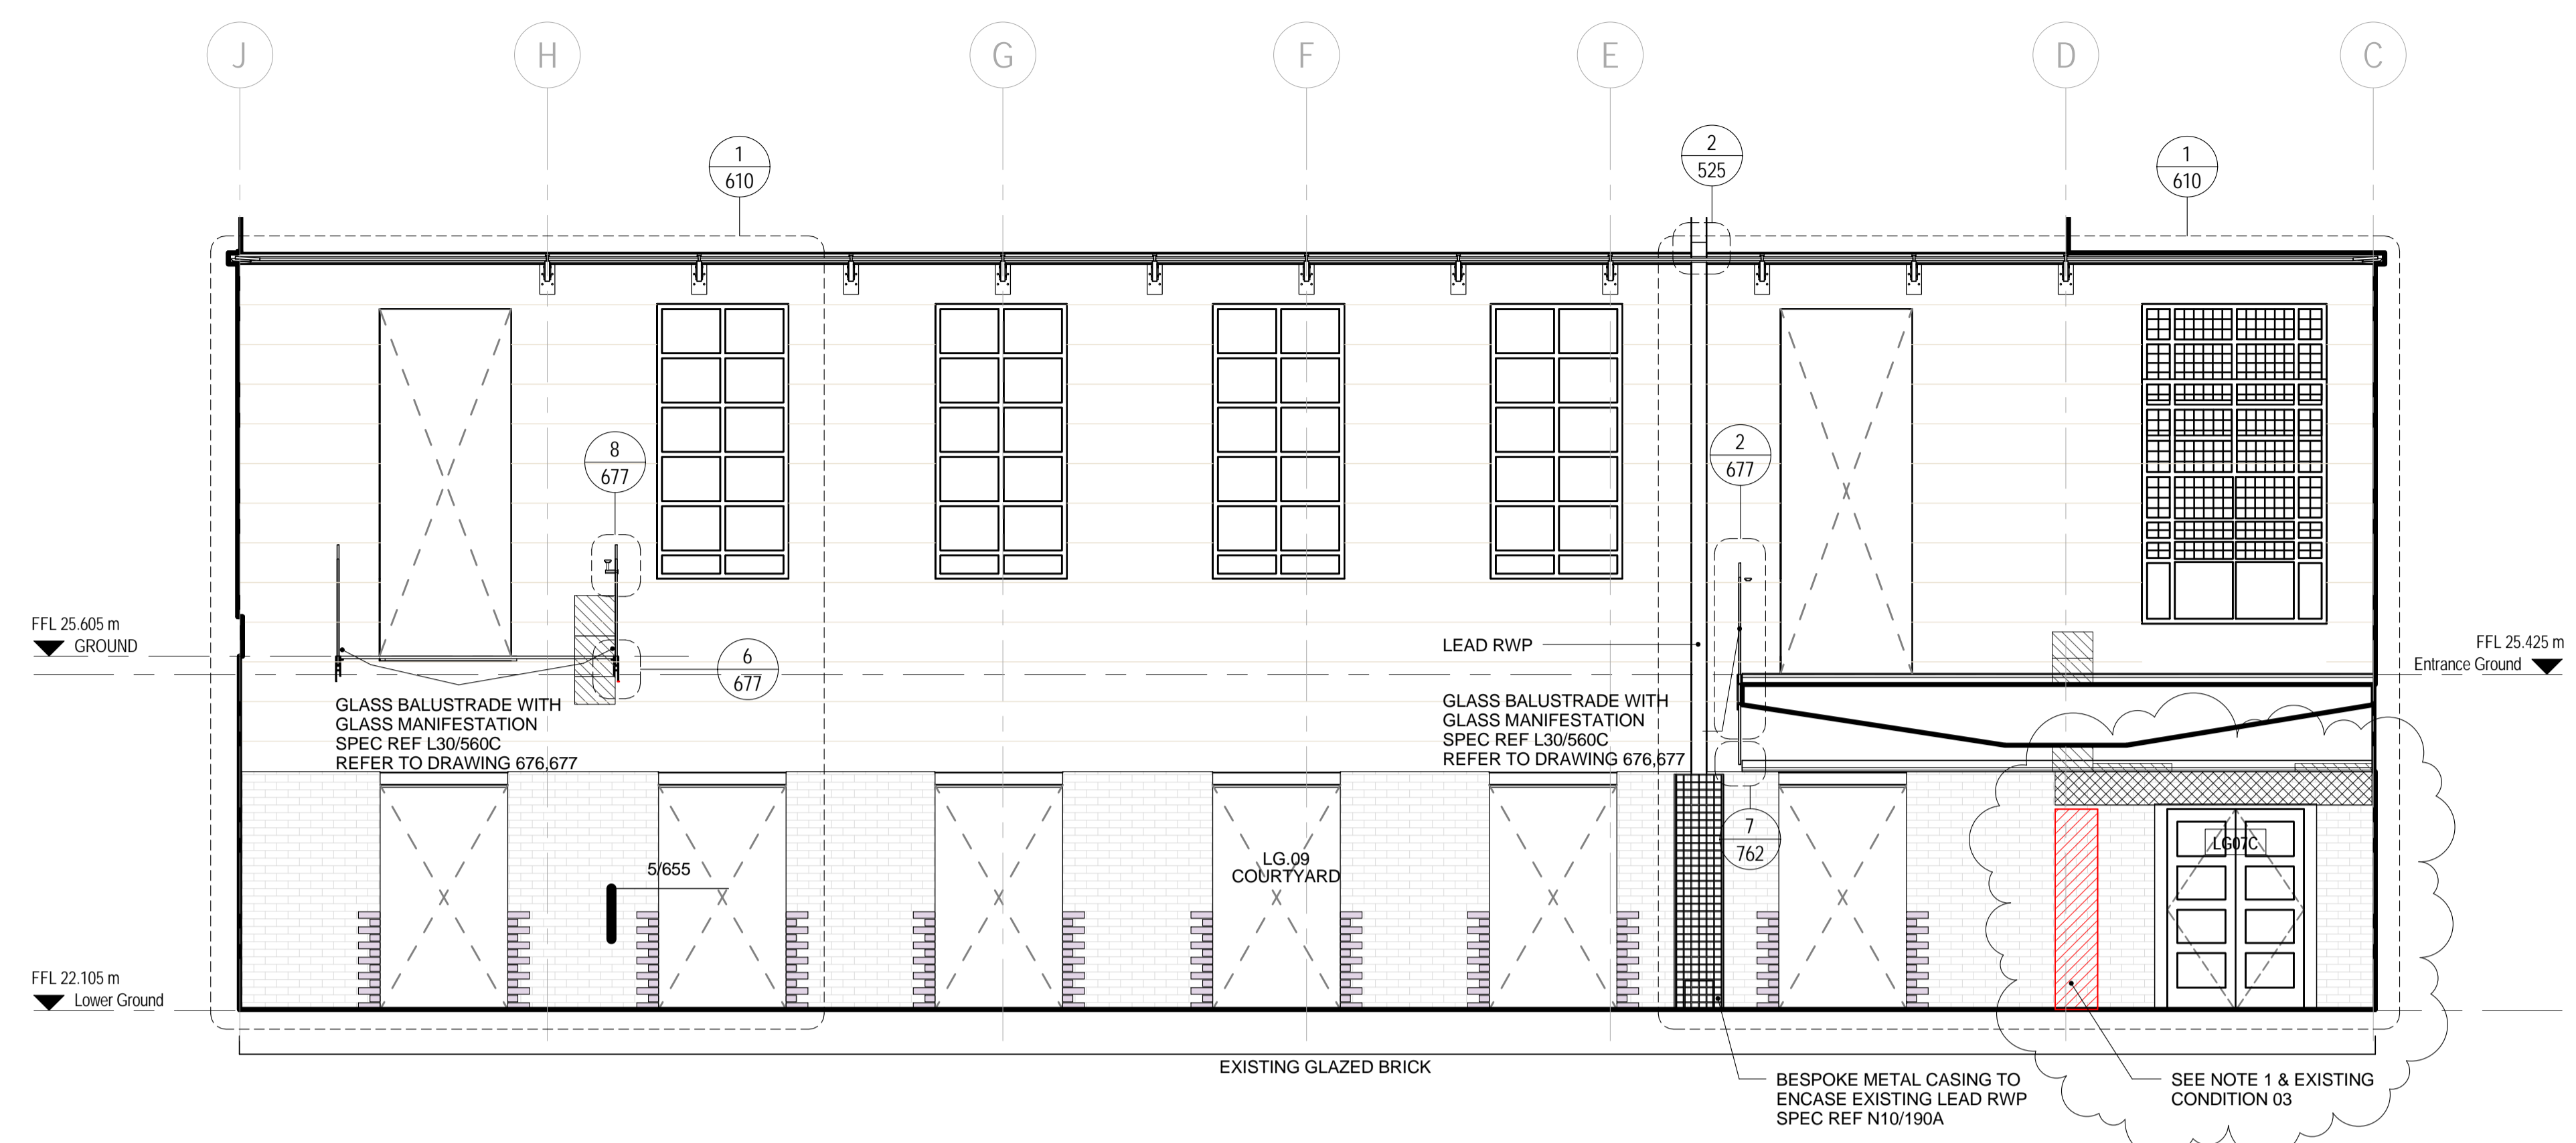
**1 LG.09 ELEVATION NORTH**  
1 : 50

- NOTES:**
- 1) ORIGINAL GLAZED PIER TO BE CAREFULLY CUT BACK TO ALIGN WITH ADJACENT SURFACE. FINISH WITH NEW GLAZED TILES TO MATCH EXISTING TO SUIT CONDITION / LOCATION. MAKE GOOD ANY EXISTING BRICKS / TILES WHERE REQUIRED.
  - 2) ORIGINAL WALL TO BE CAREFULLY CUT BACK TO ALIGN WITH ADJACENT SURFACE.
  - 3) TO BE READ IN CONJUNCTION WITH DONALD INSALL ASSOCIATES COURTYARD MASONRY REPAIRS ELEVATIONS AND SCOPE.
- PROPOSED GLAZED BRICKS / TILES TO MATCH EXISTING
  - PLASTER FINISH TO EXISTING WALL. MAKE GOOD AND PREPARE FOR PAINT FINISH
  - REPLACED / REFURBISH GLAZED BRICKS / TILES
