3. Basement Impact: Screening Maps

4. Basement Impact: Scoping

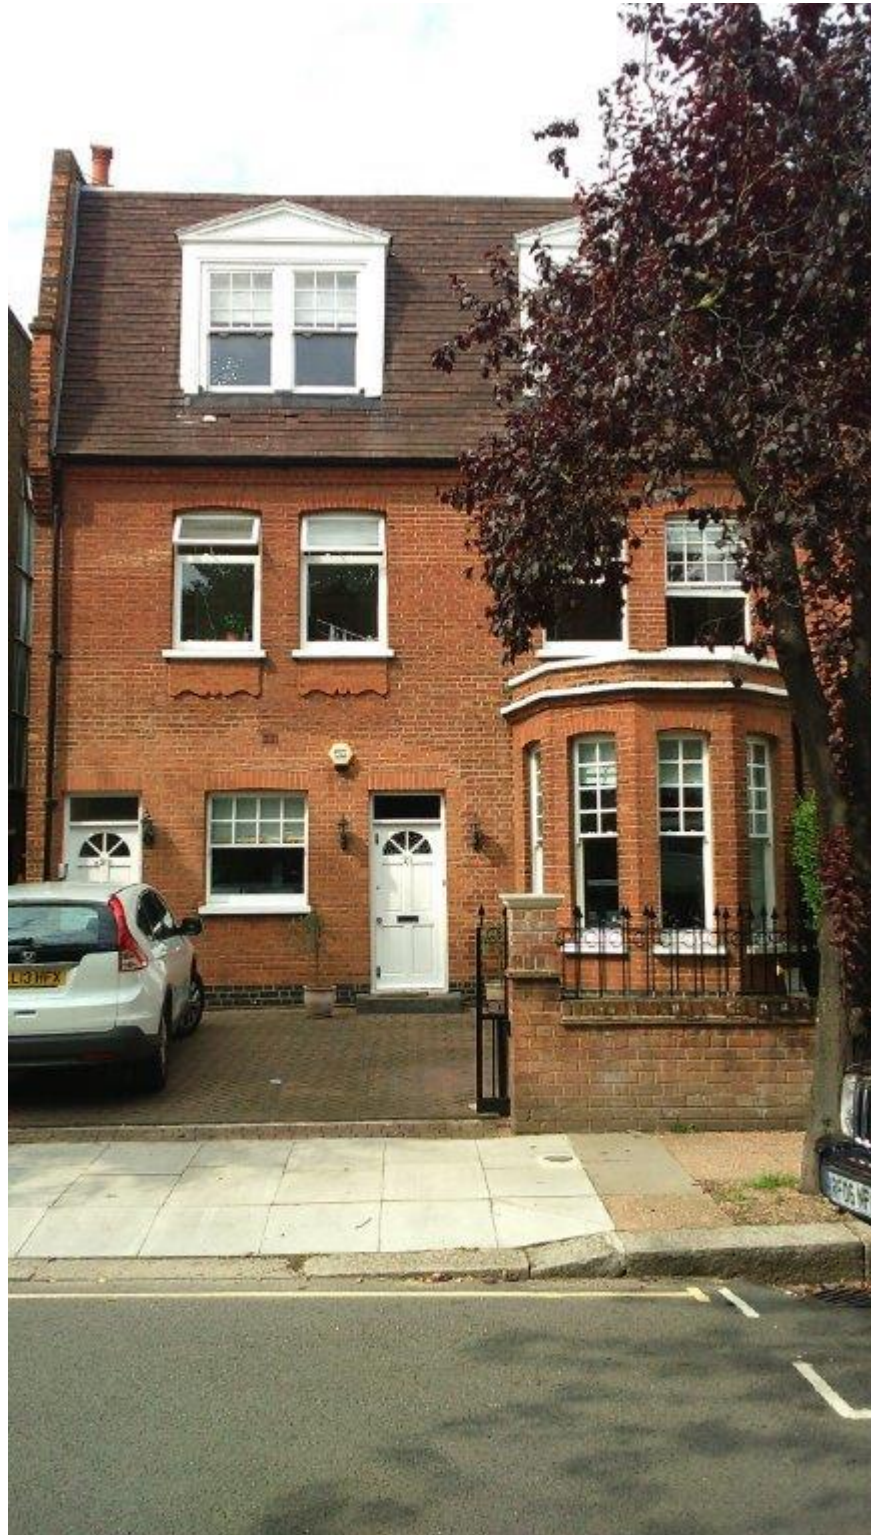
Figure 26: Street level view showing kerb raised above road

- Excess flow from Aberdare Gardens will move, owing to the slight fall on the road outside.
- This flow would travel in the direction away from the front elevation of the property owing to the site being on a slightly higher level than the opposite side of the street, and the raised level of the pavement above the road (see photo below).
