2 Gayton Road, NW3

Basement Impact Assessment

2 Gayton Road

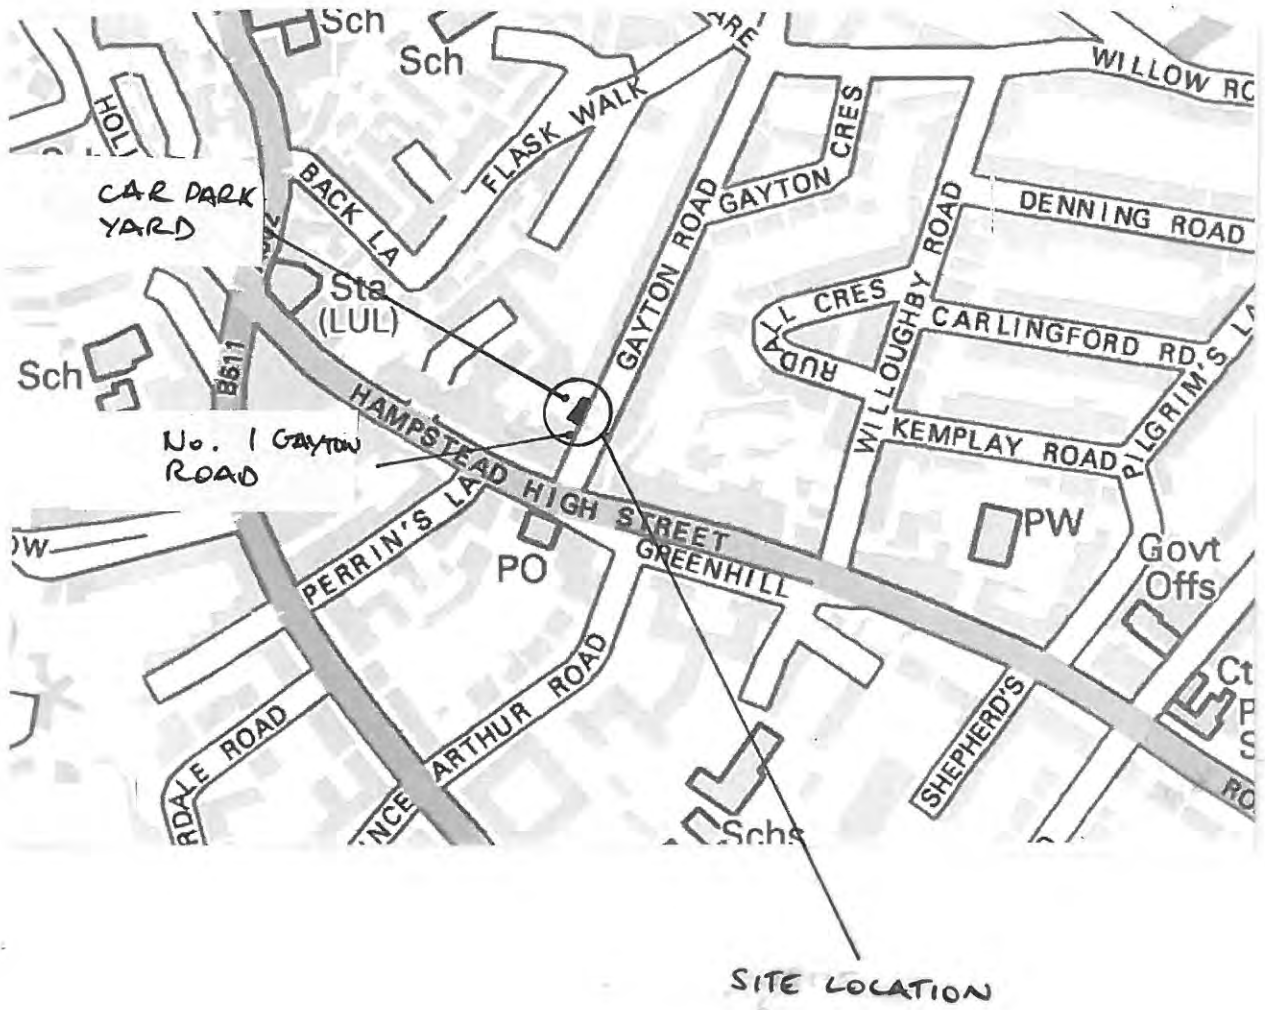
date		drawn		checked		scale (original - A4)		ISSUED AS PART OF A REPORT		DP
JULY '15		DP		LF		NTS				
job		dwg.		drg. no.		rev.		Alan Baxter 75 Cowcross Street London EC1M 6EL Tel 020 7250 1555 email aba@alanbaxter.co.uk www.alanbaxter.co.uk		
2 GAYTON ROAD, NW3		SITE PLAN		1727/70/01		-

– Hampstead Heath Map – indicate the site is not within 50m of the Hampstead Heath ponds.	
12	Is the site within 5m of a highway or pedestrian right of way?	Yes, the proposed basement is within 5m of the pavement to Gayton road, refer to site location map in Appendix A.	Y
13	Will the proposed basement significantly increase the differential depth of foundations relative to neighbouring properties?	No, the surrounding buildings have basements founded at the same level	N
14	Is the site over (or within the exclusion zone of) any tunnels, e.g. railway lines?	No, based on our in-house information, the site is outside any exclusion zones.	N

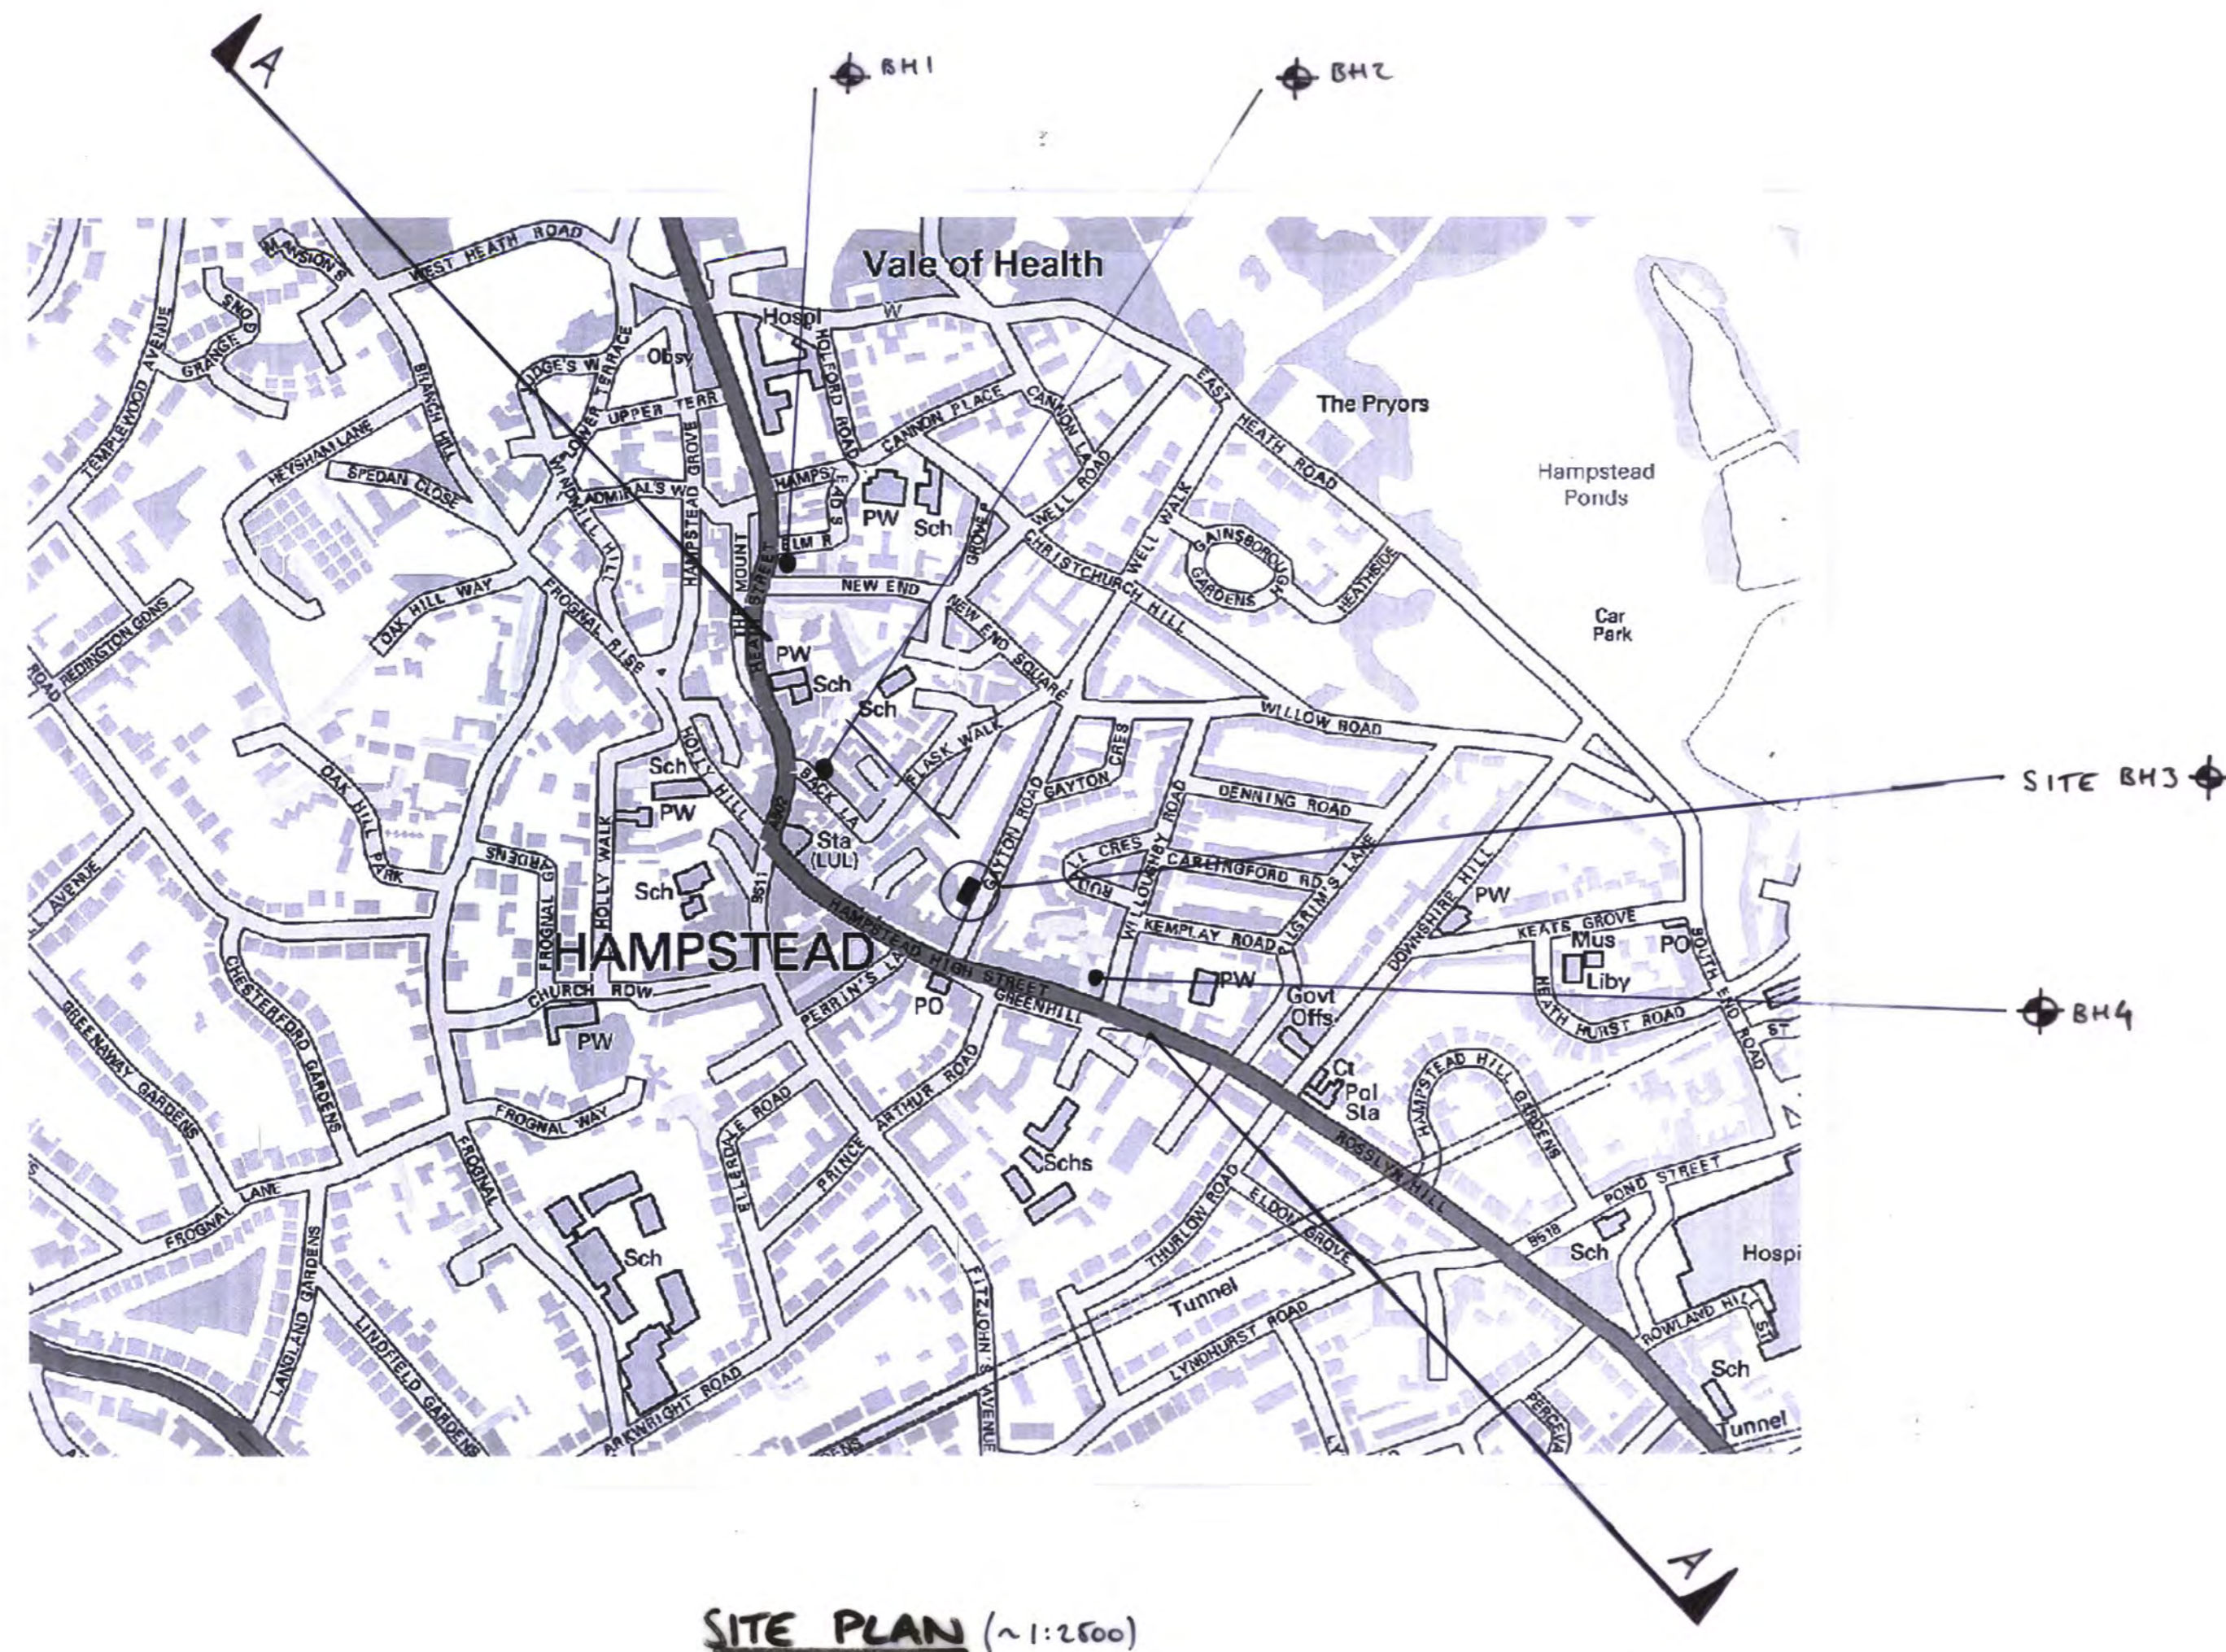
- notes
- THIS DRAWING IS TO BE READ IN CONJUNCTION WITH ALL OTHER RELEVANT ARCHITECTS AND ENGINEERS DRAWINGS AND SPECIFICATION.
 - DO NOT SCALE FROM THIS DRAWING.
 - KEY:
 - MADE GROUND.
 - SANDS AND GRAVEL (BAGSHOT FORMATION)
 - CLAYGATE BEDS
 - THE INFORMATION OF THIS DRAWING WAS OBTAINED FROM BGS BOREHOLE LOGS AND SITE INVESTIGATION CARRIED OUT AT NO.2 GAYTON ROAD.
 - BH1: TQ28NE8
 - BH2: TQ28NE94
 - BH3: CARRIED OUT BY SOUTHER TESTING IN JUNE 2015
 - BH4: TQ28NE304

- 18.7.15	ISSUED AS PART OF A REPORT	LF
job 2 GAYTON ROAD, NW3		
title SUMMARY OF BOREHOLE LOGS AROUND THE SITE		
drawn DP	checked LF	
date JULY 15	scale (original - A1) AS SHOWN	
<h2>Alan Baxter</h2> <p>75 Cowcross Street London EC1M 6EL tel 020 7250 1555 email aba@alanbaxter.co.uk www.alanbaxter.co.uk</p>		
orig. no. 1727/10/05	rev.	-
