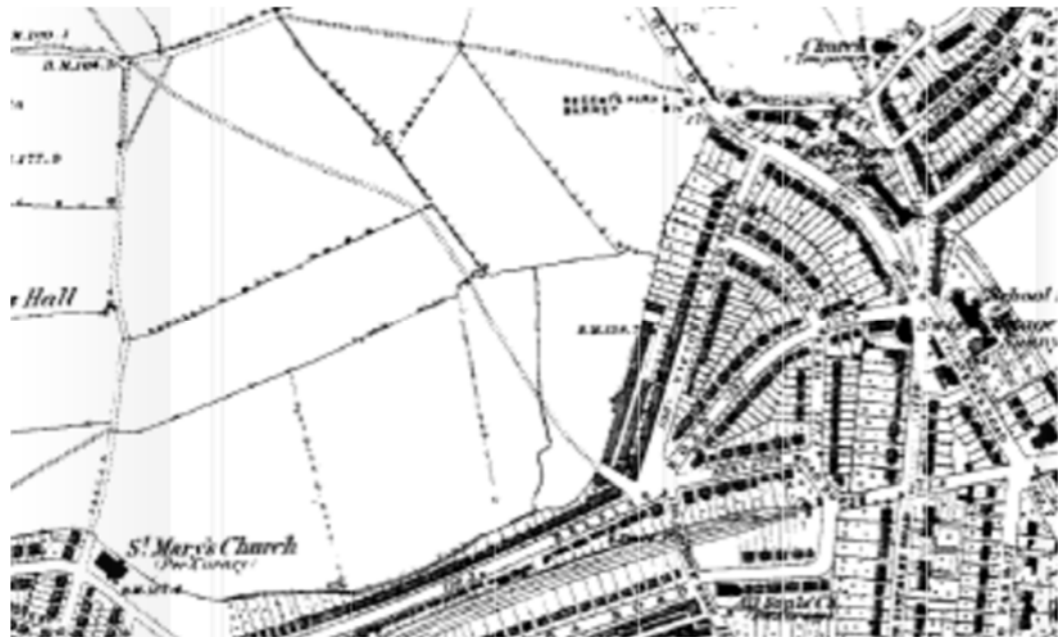
Figure 22: Historic map from 1882

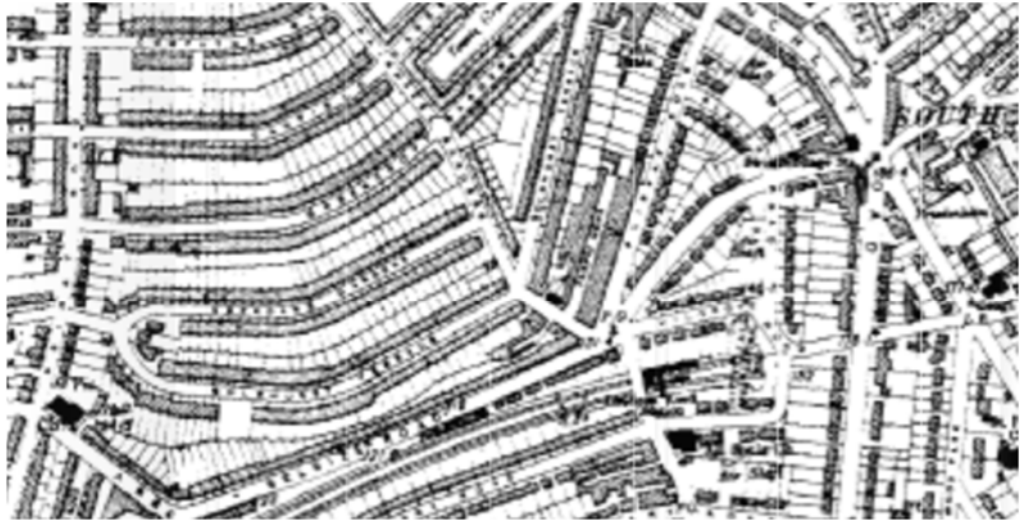
Figure 24: Historic map from 1920
