| Be | n Pentreath | h & Associ | ates |
|---|---|---|---|
| Project: | NORFOL | K ROAD | |
| | CAMDEN | 1 | |
| Title: | PROPOS | ED FRONT | Г |
| | STREET | ELEVATI | O N |

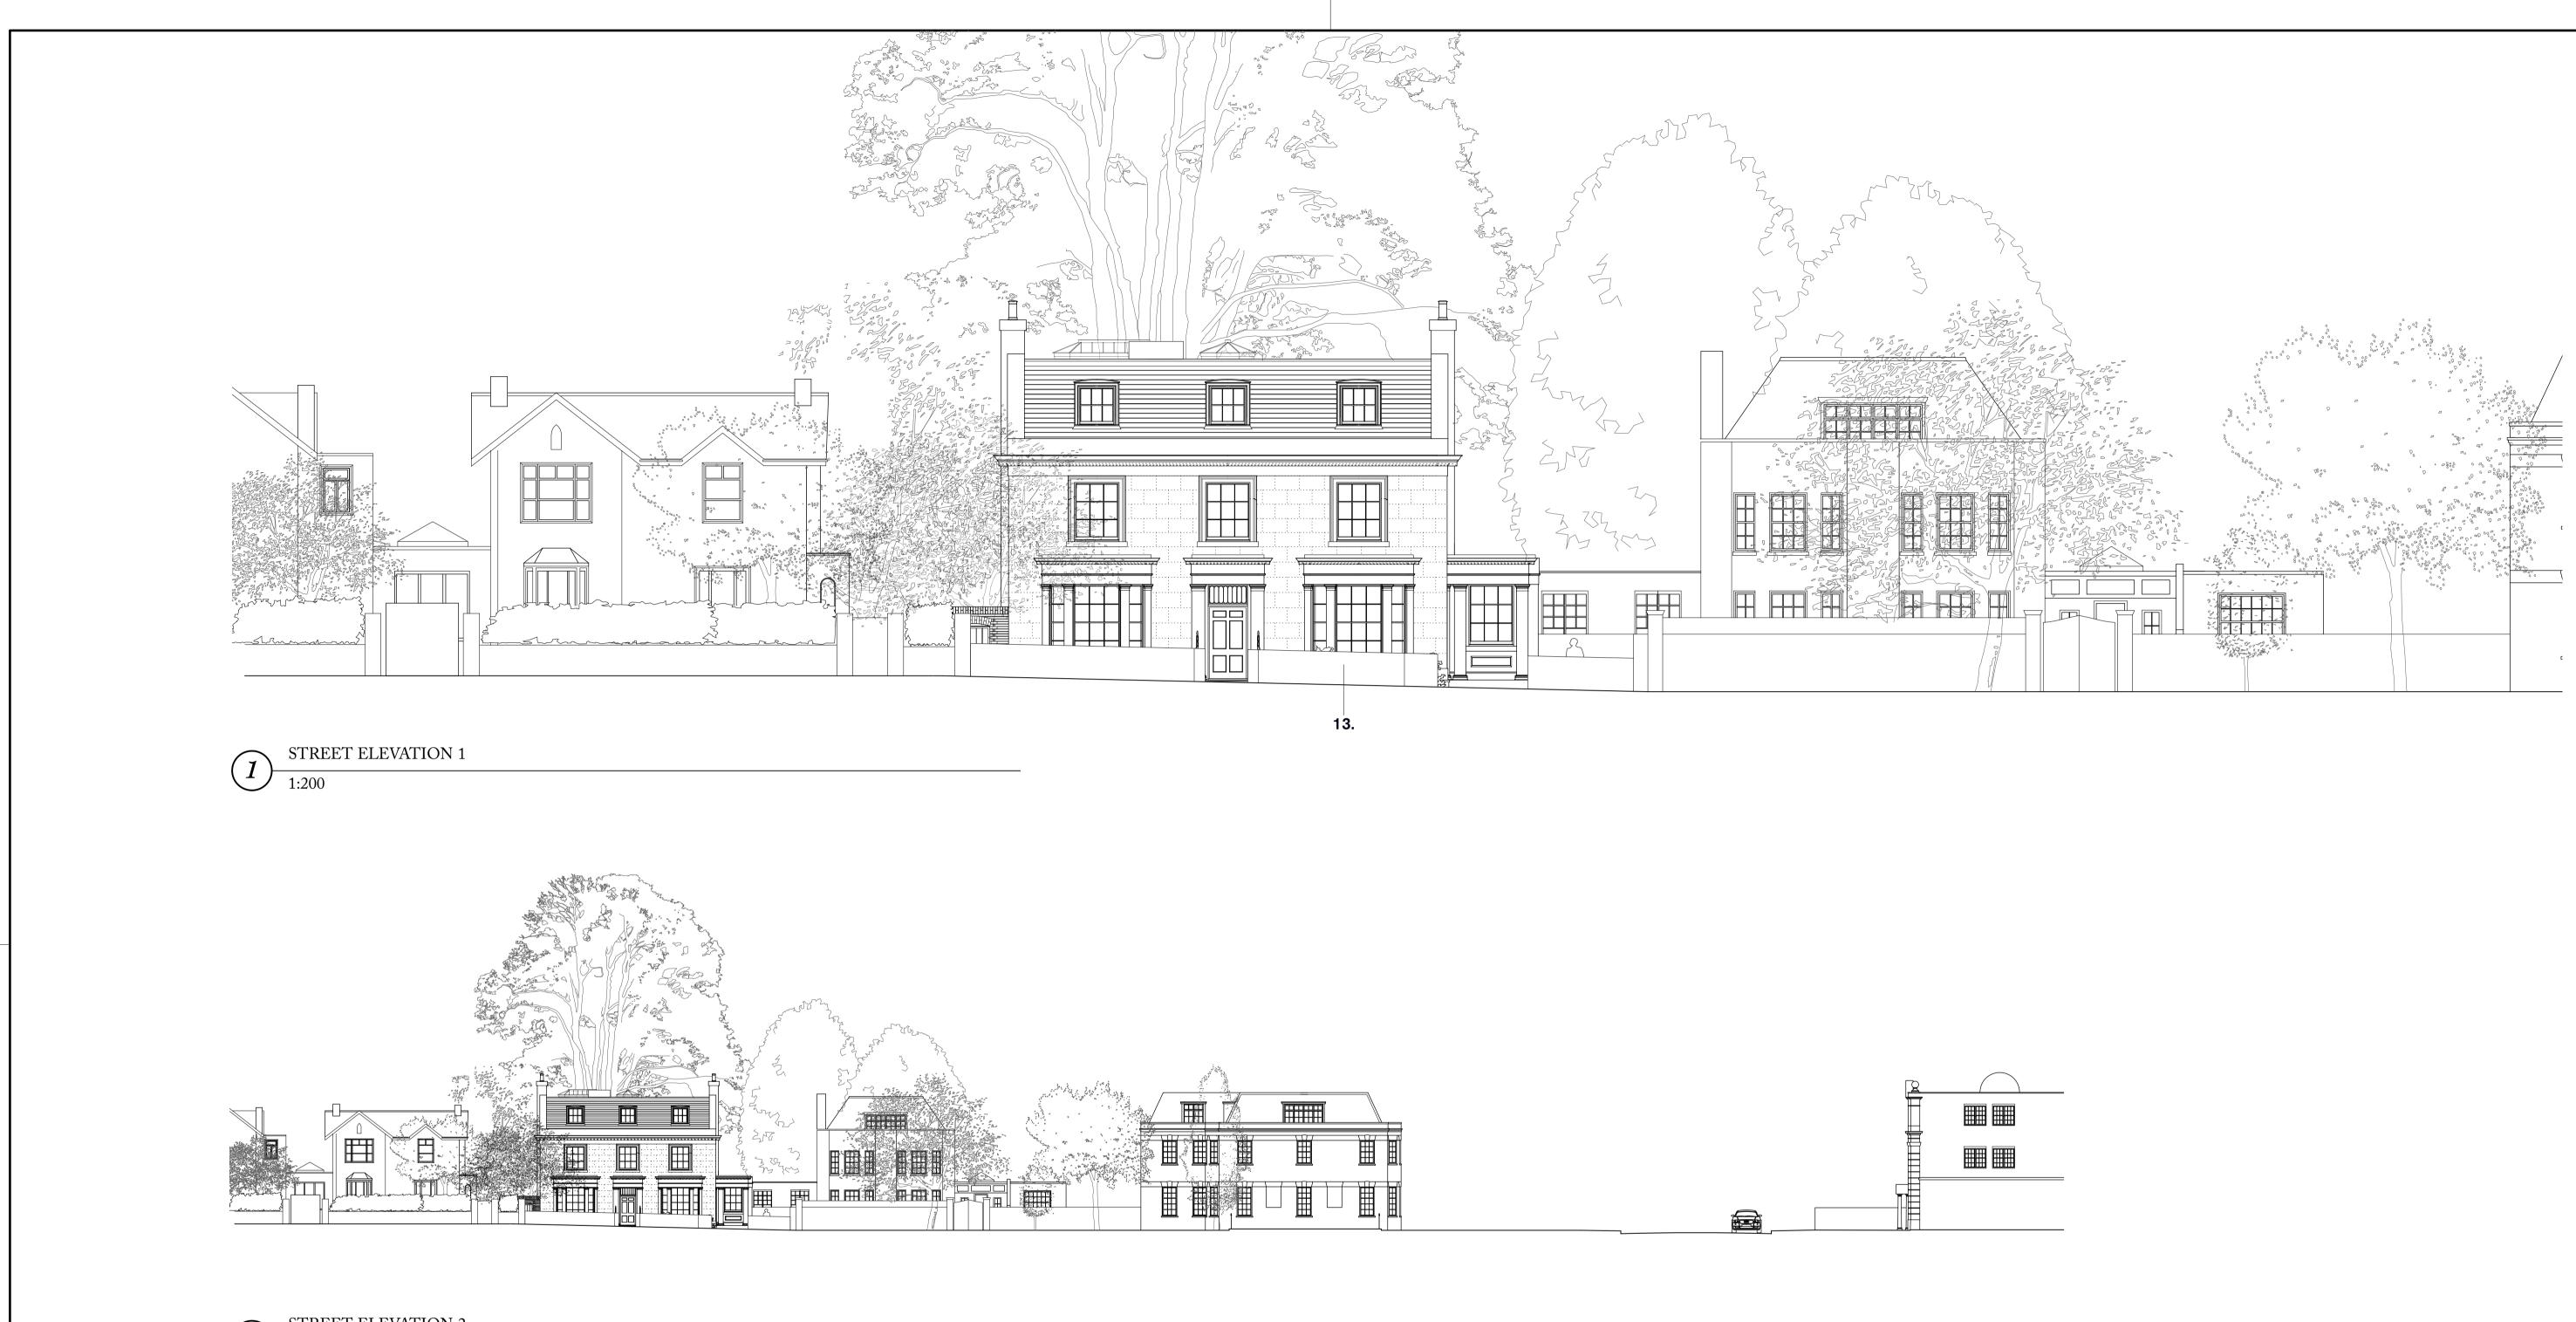
| Be | n Pentreath | h & Associ | ates |
|---|---|---|---|
| Drwg No: | 108 | Rev. No: | D |

- 1. Welsh slate roof with lead flashing to parapet
- 2. Render walls painted off white
- 3. Evalon by Alwitra single ply membrane roof
- 4. Lead covered lift overrun
- 5. PV array
- 6. Metal rainwater goods painted 'off white' Longbottom Ltd 4" downpipe
- 7. Hardwood timber door
- 8. Painted metal acoustic louvres
- 9. Reclaimed York stone open jointed pavers on suitable bed to permit free drainage
- 10. For planting see planting schedule
- 11. Openable glazed rooflights
- 12. Obscured tilt and turn sidelights with painted finish to hardwood frame
- 13. Garden wall repointed, repaired or replaced as necessary to match existing
- 14. Existing holly tree retained

- 17. Decorative jointing to stucco to detail
- 19. Decorative stucco cornicing

- 21. Portland stone cill
- 22. Render with lead dressing parapet
- 23. Clay chimney pots square base
- 26. Yellow London stock brick to match others locally
- 27. Hardwood framed glazed door painted
- 28. Boiler flue

- 16. Double glazed painted finished hardwood sash windows
- 18. Metal balustrade painted with metal based gloss paint
- 20. Lead clad dormer window cheeks timber front face
- 24. Electrically operated sliding gate. Metal gate to be painted
- 25. Metal garden gate painted with suitable metal gloss paint

- 29. Kitchen extract
- 30. Painted hardwood timber gate
- 31. SUDS technology to front garden landscaping
- 32. External refuse in secure enclosure
- 33. Composting bins
- 34. Secure cycle storage
- 35. Portland stone coping
- 36. Portland stone steps
- 37. Painted stucco window surrounds
- 38. For details of below ground construction see Structural Engineer's reports
- 39. For details of soil and groundwater conditions see Structural Engineer's reports
- 40. For details of services see Services Engineer's reports
- 41. Lead lined roof to minimum falls
- 42. Pool extract

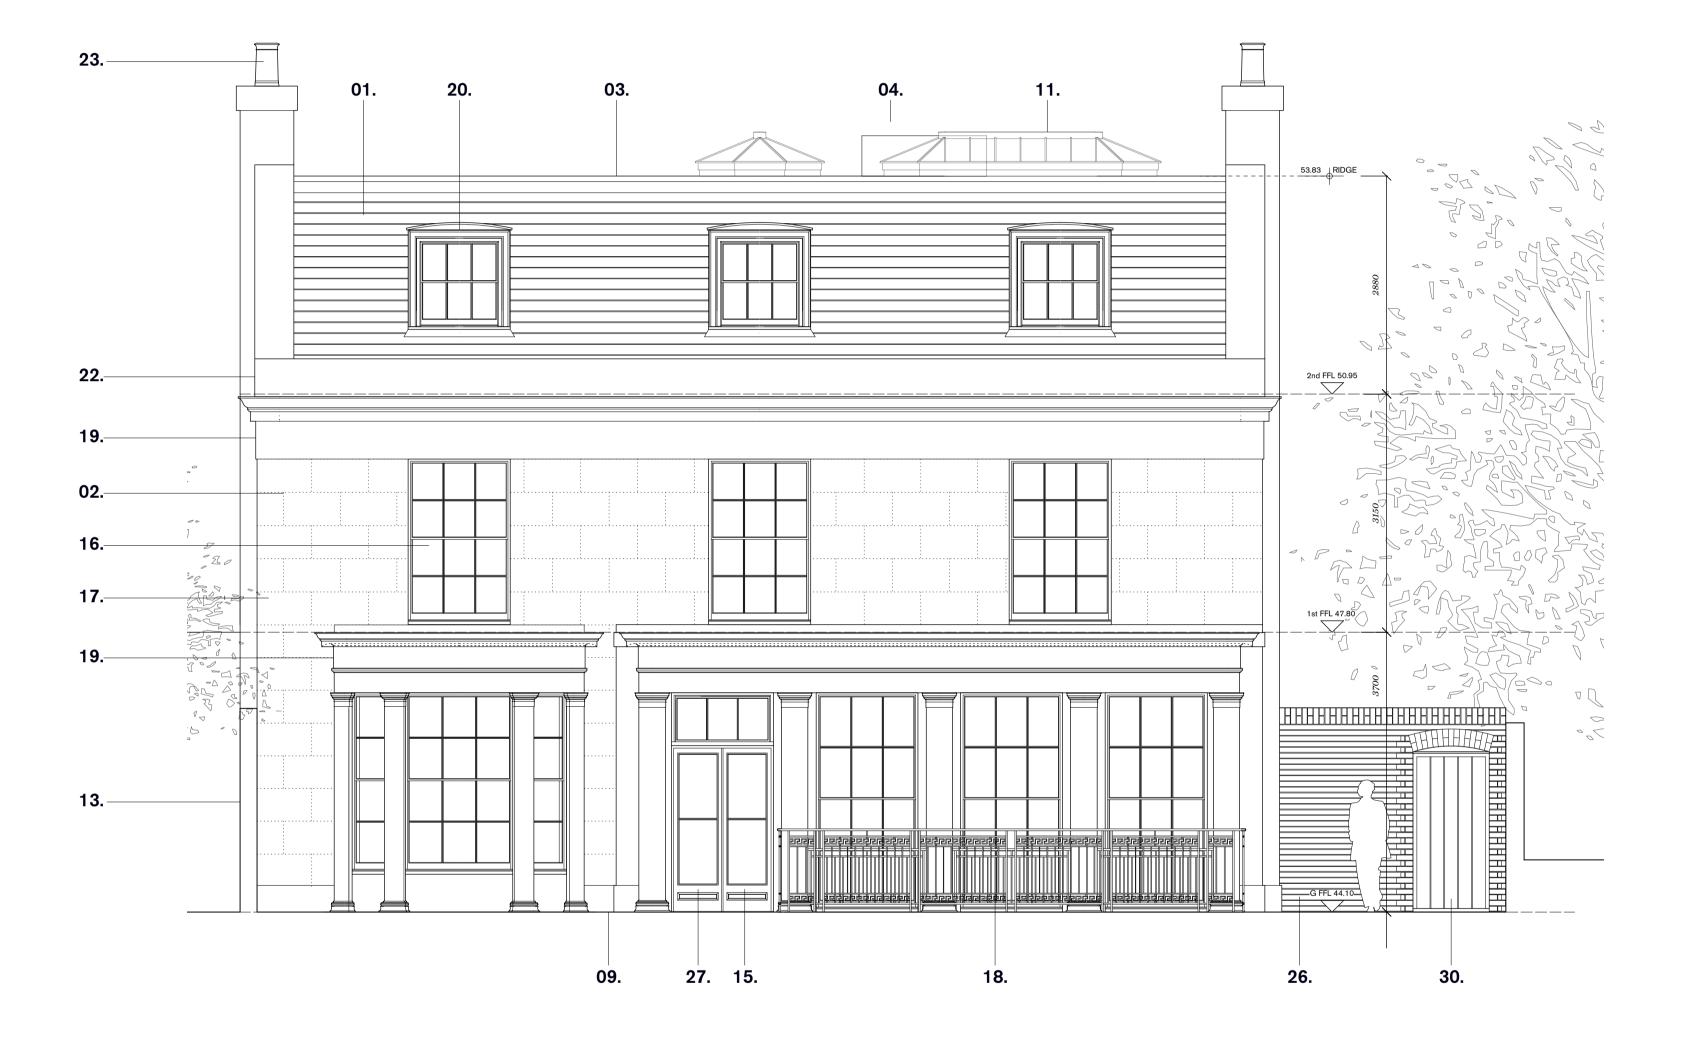
| | n Pentreath | | |
|---|--|---|---|
| Drwg No: | 110 | Rev. No: | D |

- 1. Welsh slate roof with lead flashing to parapet
- 2. Render walls painted off white
- 3. Evalon by Alwitra single ply membrane roof
- 4. Lead covered lift overrun
- 5. PV array
- 6. Metal rainwater goods painted 'off white' Longbottom Ltd 4" downpipe
- 7. Hardwood timber door
- 8. Painted metal acoustic louvres
- 9. Reclaimed York stone open jointed pavers on suitable bed to permit free drainage
- 10. For planting see planting schedule
- 11. Openable glazed rooflights
- 12. Obscured tilt and turn sidelights with painted finish to hardwood frame
- 13. Garden wall repointed, repaired or replaced as necessary to match existing
- 14. Existing holly tree retained

- 17. Decorative jointing to stucco to detail
- 19. Decorative stucco cornicing
- 21. Portland stone cill
- 22. Render with lead dressing parapet
- 23. Clay chimney pots square base
- 24. Electrically operated sliding gate. Metal gate to be painted

- 28. Boiler flue

- 15. Level access to dwelling for Lifetime Homes standards
- 16. Double glazed painted finished hardwood sash windows
- 18. Metal balustrade painted with metal based gloss paint
- 20. Lead clad dormer window cheeks timber front face
- 25. Metal garden gate painted with suitable metal gloss paint
- 26. Yellow London stock brick to match others locally
- 27. Hardwood framed glazed door painted

- 29. Kitchen extract
- 30. Painted hardwood timber gate
- 31. SUDS technology to front garden landscaping
- 32. External refuse in secure enclosure
- 33. Composting bins
- 34. Secure cycle storage
- 35. Portland stone coping
- 36. Portland stone steps
- 37. Painted stucco window surrounds
- 38. For details of below ground construction see Structural Engineer's reports
- 39. For details of soil and groundwater conditions see Structural Engineer's reports
- 40. For details of services see Services Engineer's reports
- 41. Lead lined roof to minimum falls
- 42. Pool extract
