Grove Lodge, Admiral's Walk

Review of First Steps BIA Response

MAM7409-RT003-R01-00

September 2015

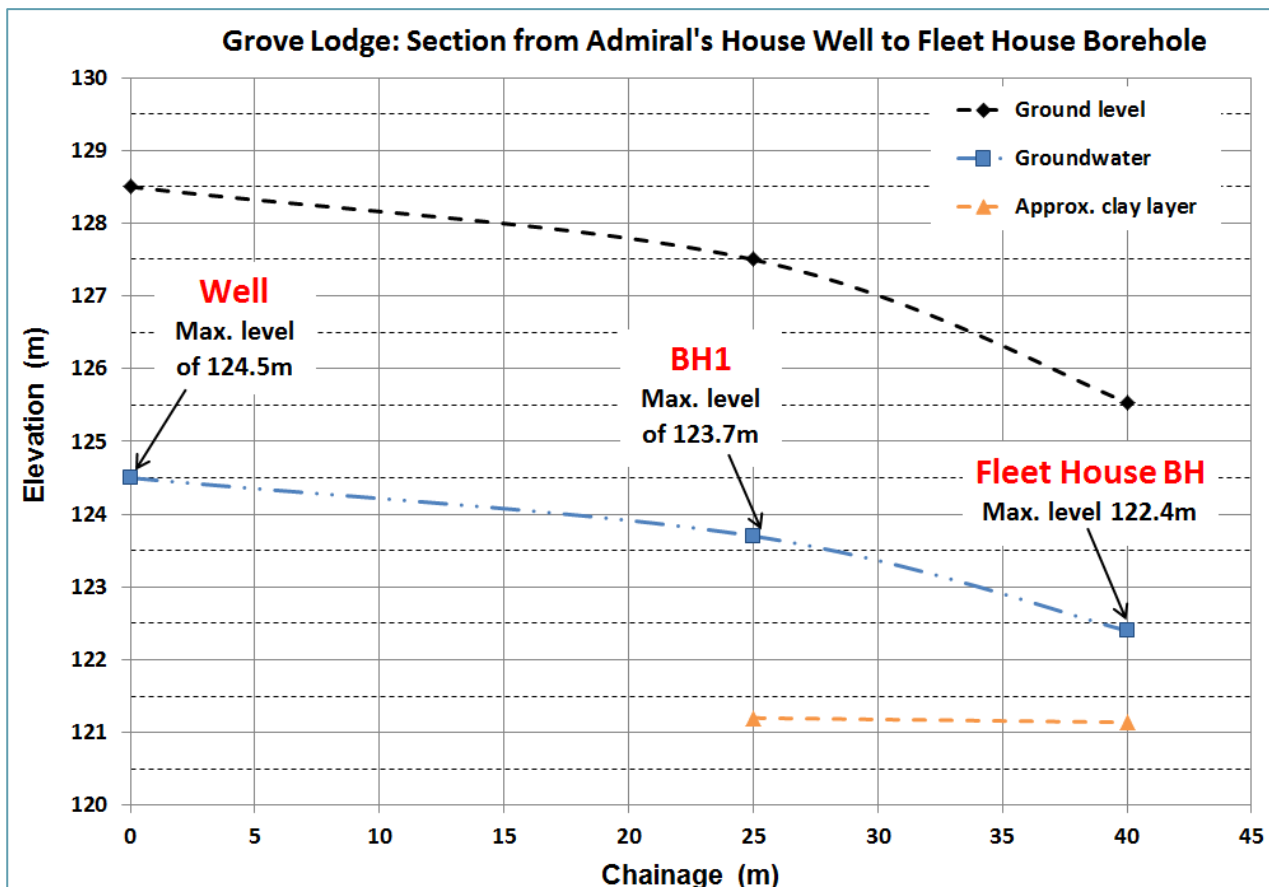
Figure 7.1: Cross-section illustrating groundwater levels.

House on the edge of Admiral's Walk (water level at approximately 122.4m) indicates a significant hydraulic gradient in that area. The perched groundwater levels at the basement site will be significantly less than the perched water levels at the well and at the swimming pool. For Dr de Freitas to quote levels at those locations and simply to compare them to the basement level is quite inappropriate. This is illustrated on Figure 7.1 – a long-section from the well, through the site of BH1, to a borehole drilled at the edge of Admiral's Walk at Fleet House (2012). Whilst it is accepted that the groundwater level data illustrated is for different days, we have included the highest levels available for each site.

Our approach of recognising changes in groundwater level across the area and to use actual groundwater levels from the basement site is considered to be the most robust approach.
