# KNAPP HICKS & PARTNERS LTD

Client	B chitecture, 11A Beresford Road, London, N2 8AT
Project	Proposed Basement Extension at: 13 Ferncroft Avenue, London, NW3 7PG
Title	Site Plans Showing Proposed Foundations & Steelwork

Client	B chitecture, 11A Beresford Road, London, N2 8AT
Project	Proposed Basement Extension at: 13 Ferncroft Avenue, London, NW3 7PG
Title	Elevation 'A' - Showing Proposed Underpinning to Right Flank

Client	B chitecture, 11A Beresford Road, London, N2 8AT	  <b>KNAPP HICKS AND PARTNERS LTD.</b> CONSULTING ENGINEERS Prospect House, 1 Highpoint Business Village Henwood, Ashford, Kent TN24 8DH Tel: +44 (0) 1233 502255	Drn.	CCG	
Project	Proposed Basement Extension at: 13 Ferncroft Avenue, London, NW3 7PG		Date	25/09/2015	
			Scale	1:100 @ A3	
Title	Section 'A-A' - Showing Proposed Foundations		Drawing No.	32655T-03	Rev

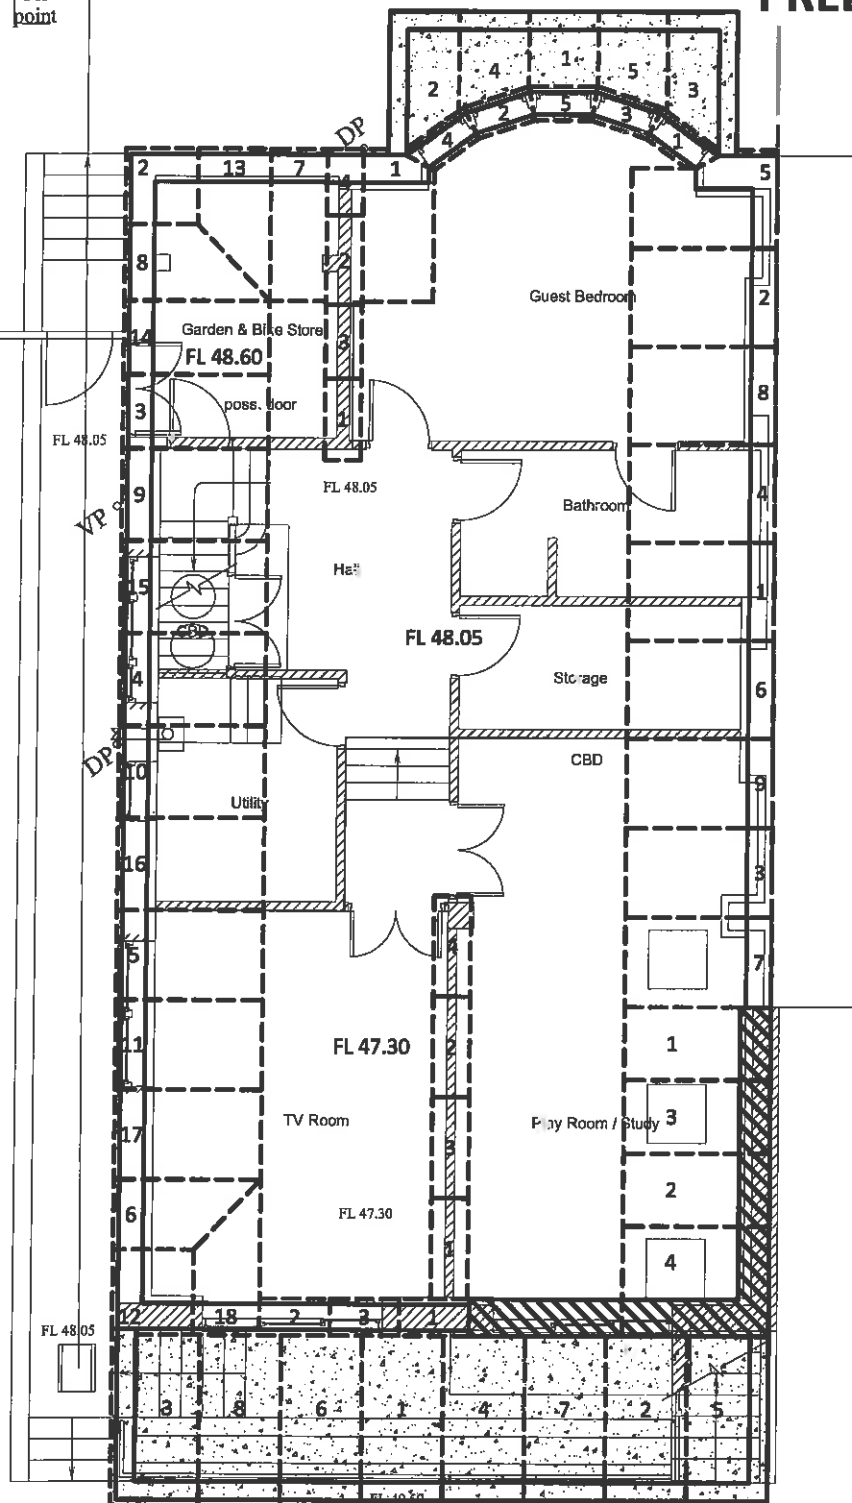
Basement Plan Showing Proposed Foundation Arrangement  
Scale 1:100 @ A3

- D) Excavate 3 no. underpin locations marked '1' on foundation plan - to the front lightwell retaining wall, left party wall underpin legs and rear lightwell retaining wall. Then assess in accordance with Item 5.3.2 of the Hydrogeological Desk Study and confirm dewatering method to be employed.

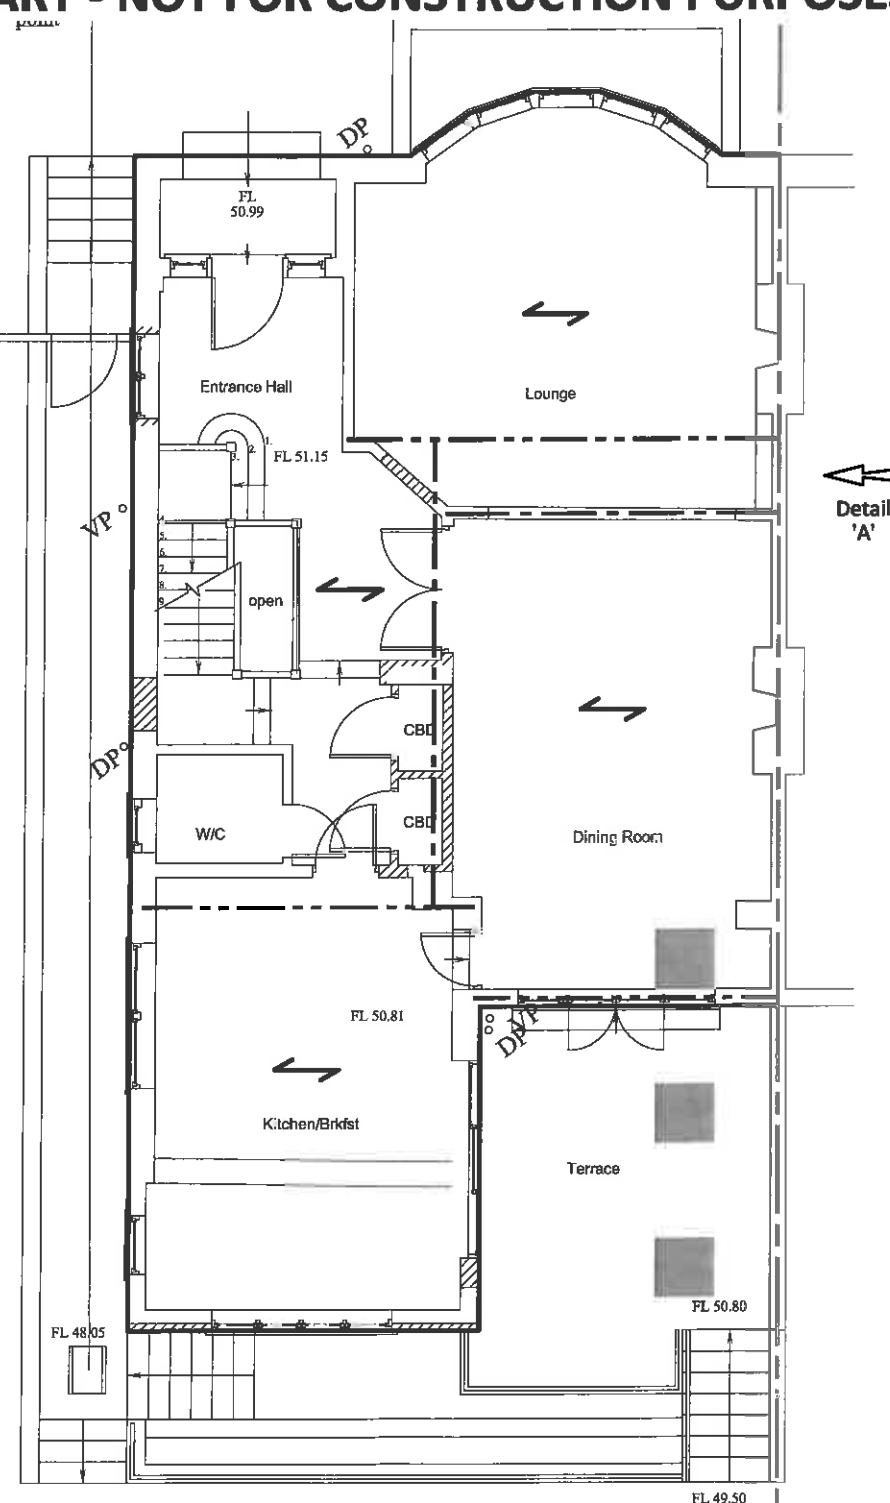
Ground Floor Plan Showing Supporting Steelwork  
Scale 1:100 @ A3

- A) Install & fix ground floor support steelwork.
- B) Remove & dispose of existing suspended timber ground floor construction.
- C) Excavate down to existing foundation levels - external & internal walls (above ground water level).

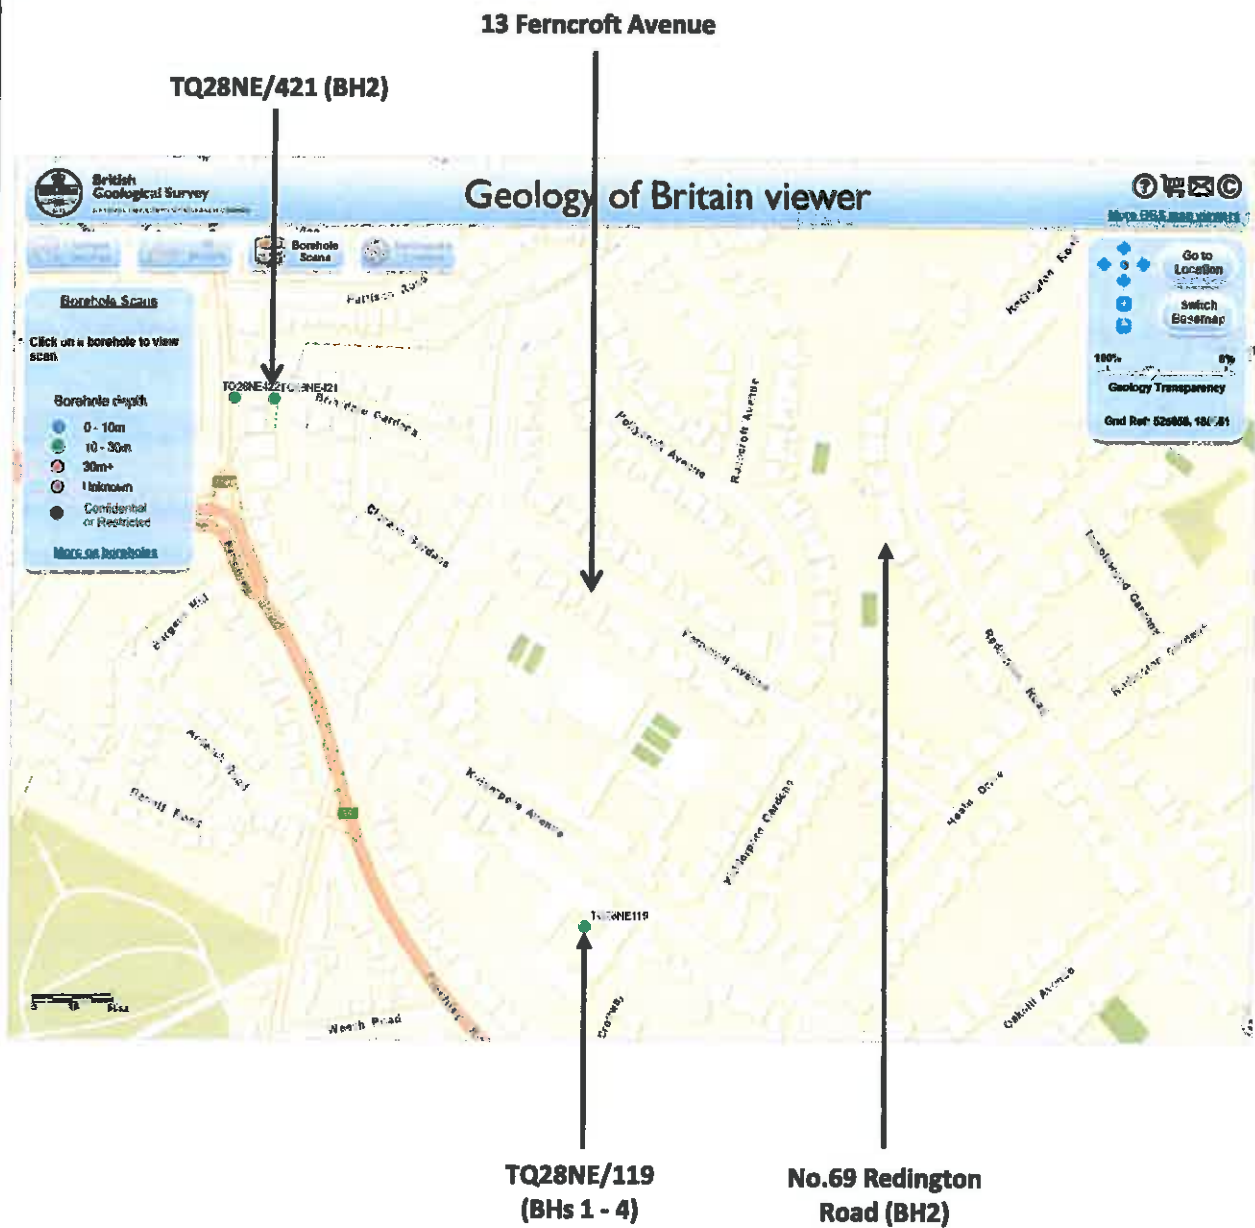
**Title:** Location Plan of Boreholes
