**Flat 2, 55 Greencroft Gardens  
London NW6 3LL**

**Basement Impact Assessment  
Audit**

For  
London Borough of Camden

Project Number: 12066-55  
Rev: F1

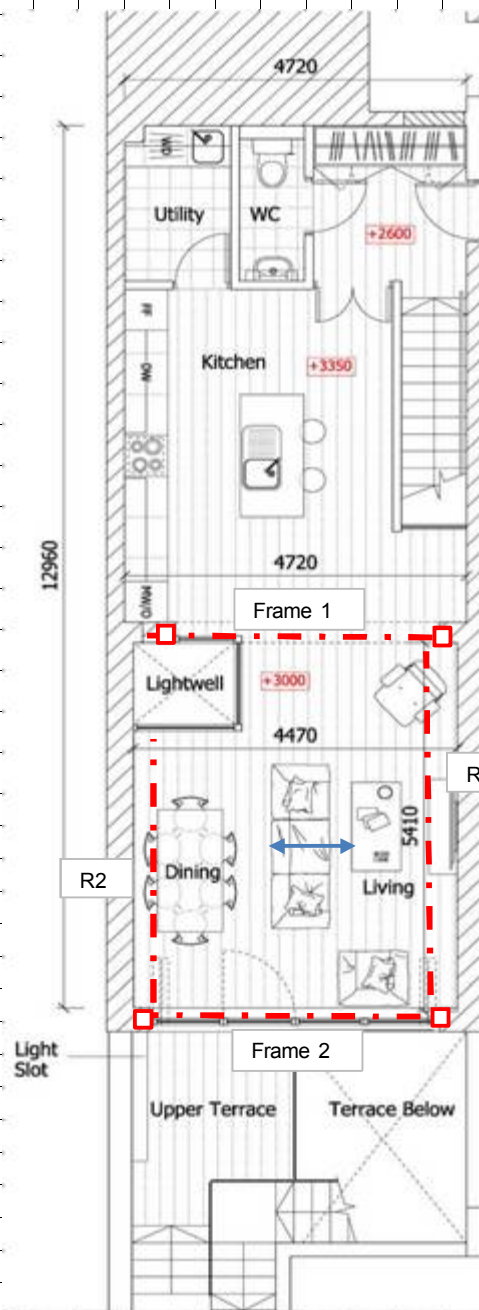
### Ground floor plan - Proposed - showing structure over

Rafters 200 x 50 @ 400 ctrs

R1 & R2 203 x 133 x 25 UB

The frame is to be a box frame bearing on the extg foundation  
with intermediate beam to carry Grd floor

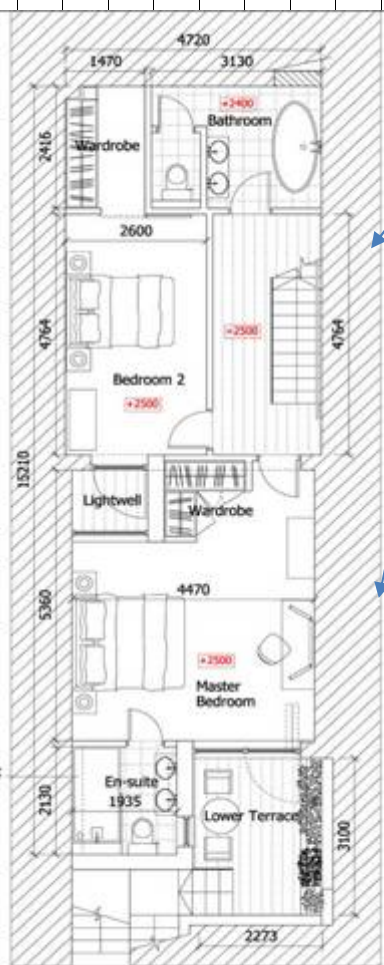
### Underpinning to Party walls to allow extension of LG floor

**Lower Ground Floor Plan**

wall previously underpinned to develop adjoining property

Note trial holes will be required to determine the exact level of the existing foundations currently LG floor is 1m below Grd floor so area to be lowered a maximum of 2.5m.

Existing party wall is likely to be min of 340mm Reinforced underpin to be equal to wall thickness with heel extended to existing foundation width

- 2.3.2 The base of the underpinned is to be widened by the provision of a heel to match the width of the stepped footing so that the foundation width is maintained and the GBP is not increased.

Heel to be same width as existing foundation

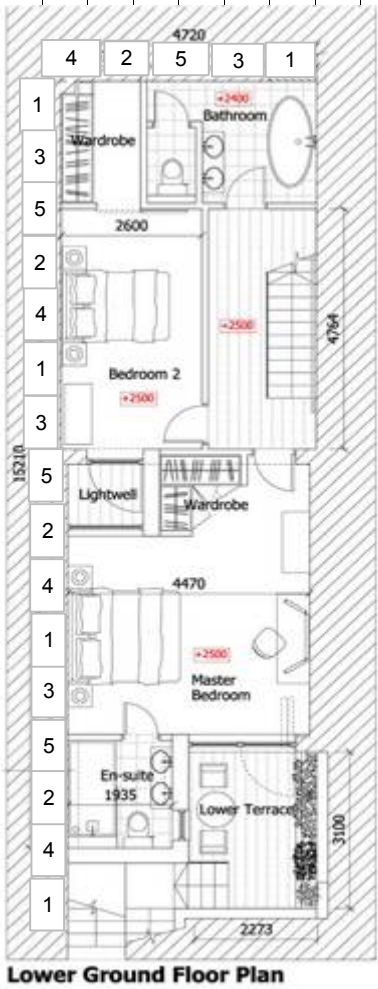
Underpinning sequence

Indicative underpinning sequence  
shown, pins to be constructed and  
completed in sequence including drypacking

4.2 During any underpinning operation there is the potential for movement to occur and as there will be a load transfer from the existing to the new foundations and that can result in minor cracking of finishes. The sequencing of the work and limiting the extent of open work at any one time is designed to minimise this type of movement to the point where any movement comes under the category of minor redecoration to make good.
