Ref: 15/23908-2
November 2015

**15 LYNDHURST TERRACE,
LONDON NW3 5QA**

BASEMENT IMPACT ASSESSMENT

**Prepared for
Emanuel and Carmel Mond**

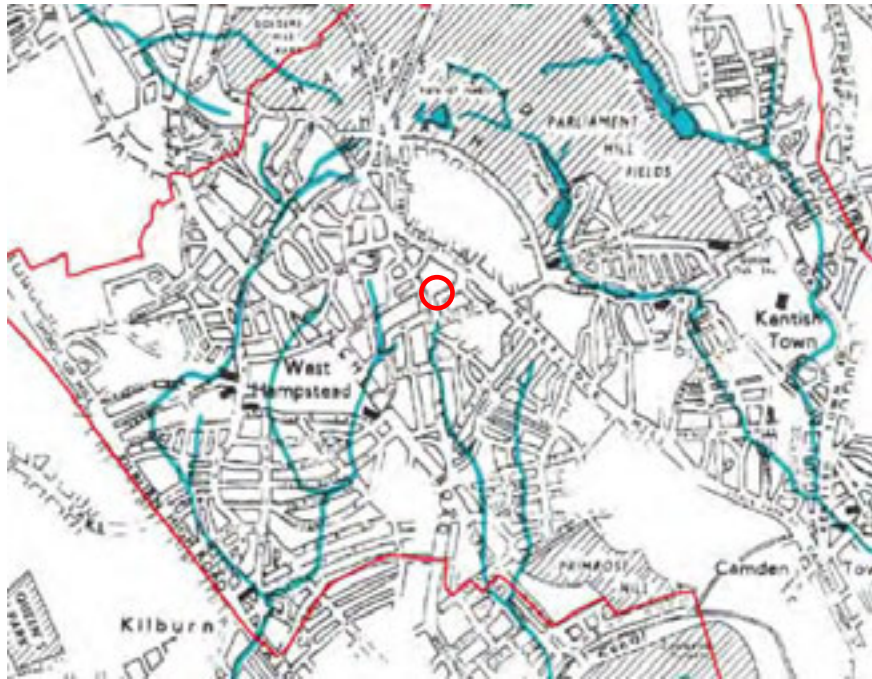
Figure 6. Location of site (circled) relative to the 'Lost Rivers' of London
(Source: Barton, 1992)

With reference to Camden Geological, Hydrogeological and Hydrological Study (1999), Talling (2011) and Barton (1992) springs that sourced tributaries of the 'lost rivers' River Westbourne and River Tyburn were located approximately 200m south-west and 150m south of the site respectively (Figure 6). Both spring lines are shown on the annotated historical OS map dated 1871-79 (Figure 7).

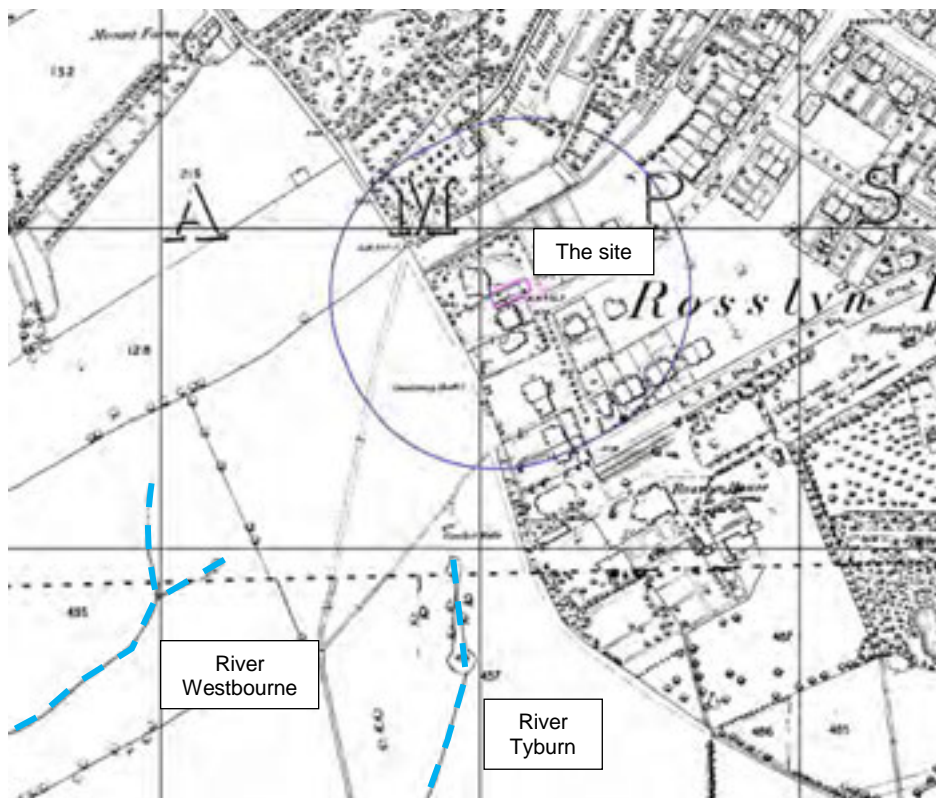
Figure 7. Location of River Tyburn and River Westbourne with respect to the site from OS map dated 1871 (Purple boundary indicates >100m distance)

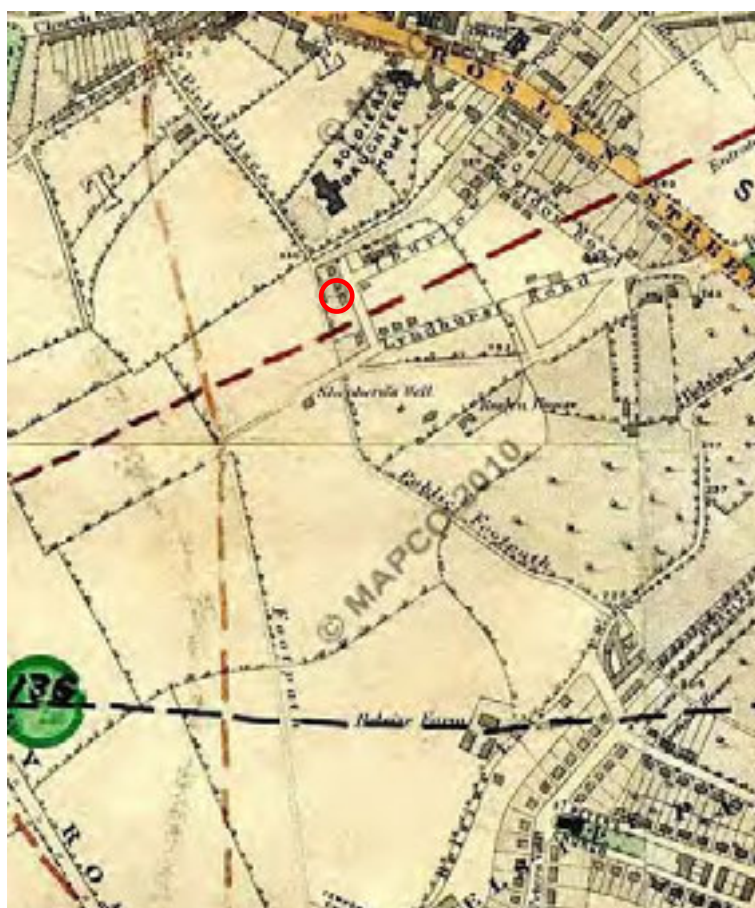
Figure 8. Former Location of Shepherd's Well relative to the site (circled)
(Source: Stanford, 1868, available online <http://london1864.com/stanford>)

The River Tyburn flowed in a southerly direction from Shepherd's Well (or Conduit Well) located to the south of Spring Path as detailed is detailed on the 1879 OS map and also Stanford's 1896 map (Figure 8). A plaque on the corner of Fitzjohn's Avenue and Lyndhurst Road marks the approximate location of the well and from here it flowed southwards down Fitzjohn's Avenue, through Swiss Cottage and into Regent's Park, where it entered into a large lake (Barton, 1992). From the lake it flowed southwards through the West End and the City of Westminster, before issuing into the River Thames close to Vauxhall Bridge.

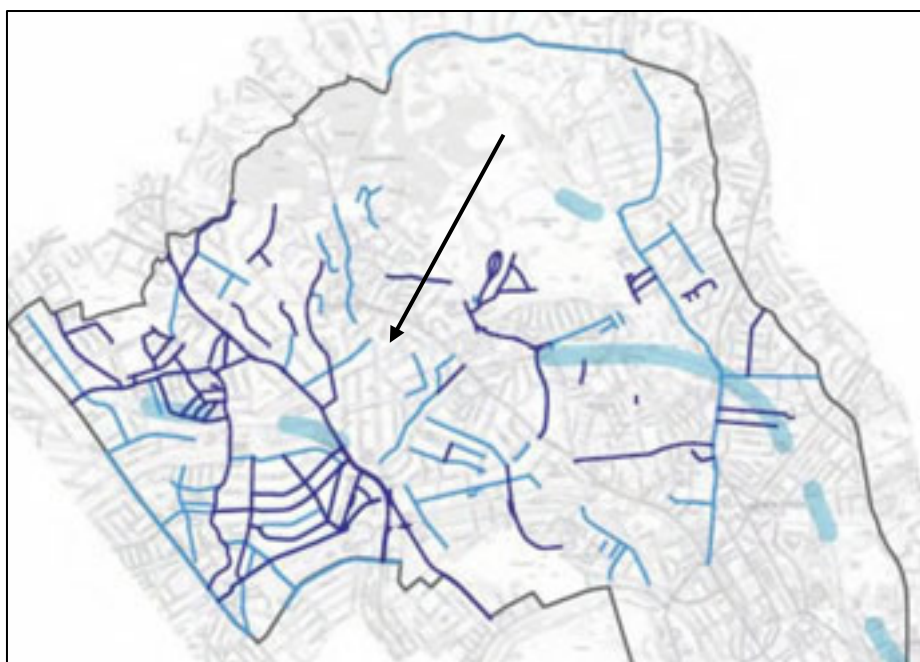
Figure 9. Extract from Figure 15 of the Camden CPG4 showing roads which flooded in 1975 (light blue), in 2002 (dark blue) and 'areas with potential to be at risk from surface water flooding' (wide light blue bands)

Figure 9 shows that Lyndhurst Road did not flood during either the 1975 or the 2002 flood events. The closest road to the property which flooded in either of these events is Arkwright Road located 130m to the north-west which flooded in 1975 and 2002.

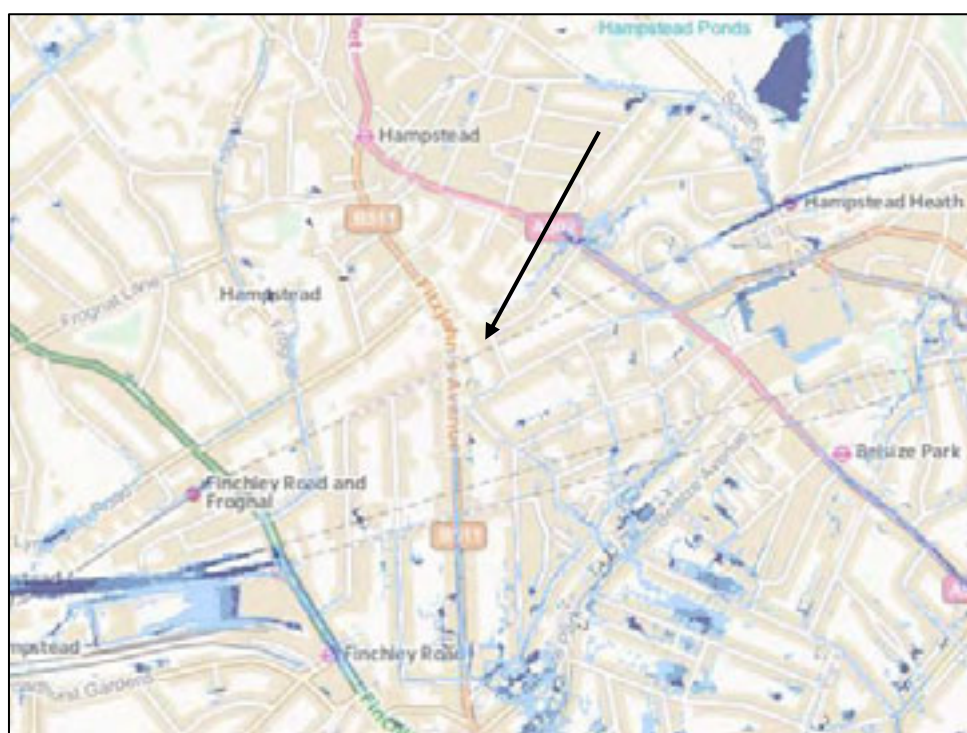
Figure 10. Extract from the Environment Agency's 'Risk of Flooding from Surface Water'.
Ordnance Survey Crown copyright 2015. All rights reserved.

Further modelling of surface water flooding has been undertaken by the Environment Agency and was published on its website in January 2014; an extract from their model is presented in Figure 10. Whilst this map identifies four levels of risk (high, medium, low and very low) it is understood that it is based at least in part on depths of flooding. This modelling shows a 'Very Low' risk of flooding (the lowest category for the national background level of risk) for No.15 and the surrounding area.

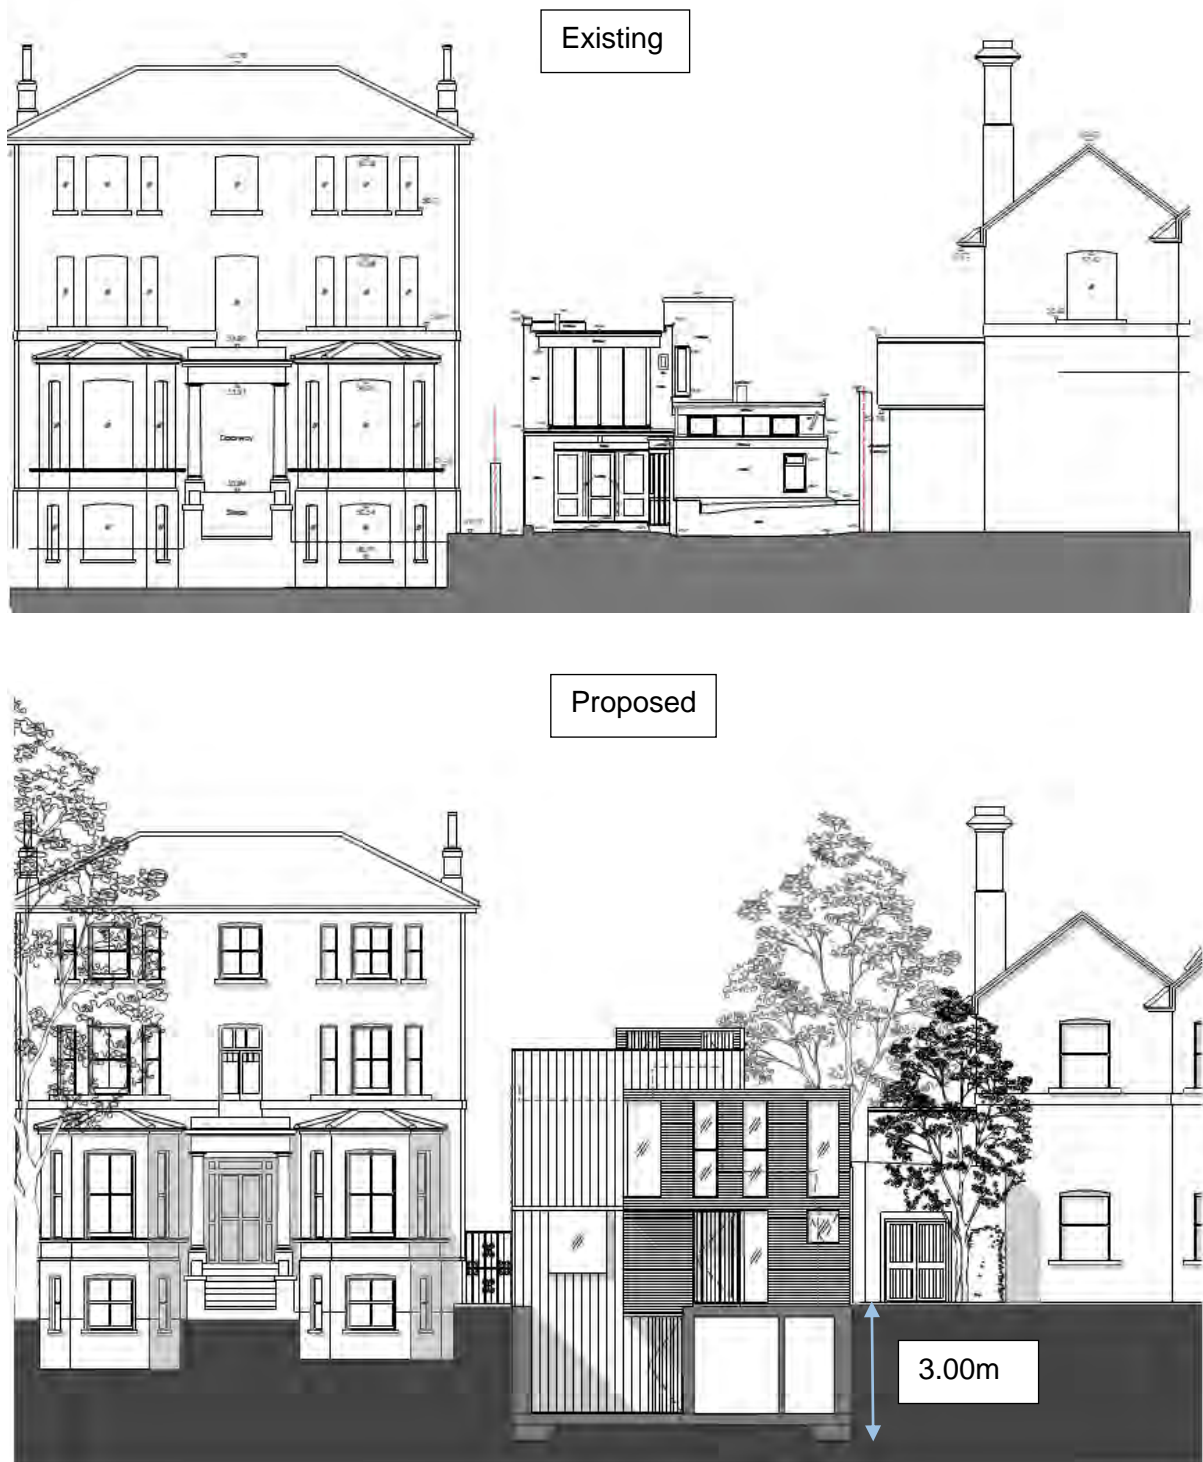
It is proposed to demolish the existing property at the site and construct a new three to four-storey residential property including a single storey basement to 3.00m maximum depth (46.50mSD). Sections showing the existing and proposed layouts are detailed in Figure 10 below.
