New basement 168 Haverstock Hill, London NW3 2AT

Basement Impact Assessment Report

New basement and extensions 168 Haverstock Hill London NW3 2AT

Report: STM3333T-BIA

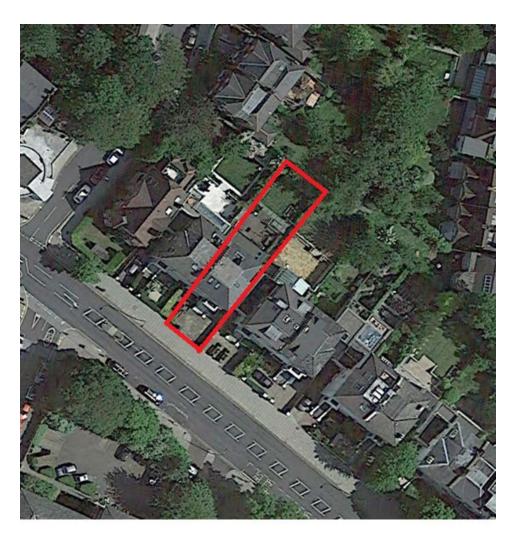
Aerial photograph of property

Approximate property boundaries edged in red.

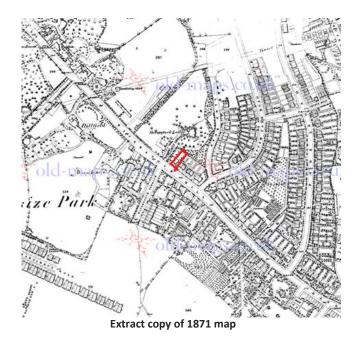
Review of Ordnance Survey maps dating back to 1870s (first editions) records the current main house footprint. An extract copy of the 1871 map is presented below with the property edged in red.

At this stage is important to note there are no water courses recorded on the 1879 predevelopment map close to the property, and no evidence of any opencast quarrying activities in the locality.

With reference to old mapping of the area described in section 3.1 above, the 1871 map does not record any water courses close to or within the immediate area of the property. The Westbourne was a natural stormwater drainage system for this area of London prior to urbanisation. Development of London has resulted in original watercourses being culverted. The following is an extract plan showing main sewers installed between 1856 and 1930 to drain London. The nearest main sewers recorded on the map (in blue or brown) are located at least 350km distant from the property.

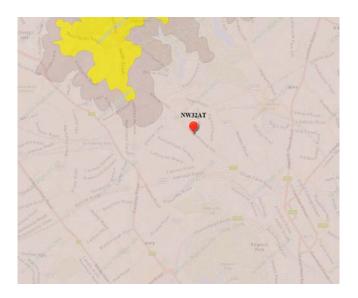
An extract copy of the geological map is presented below, with brown shading representing the outcrop of the London Clay Formation (LC). The property position is highlighted.

Based on the above any excavations within the property will be located within London Clays, however is it is acknowledged that a covering of made ground is inevitable, associated with development of the area.

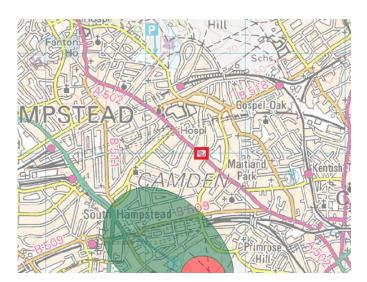
The site is not recorded as being located within or close to a zone protecting a potable water supply abstracting from a principle aquifer (i.e. a source protection zone). An extract of the plan recording source protection zones is presented below, with green shading representing outer protection zones and red inner protection zones. The property is located within the red square and remote from source protection zones.

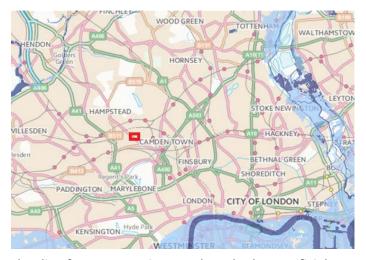
The Environment Agency website indicates the site is not located within a fluvial or tidal flood plain. An extract copy of the flood risk map is presented below which shows no blue shading representative of flooding. The property is located within the red square.

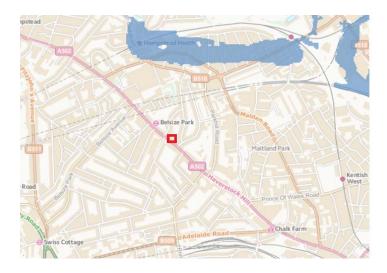
The Environment Agency website indicates the site is not located within an area considered at risk of flooding from breach of reservoir containment systems. An extract copy of the flood risk map is presented below which shows no blue shading representative of flooding as a result of failure of containment systems close to the site. The property is located within the red square.

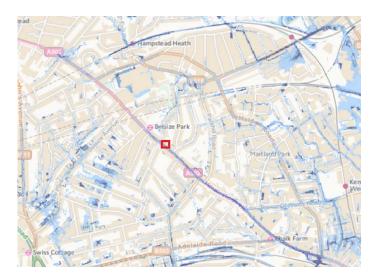
We have viewed the Environment Agency web site which provides maps showing areas a risk of flooding from surface waters. An extract of the map is presented below. The property is located within the red square and blue shading represents areas at risk of surface water flooding. The property is remote from blue shaded areas.

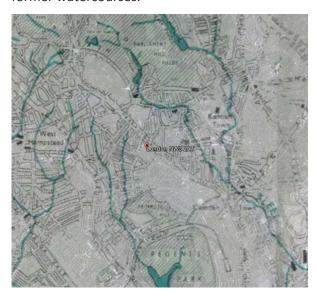
An extract of figure 11 from the Camden Geological, Hydrogeological and Hydrological Study is presented below. Blue shading show the locations of branches of the former River Westbourne (immediately to the south of the property) and the Fleet to the north. The property marked on the map. The property seems to be at the head waters of an upper branch of the Westbourne, but remote from these former watercourses.
