DESIGN & ACCESS STATEMENT

**Proposed Repair of Part of the boundary Wall
To St Giles-in-the-fields Churchyard and installation of new railings
at
45 New Compton Street,
Camden, London.
WC2H 8DF**

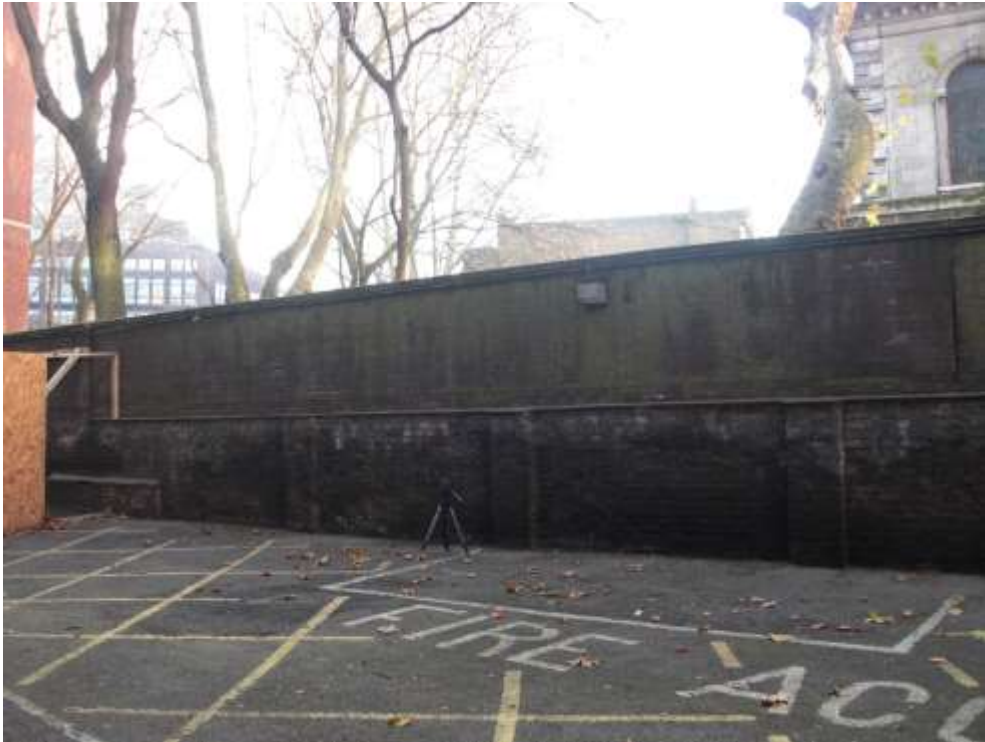
Wall from Car Park Side 45 New Compton Street

- 2.3 The existing wall is of mixed age and construction. The lower part, approximately 1.5m height, is a retaining wall and in poor repair. Above this is a C20 brickwork wall approximately 1.5m in height. This is divided into three panels with movement joints between each.

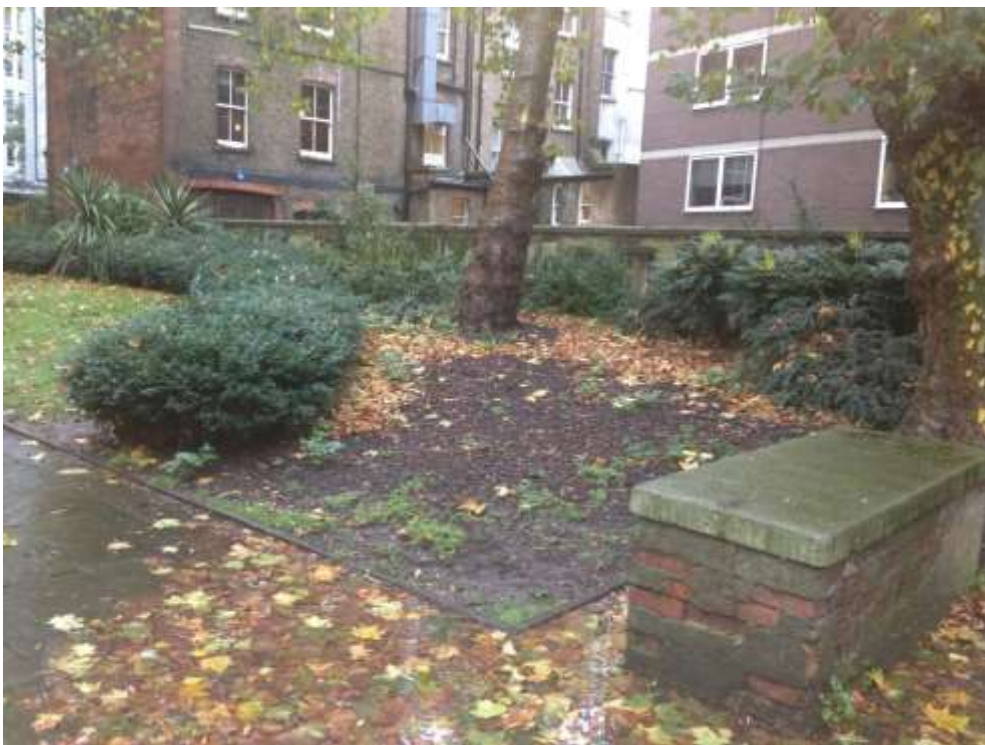
Wall from St Giles In The Fields Churchyard
