**The HR Wallingford document of September 2015 entitled:**  
**“Grove Lodge, Admirals Walk**  
**Review of First Steps BIA Response”**  
**attached to and relied on in the Campbell Reith Report of October 2015**  
 **(“the WR”)**

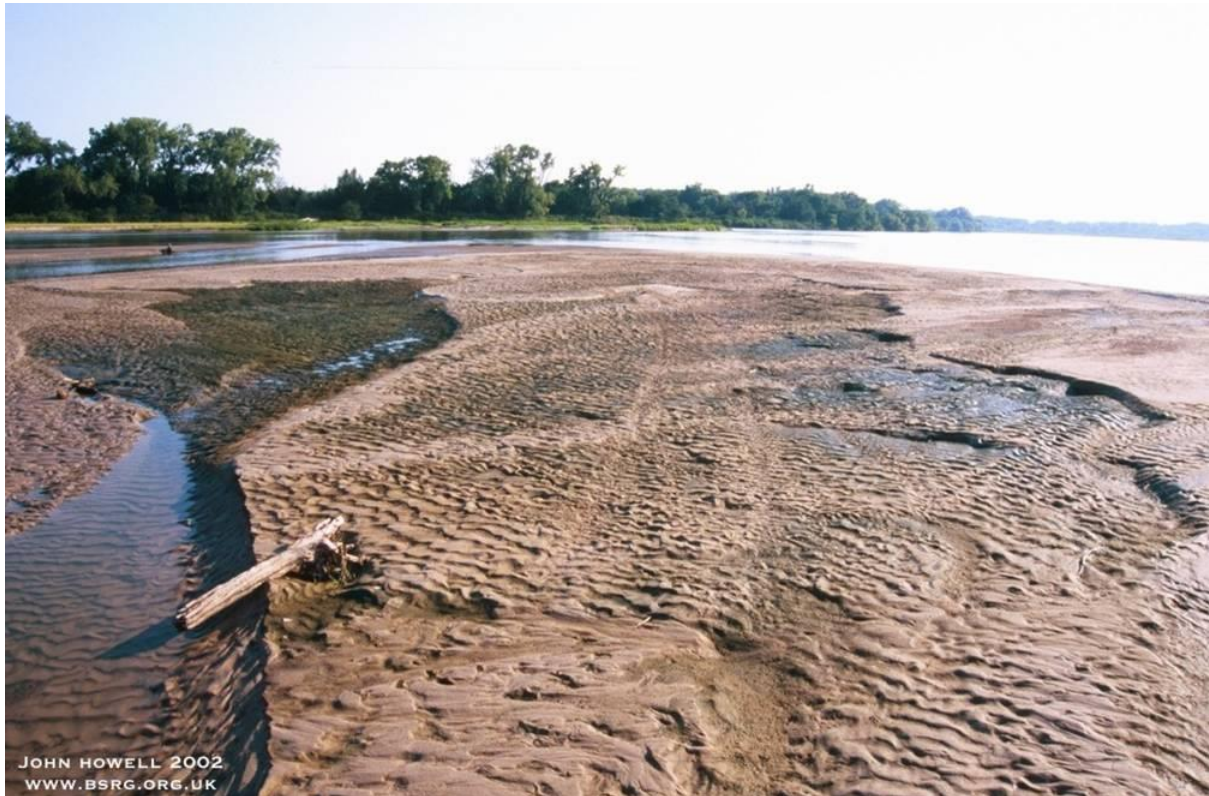
**Attachments.** Four Figures depicting (top) an example of the environment of sedimentation encountered in the Bagshot Formation; (below) an illustration of environments; (below) a typical vertical succession as might be encountered in a BH core through the Bagshot Formation; (last) typical deposit seen in 3D.
