UNDERPIN SEQUENCING - Option 4

44 Downshire Hill, London NW3 1NU

1:50 22 Dec15 53022-11

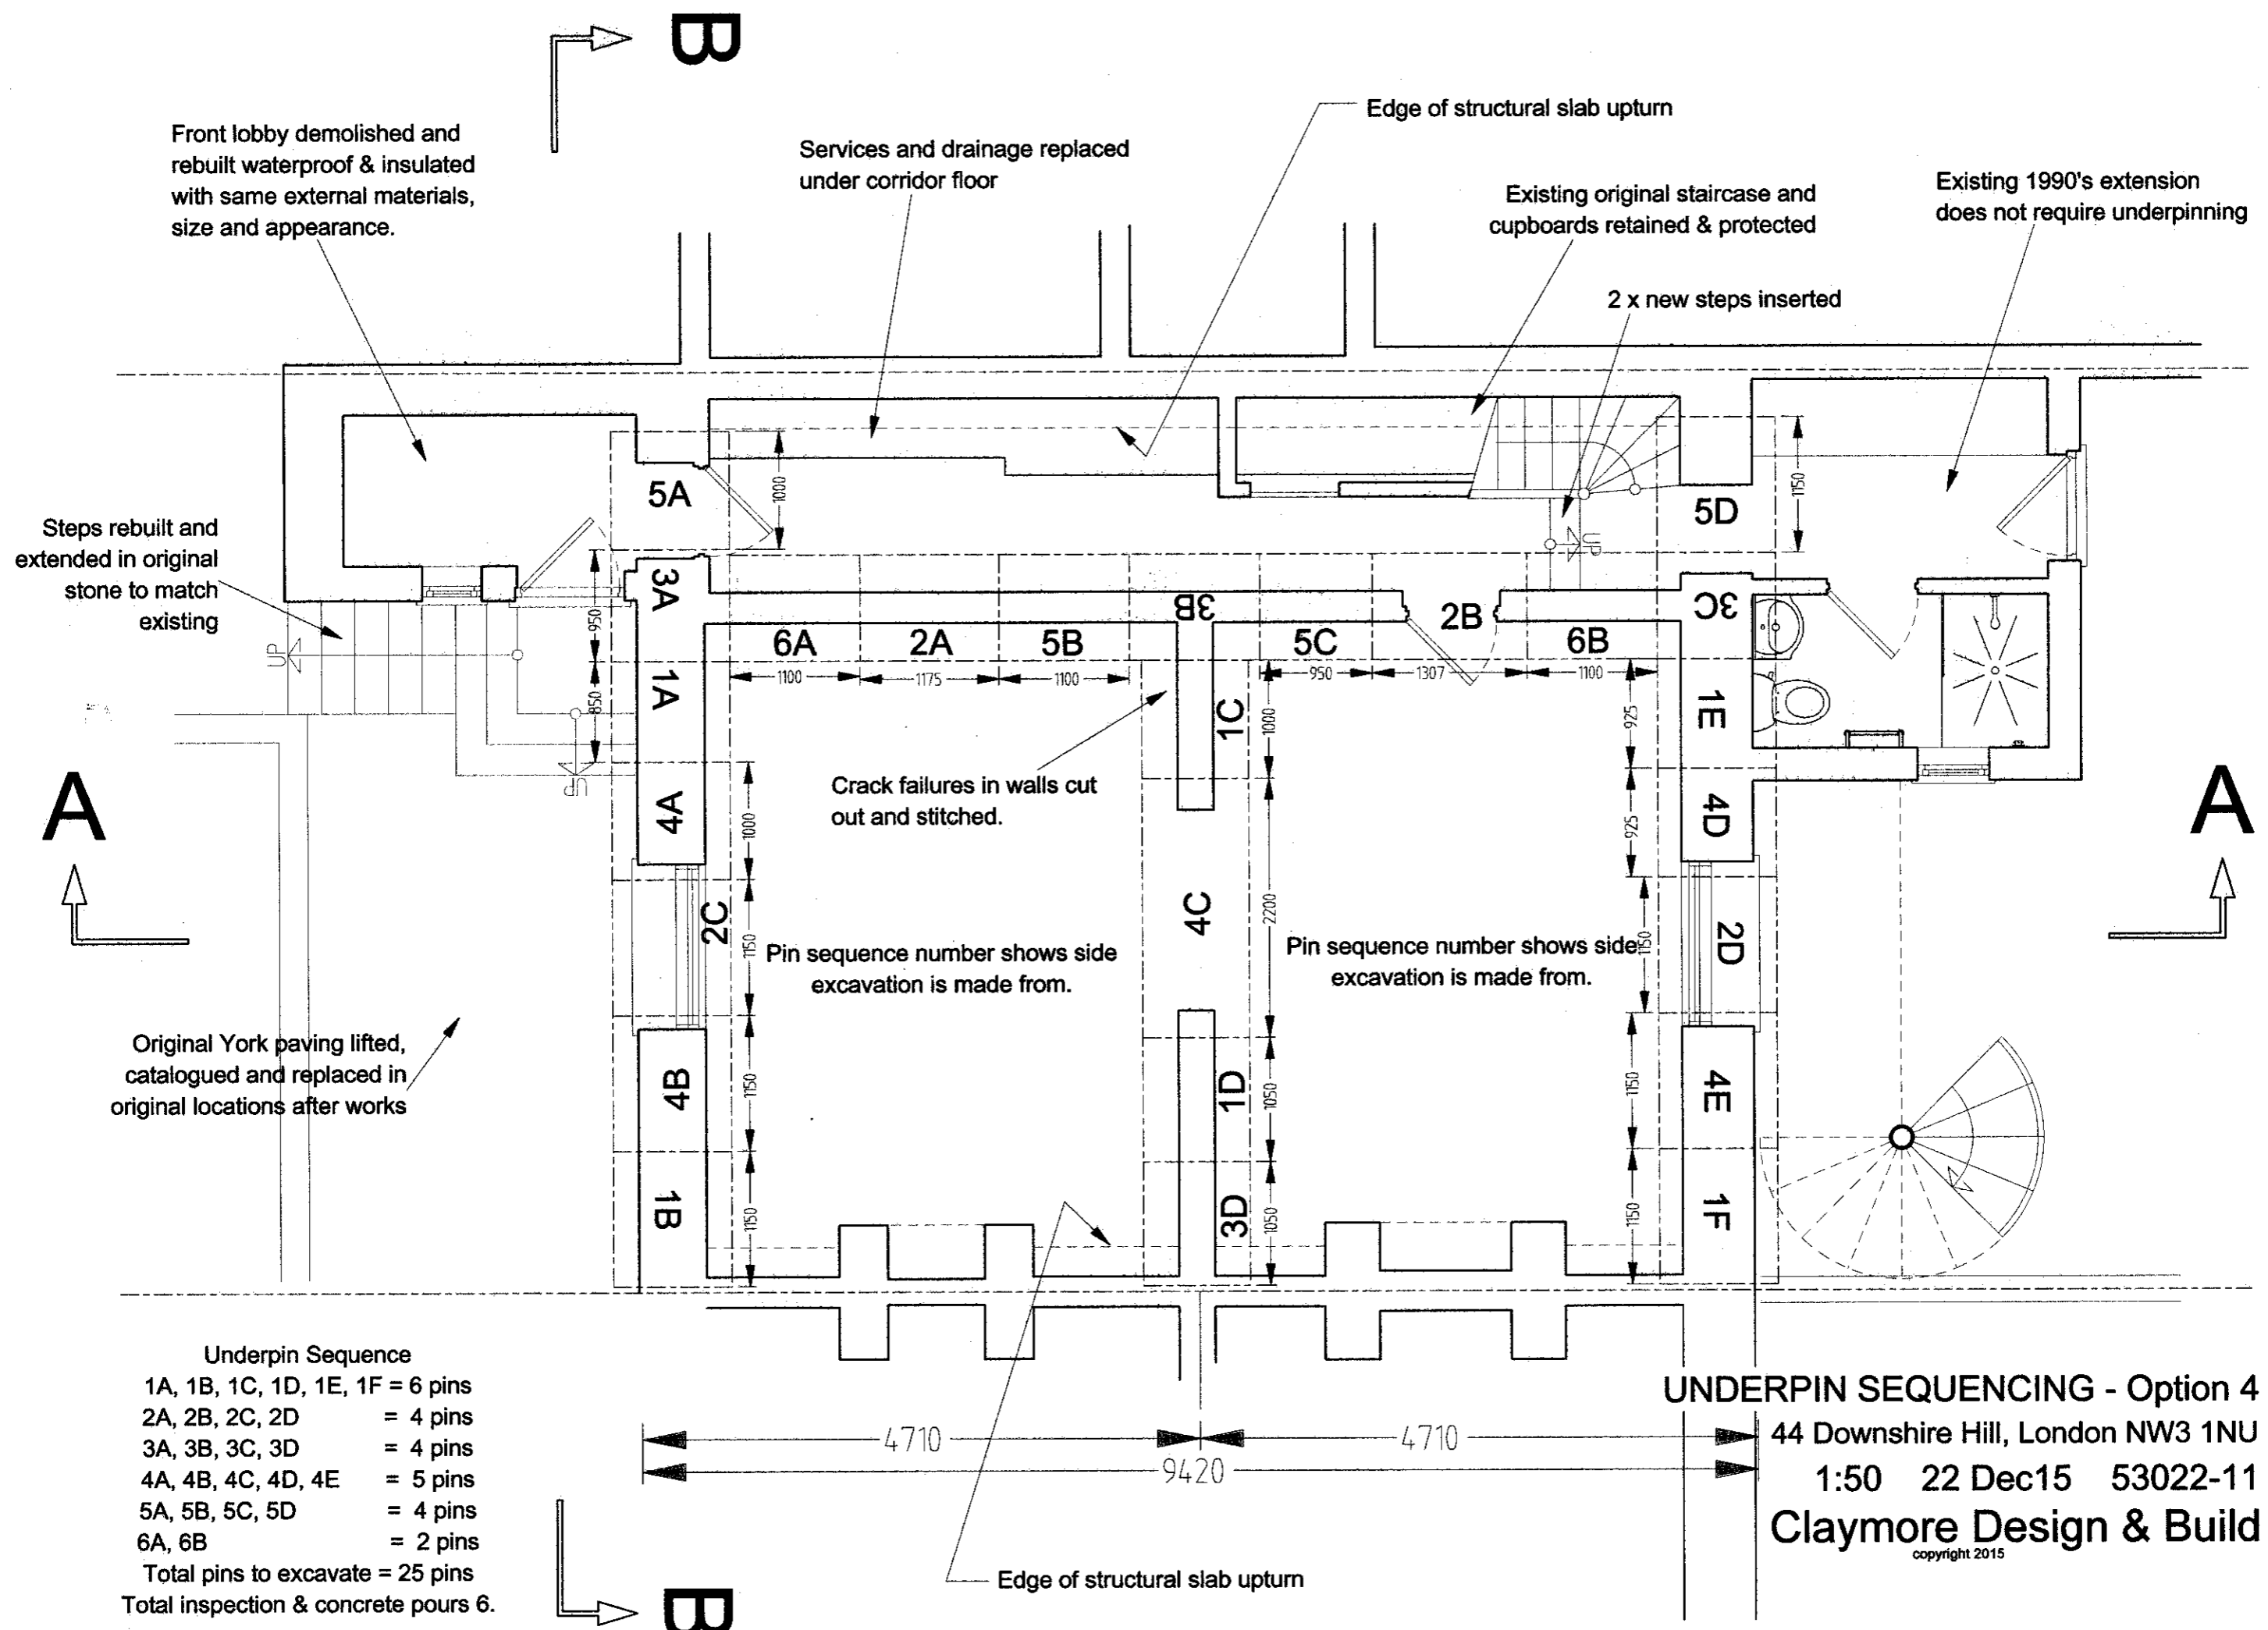
Front lobby demolished and rebuilt waterproof & insulated with same external materials, size and appearance.

Services and drainage replaced under corridor floor

Edge of structural slab upturn

Existing original staircase and cupboards retained & protected

Existing 1990's extension does not require underpinning

2 x new steps inserted

Steps rebuilt and extended in original stone to match existing

Crack failures in walls cut out and stitched.

Pin sequence number shows side excavation is made from.

Original York paving lifted, catalogued and replaced in original locations after works

- Underpin Sequence**
- 1A, 1B, 1C, 1D, 1E, 1F = 6 pins
 - 2A, 2B, 2C, 2D = 4 pins
 - 3A, 3B, 3C, 3D = 4 pins
 - 4A, 4B, 4C, 4D, 4E = 5 pins
 - 5A, 5B, 5C, 5D = 4 pins
 - 6A, 6B = 2 pins
- Total pins to excavate = 25 pins
Total inspection & concrete pours 6.
