Mr Maurice Ostro
6 Elsworthy Terrace
Screening Assessment for a Pavilion

Document Ref: 773521-REP-ENV-001

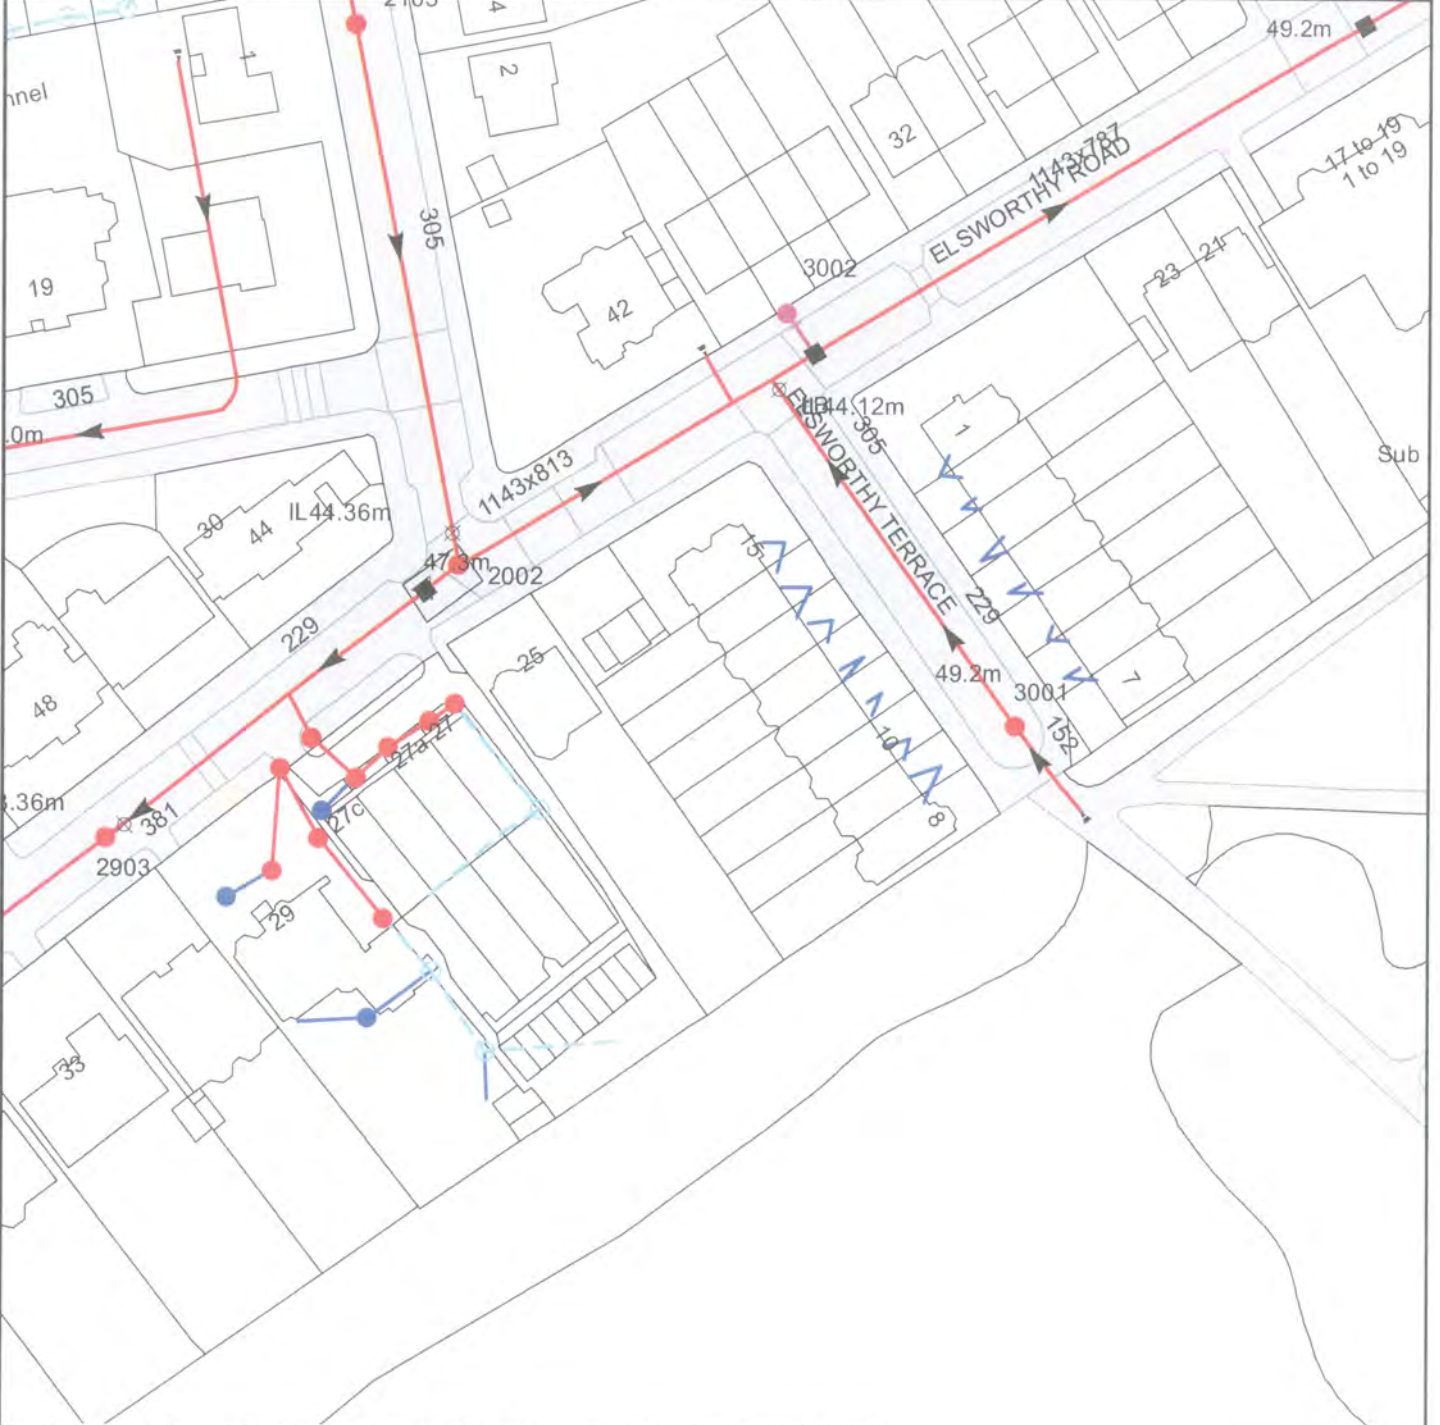
Existing Surface Water Drains

The width of the displayed area is 200m and the centre of the map is located at OS coordinates 527327,184011
The position of the apparatus shown on this plan is given without obligation and warranty, and the accuracy cannot be guaranteed. Service pipes are not shown but their presence should be anticipated. No liability of any kind whatsoever is accepted by Thames Water for any error or omission. The actual position of mains and services must be verified and established on site before any works are undertaken.
Based on the Ordnance Survey Map with the Sanction of the controller of H.M. Stationery Office, License no. WU298557 Crown Copyright Reserved.
