CONDITION SURVEY

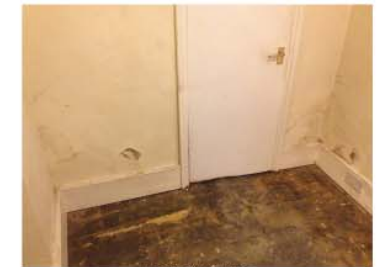
IMG\_7947.JPG

6	Basement	B.01	Walls	ADJ. Chimney Breast	Plaster	Blown Plaster, Water Ingress	Remove modern gypsum plaster and replace with lime based plaster	7947	1	m <sup>2</sup>	
7	Basement	B.05	Walls	West Wall	Plaster	Blown Plaster, Water Ingress. Bottom of walls	Remove modern gypsum plaster and replace with lime based plaster	7948	2	m <sup>2</sup>	
8	Basement	B.06	Ceiling	Middle	Plaster Board	Crack to Board	Fill, prepare and redecorate	7949	2	m	
9	Basement	B.06	Walls	External	Plaster	Blown Plaster Due to Damp	Remove modern gypsum plaster and replace with lime based plaster	7950-7951	7	m <sup>2</sup>	
10	Basement	B.07	Walls	External	Plaster	Blown Plaster Due to Damp	Remove modern gypsum plaster and replace with lime based plaster	7952	2	m <sup>2</sup>	
11	Basement	B.08	Walls	External	Plaster	Blown Plaster Due to Damp	Remove modern gypsum plaster and replace with lime based plaster	7953	2	m <sup>2</sup>	
12	Basement	B.09	Walls	External	Plaster	Blown Plaster Due to Damp	Remove modern gypsum plaster and replace with lime based plaster	7955	2	m <sup>2</sup>

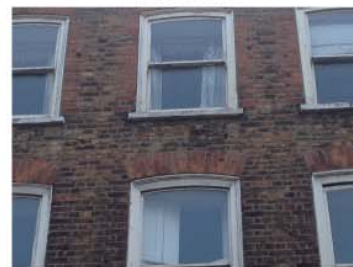
IMG\_7956.JPG

196	Exterior	Front wall	Wall	Below 3rd Floor middle windows	Bricks	Blown Bricks	Replace bricks to match adjacent	7957	3	no.	
197	Exterior	Front wall	Between	Between Central and South Window 3rd floor	Bricks	Blown Bricks	Replace bricks to match adjacent	7957	2	no.	
198	Exterior	Front wall	Rhs to N Windows		Bricks	Structural Movement. ADJ. North Party Wall. Dropped 3 inches.	Historic - monitor	7962	2	m <sup>2</sup>	
199	Exterior	Front wall	ADJ. South Party Wall.	Damage		Damage owing to Historic Water Ingress. Blown pointing	Rake out and re-point using lime based mortar	7963 - 7964	3	m <sup>2</sup>	
200	Exterior	Front door	Surround	Bottom Section		Water Damage	Cut back to sound wood, timber repair and redecorate like-for-like	7965-7966	1	m	
201	Exterior	Front door	canopy	All		Water Damage	Cut back to sound wood, timber repair and redecorate like-for-like	7967-7968	1	m	
202	Basement	B.01	Stair banister	Up to ground floor	Timber	Loose & unsecure fixings	Ensure firmly fixed, using nails as per original construction method like-for-like	7956	3	no.
