EXAMPLES OF REPAIR TO WALL PANELLING *IN SITU*

| PROJECT | 40 Great James Street |

| DRAWING TITLE | Proposed Typical Panelling Repair |

| DRAWING NO. | C(22)03 |

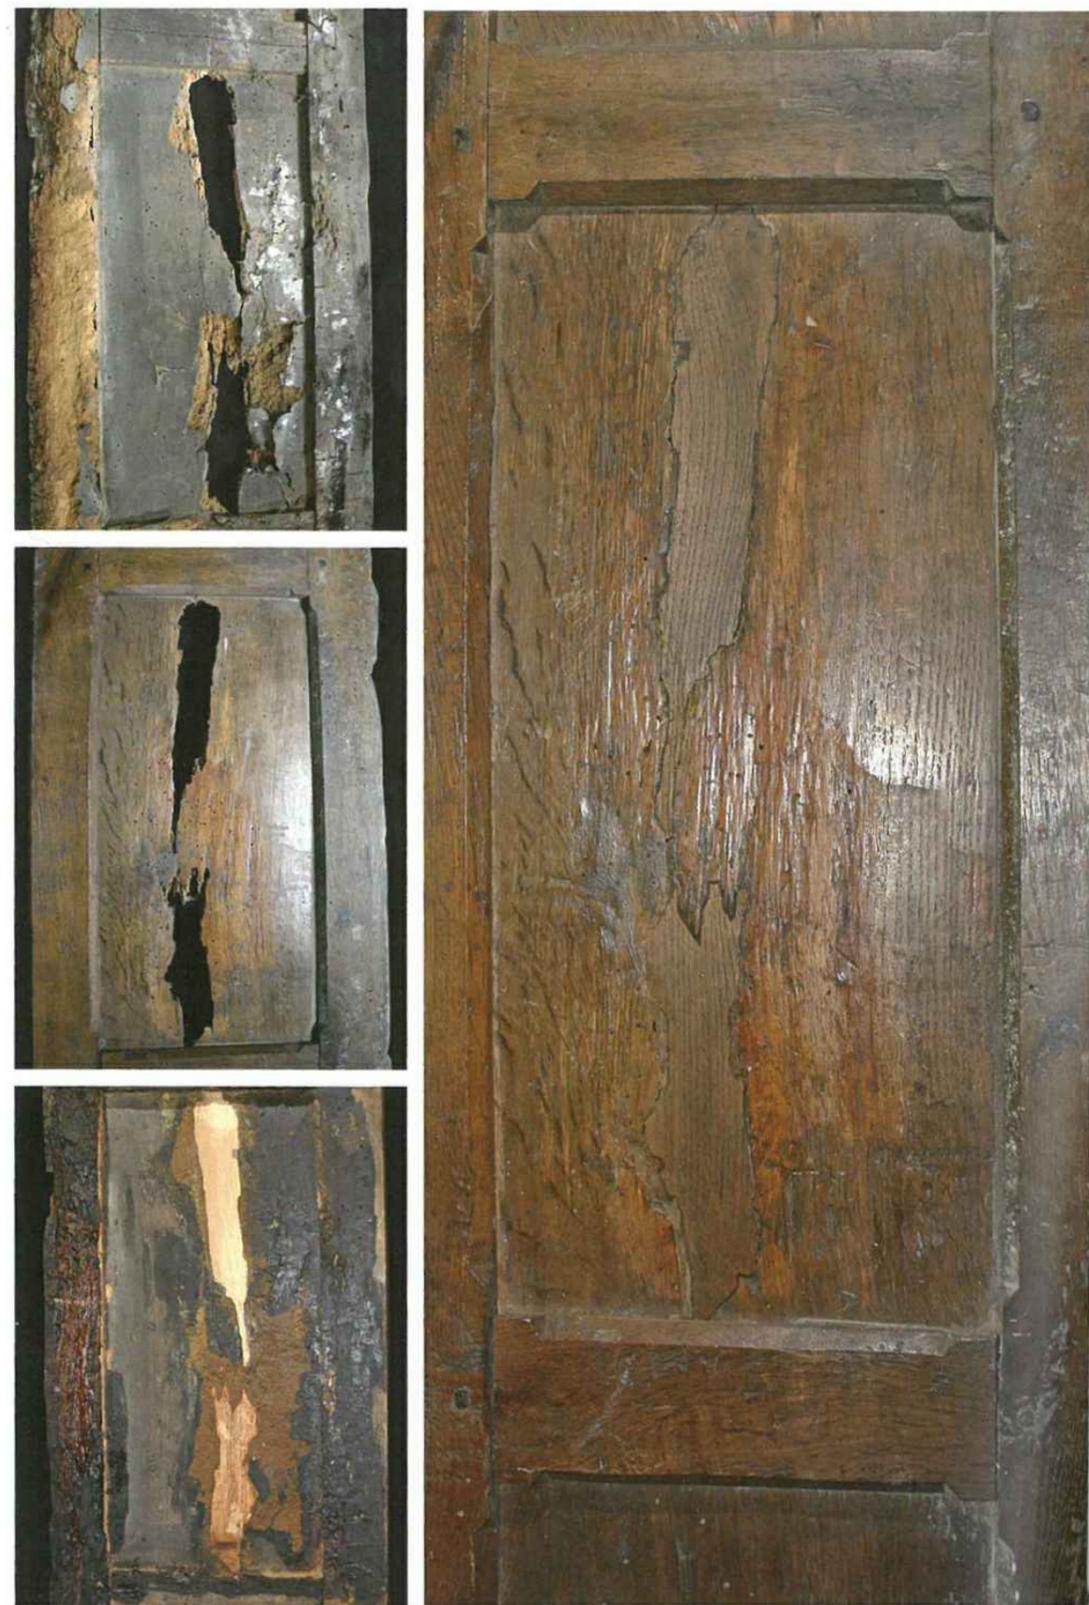
Example of panel repair where apertures require repair.
New timber infills to match existing timber, pieced in on site to suit individual repair required.

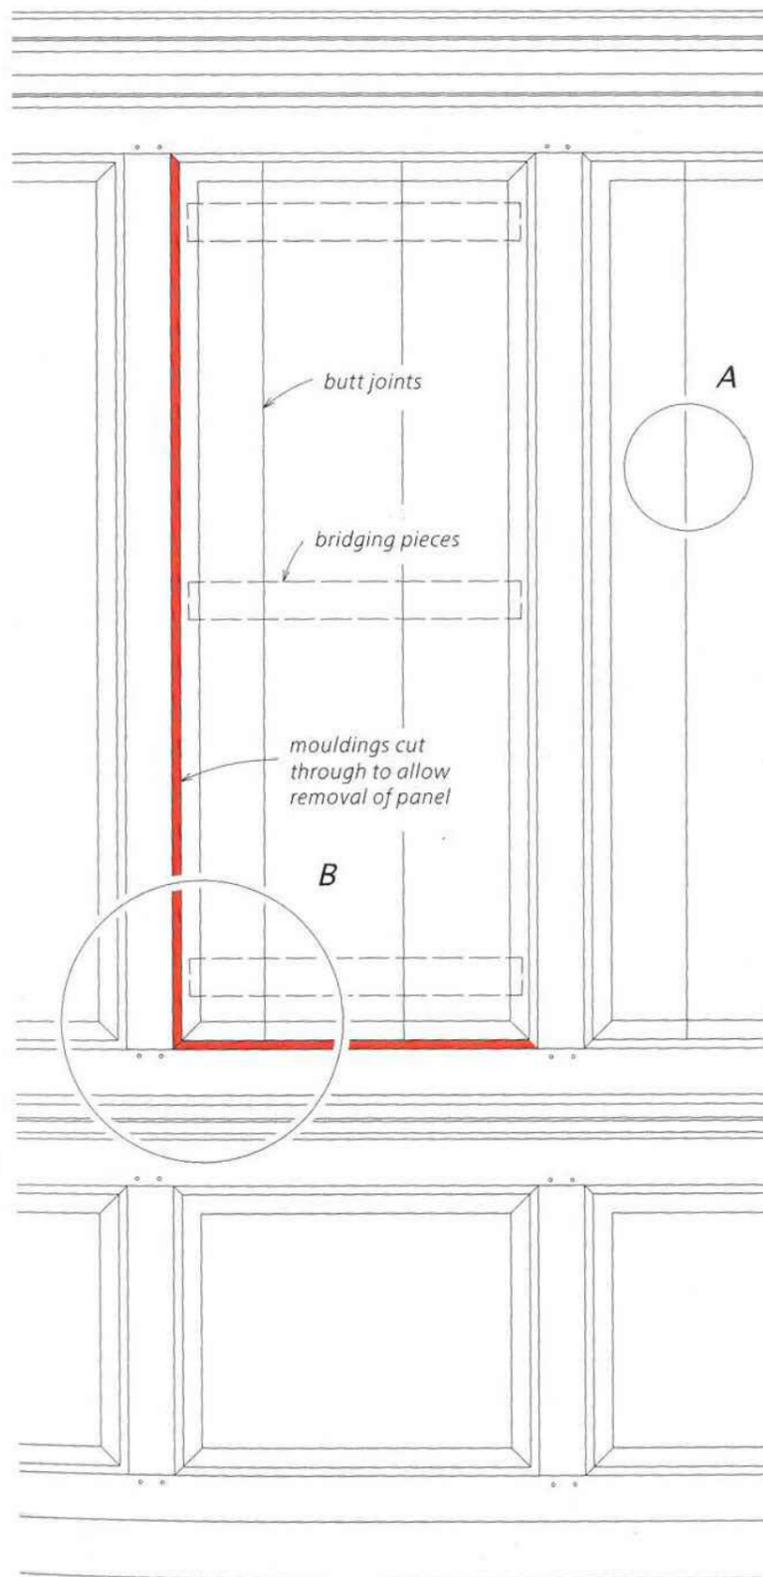
Proposed method for repairing splitting of timber.

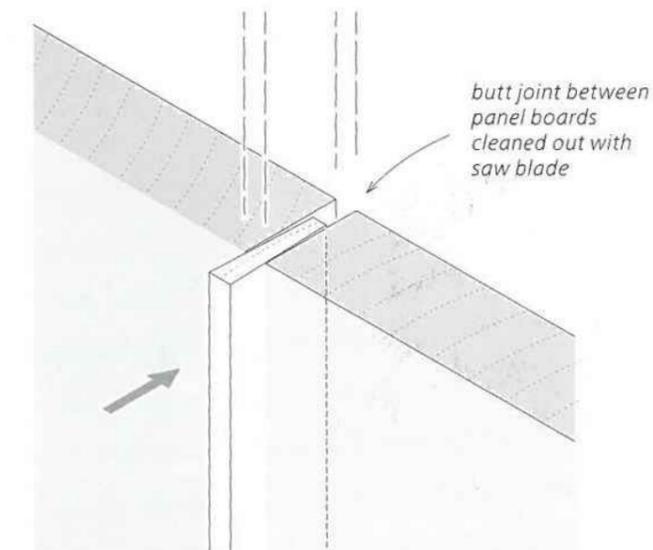
DETAIL AT A

In situ repair to open joint between component boards of panel

Tapered timber fillet inserted into joint and fixed with glue; surplus timber planed flush with face of panel once glue has set

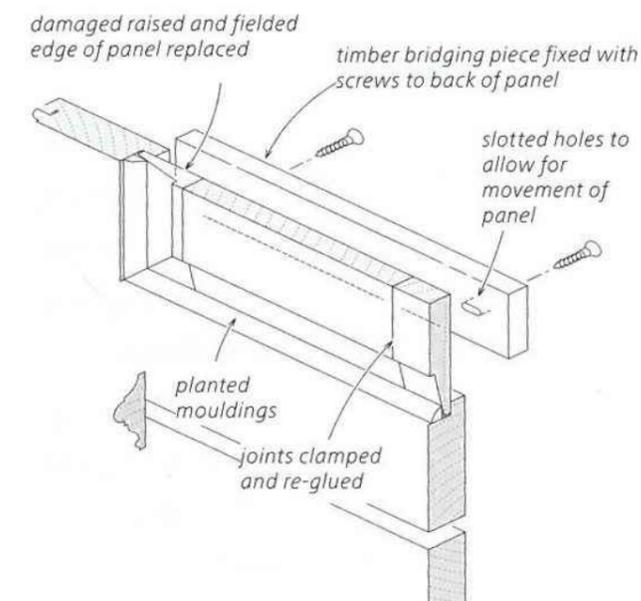
DETAIL AT B

Panel removed from framing for repair
