**No 12 Gray's Inn Square First Floor North Floor Repairs & Beam Strengthening**  
For The Honourable Society of Gray's Inn  
**Details of Proposed Repairs / Strengthening To Existing Flooring**

**Drawing No: HK 2191 / SK 037**

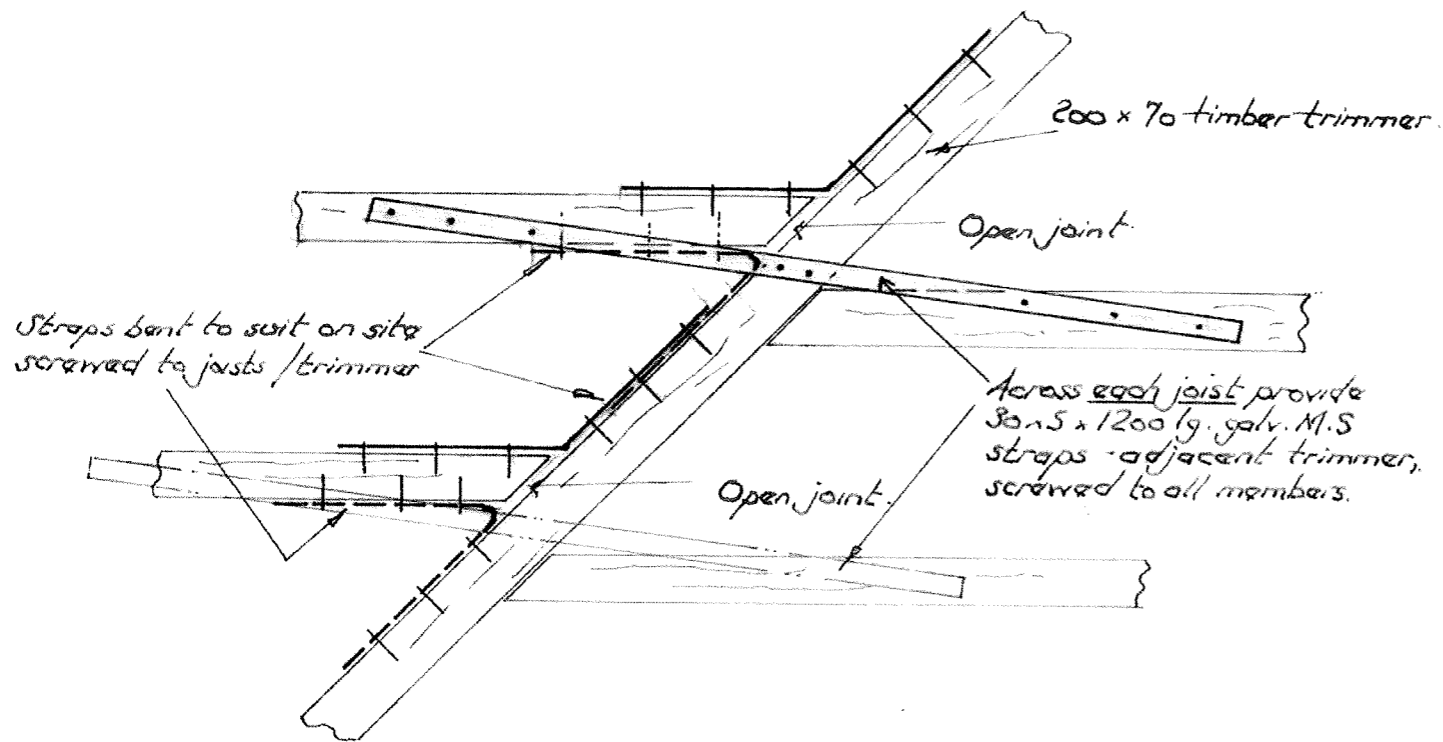
**Detail No 2** North East corner of Floor - Repairs to Diagonal Timbers / Joists, within depth of existing floor construction

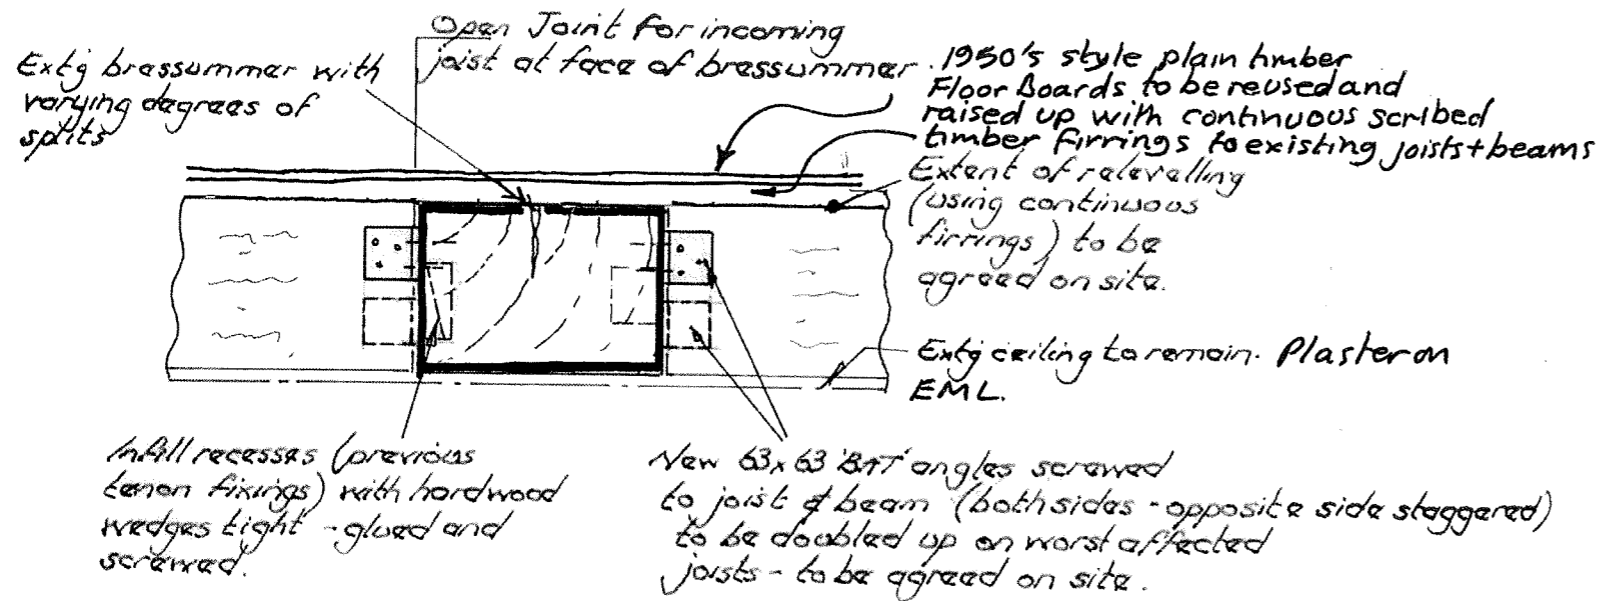
**Detail No 3** Details of Bressummer Beam / Joist strengthening within existing floor construction depth

⊗ Beam No ① on drawing HK 2191/036 to have slots cut from the top + resin / stainless steel reinforcing rods inserted by Timber repair specialist. + 45mm laminated plywood glued + screwed to top surface of beam with staggered / lapped joints. Splayed timber threshold to be provided at Entrance Door - oak to cater for 45mm raised floor level

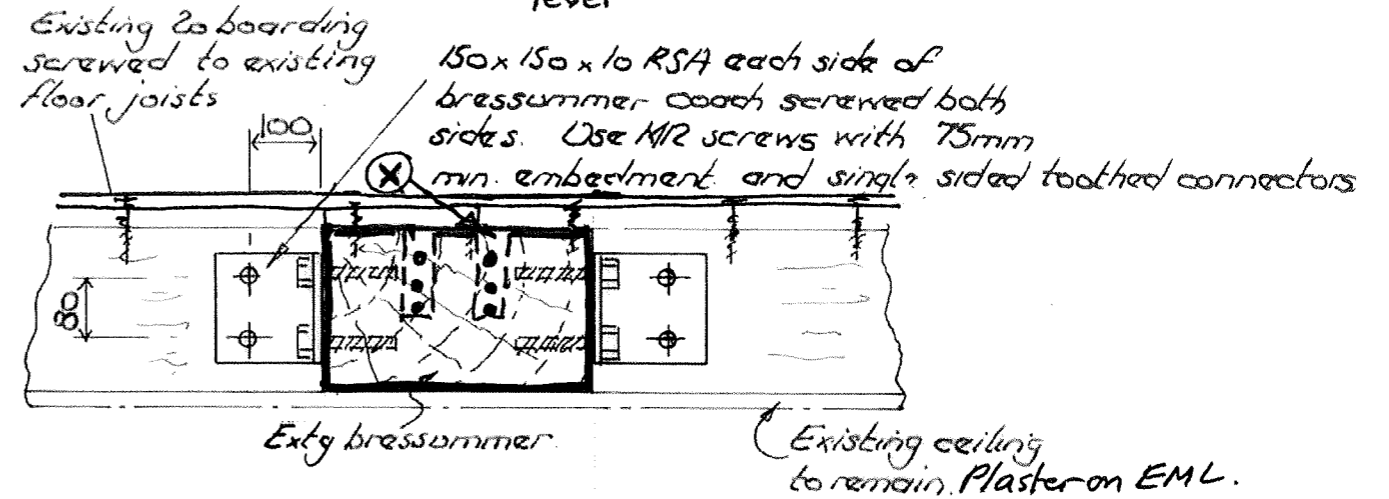
**Detail No 1** Bressummer Beam connections with additional strengthening angle fixings within depth of existing floor construction depth.

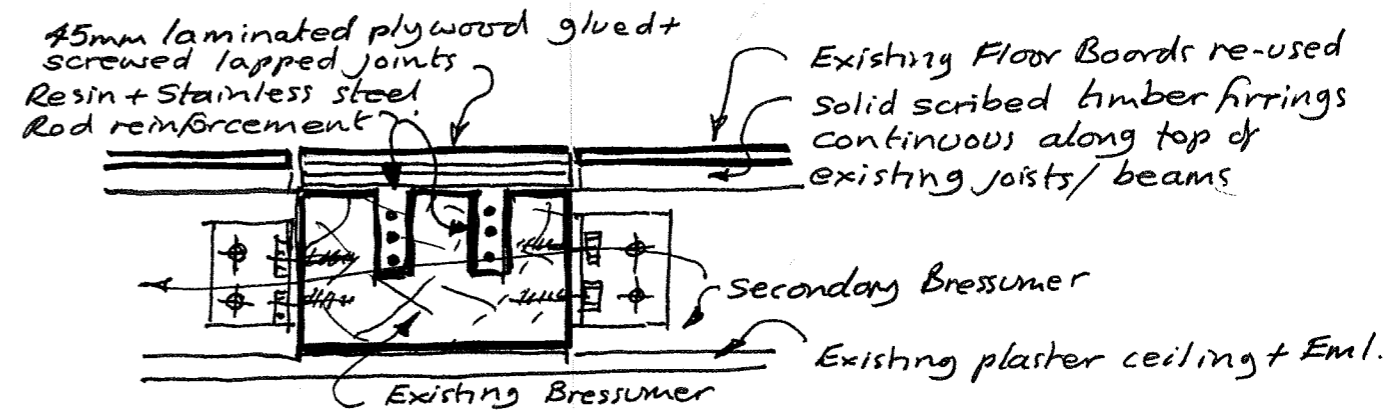
**Detail No 4** Beam ① section with proposed Timber repair details Repair details as Detail No 1 Above.
