**PROPOSED RESIDENTIAL DEVELOPMENT
AT
PLENDER STREET, CAMDEN, LONDON
FOR
HIGGINS CONSTRUCTION PLC
REMEDIATION METHOD STATEMENT**

REPORT NUMBER 13804RS

MARCH 2016

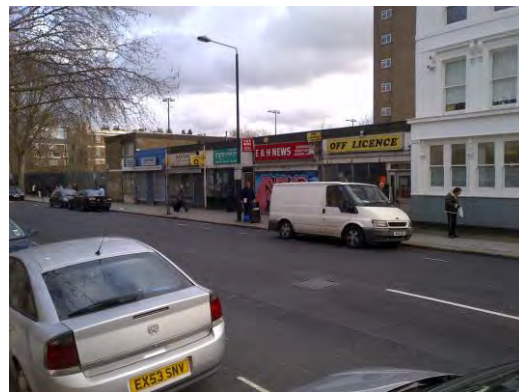
Figure 1

The site was situated in a predominantly residential area although the north western portion of the site comprised of a row of low rise commercial properties (Figure 1). The site comprised a 'T' shaped parcel of land measuring approximately 85 m north east to south west and 80 m north west to south east, bounded by Plender Street to the north, Camden Street to the east and a former public house with a beer cellar to the west (Figure 2). The southern portion of the site extended along Bayham Place adjacent to existing tennis courts/school playground which were to

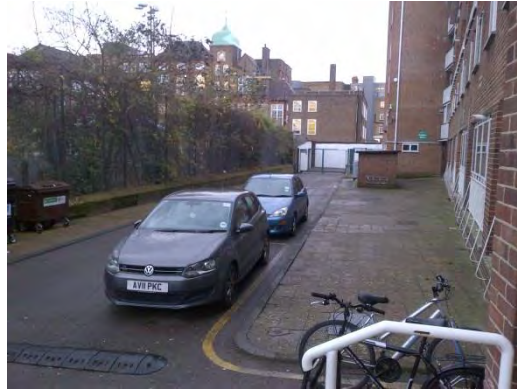
Figure 3

the east and Rainham House, a high block of flats, to the west (Figure 3).

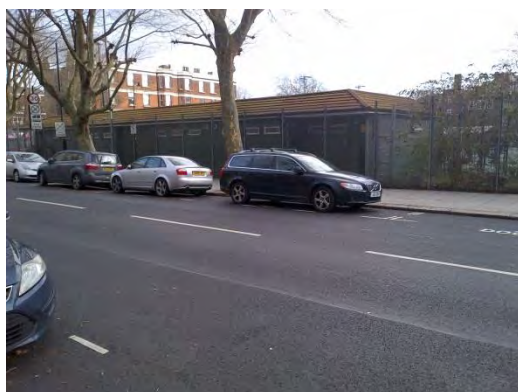
Figure 4

The eastern portion of the site comprised a one storey temporary building (Figure 4) used as changing rooms for the tennis courts located immediately south east of the site (Figure 5). The tennis courts formed part of the Richard Cobden Primary School playground, but were understood to be used by members of the general public during evenings and weekends. This area of the site was relatively flat and was bounded by wire mesh fencing approximately 3 m in height that surrounded the entire school tennis pitch area.

A row of mature trees suspected to be London Planes grew in the pavement immediately to the north of the changing rooms (Figures 4 and 5).

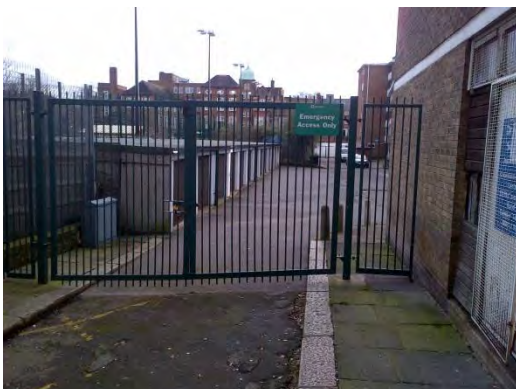
Figure 7

An emergency access road to the flats was located between the changing rooms and the surgery where a pair of locked metal gates approximately 2.2 m in height prevented both vehicular and pedestrian access (Figure 7). Beyond the gate were thirteen terraced garages adjacent and backing onto the tennis courts (Figure 8). The blockwork constructed garages with cast in-situ concrete floors had been recently renovated with corrugated metal roofs.

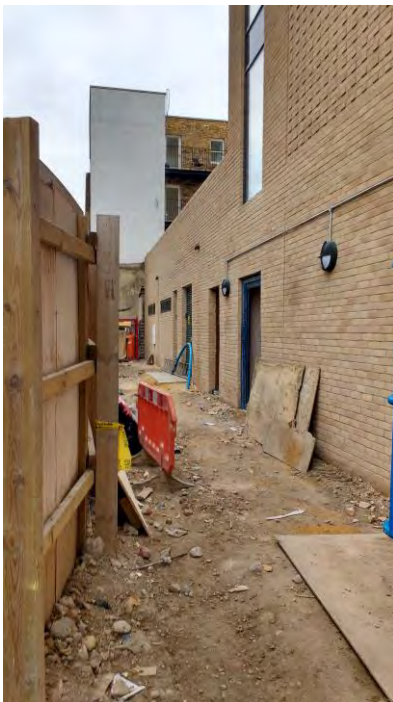
Figure 9

The development had been constructed across the east and west (Figure 9) limbs of the site and work was being undertaken on the southern limb of the site to construct areas of soft landscaping (Figure 10). No soft landscaping had been installed.

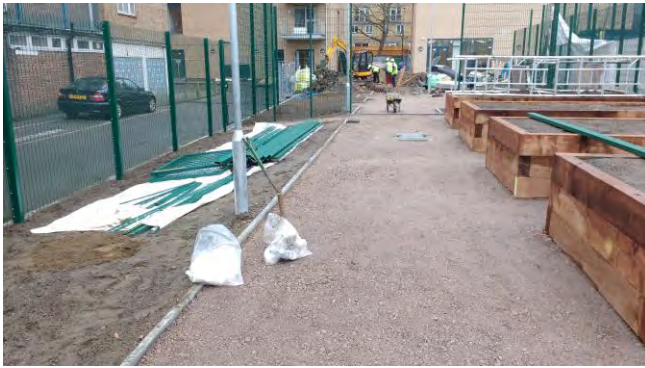
Figure 11

Soft landscaped areas had been installed across the southern (Figure 11) and western (Figure 12) areas of the site and work was continuing across the central access road.
