**Planning Ref: 2015/4513/P Proposed Works at Flat 3, 269 Goldhurst Terrace, London NW6 3EP  
Supplementary Flooding Information**

A Flood Risk Assessment (FRA) for the proposed extension at 269 Goldhurst Terrace, London, was prepared by AND Designs Limited in June 2015 and submitted within their Basement Structural Method Statement (BIA) as part of the planning application for the development. A site location plan is shown in Figure 1. The planning proposal is described as the *“Erection of single storey side extension and creation of basement below existing dwelling and new extension, with 2 no. front and 2 no. rear light wells”*.

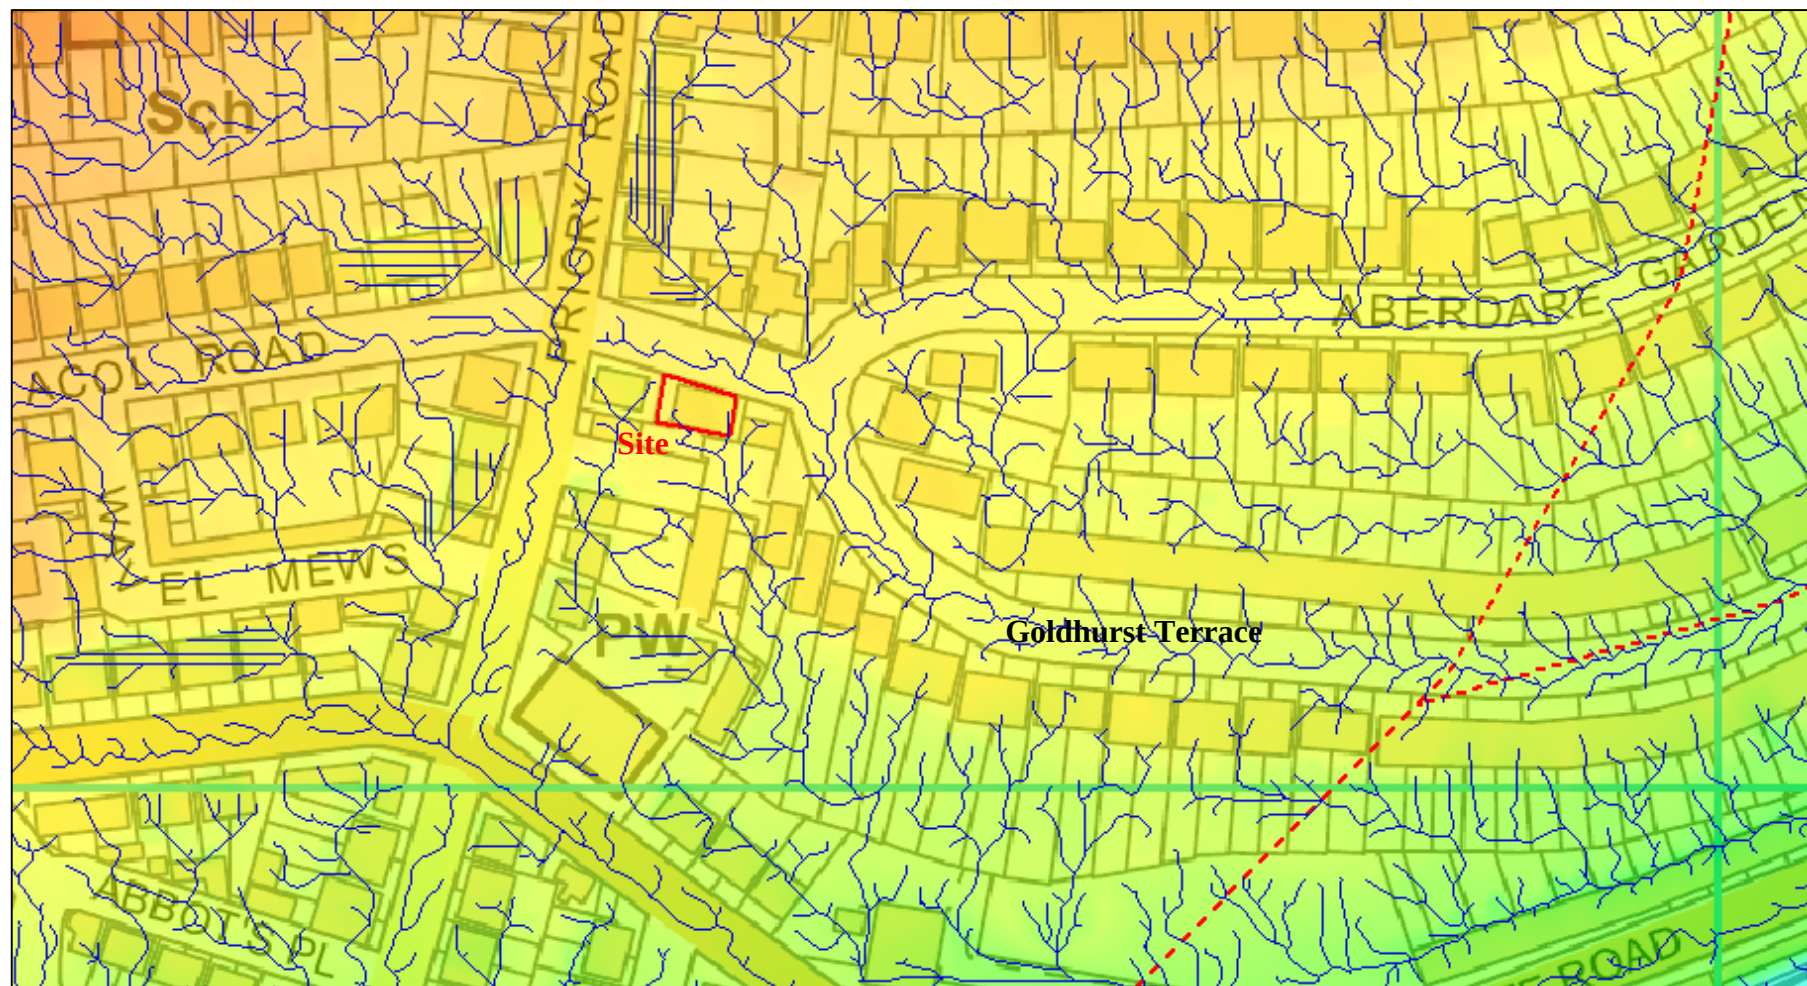
Figure 2: Indicative overland flow paths

It is possible that excess surface water could enter the basement through the light wells at both the front and back of the building. LiDAR ground elevation data was obtained and was analysed for overland flow paths within the area. The results are shown in Figure 2, which indicate the land falls to the south and east.

Goldhurst Terrace level drops from about 41.7 m AOD in front of the site to 37.8 m AOD along the section of the road shown in Figure 2, over some 370m. Ground levels in the approximate location of the Thames relief sewer are around 39.1 m AOD, over 2 m below the site level.

The overland flow paths shown in Figure 2 indicates that the catchment area from which surface water runoff could drain towards the site is very small and therefore the risk of flooding of the site from surface water runoff is low. Most of the surface water runoff upslope of the site flows southwards along Priory Road away from the site.

Based on the LiDAR data, the site sits at approximately the same level as the road, but there is a raised kerb and pavement between the property and the road and given the very small area of surface water runoff draining towards the site (Figure 2), it is unlikely that water would reach depths high enough to overtop the pavement. Nevertheless, the BIA and BIA Audit recommends each of the 4 light wells should be protected by integral upstands to reduce any risk of flood water potentially entering the basement and this is recommended as a precautionary measure.

It is understood that an unspecified part of Goldhurst Terrace was subject to flooding in 1975 and 2002 due to surcharging from Thames Water relief sewer. It is understood that the capacity of this sewer has been increased since then. Figure 2 indicates that any flood waters surcharging from the sewer would tend to flow east. This indicates that the risk of flooding from flood waters surcharging from the Thames sewer appears low.

As the area is developed, it is served by a local sewer system. Any flood waters surcharging from the local sewer system would tend to flow east, following the indicative overland flow paths shown in Figure 2. Therefore, the risk of flooding of the site from surcharging local sewer system appears low.

In summary, giving the fall of the land to the east as shown in Figure 2 and the small upstream catchment area from which surface water runoff could drain towards the site, the risk of flooding from surface water runoff is considered low.
