## *HERITAGE, DESIGN AND ACCESS STATEMENT HILL GARDEN PERGOLA*

### 1.00 INTRODUCTION

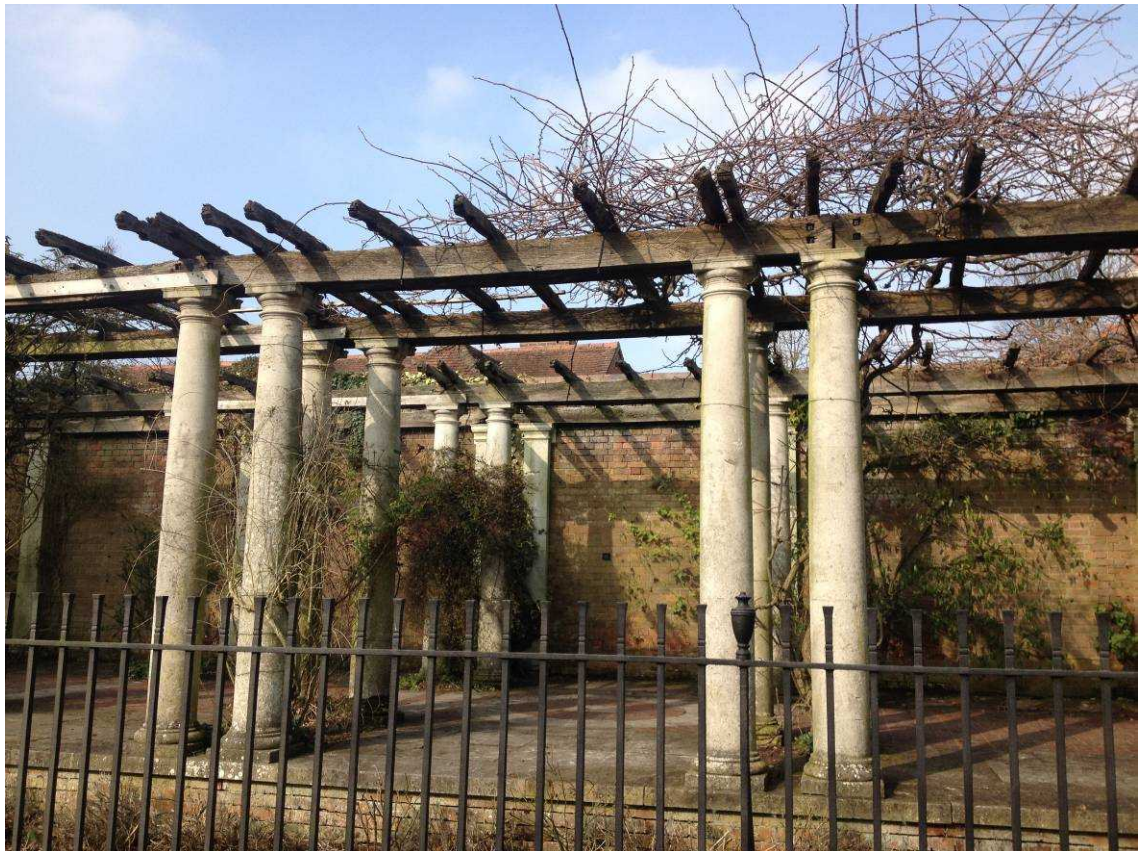
View of a typical bay of the Pergola Colonnade

The pergola runs West to a Belvedere summer house; this section from the bridge to the west summerhouse, added c 1911-12, has a wall along the north side (the rest of the pergola is open on both sides). Portland stone columns (double and single) support the wooden pergola, together providing the framework for wisteria, roses and other climbing plants, with herbaceous planting at the foot of the columns.
