This statement has been prepared by Union Architects on behalf of our client Myles Payne.

It describes proposed alterations to no.11 Highgate West Hill, a Grade II listed property within the London Borough of Camden.

11 Highgate West Hill
London
N6 6JR

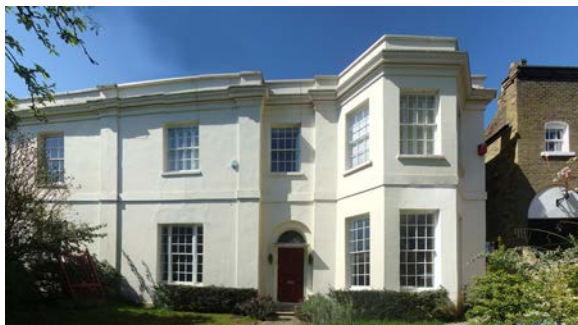
fig.5 Front elevations to no 11.

The buildings themselves remain broadly as described within the listing details - rendered entirely in Cream Stucco around a series of pilasters and cornices. The multi-paned, single glazed sash windows are believed to be original.

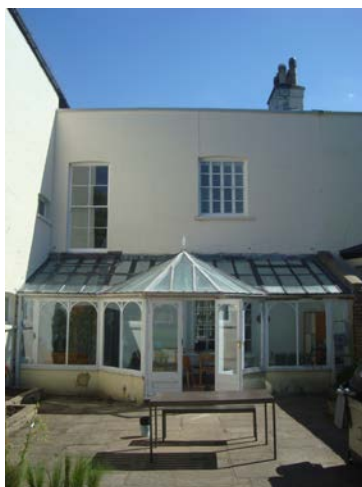
fig.6 Rear elevations to no 11.

With the exception of the aforementioned dwelling division and a modern glass conservatory to the rear (planning application reference 8470008), no significant changes appear to have been made to the ground floor room arrangement.

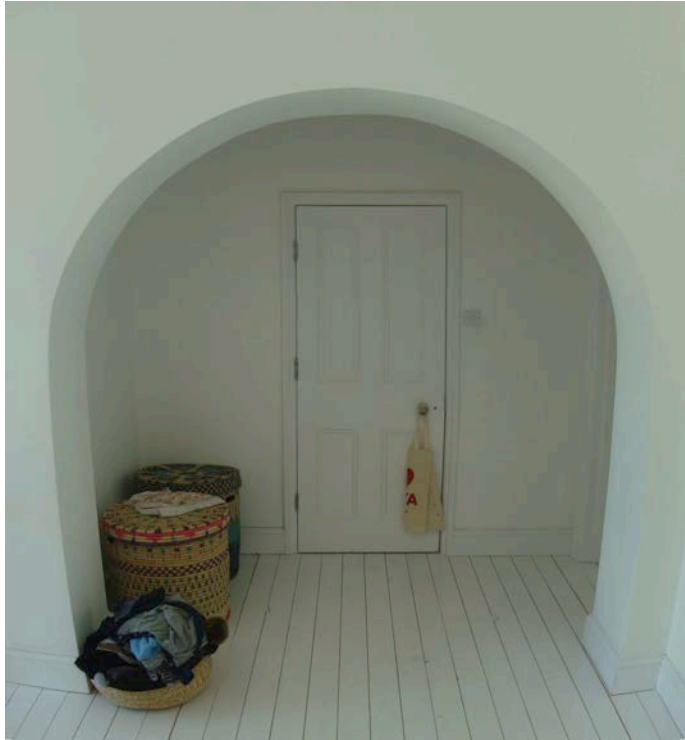
fig.7 Entrance to the main bathroom from first floor landing

At first floor level, two small bathrooms have been built - one located off the landing presumably to serve the main house, via what is thought to be an original arch. The other acts as an en-suite to bedroom 01 (see plan). Together these occupy the footprint of what perhaps would have originally been a larger *Piano Nobile* style room at first floor offering fine views from the bay window. We believe access to a similar sized room to the rear (now part of no 11a) via a door opening to the left of the existing family bathroom door.

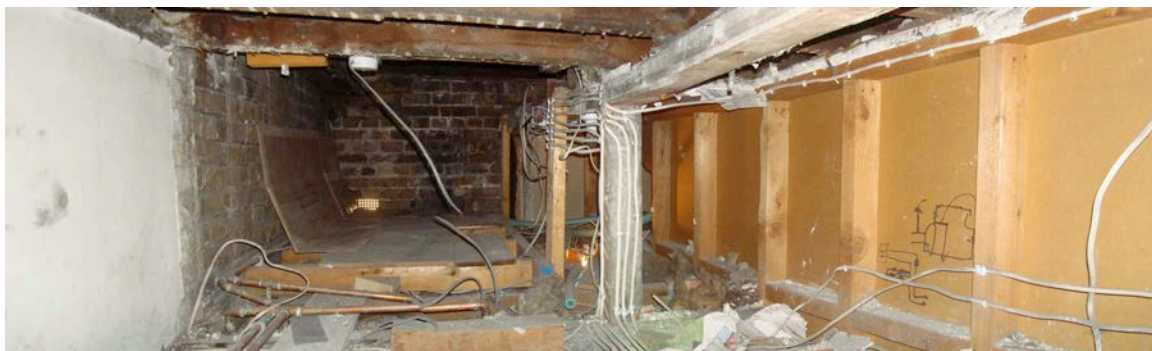
fig.8 Void between original first floor ceiling joists & modern bathroom ceiling

Given the original first floor to ceiling heights, sub-division into these smaller rooms would otherwise have resulted in disproportionately tall spaces. This perhaps explains the reason for a false, secondary ceiling over both bathrooms. Between these and original ceiling joist level now exists a redundant void containing modern pipework and timber studs (see fig.8).

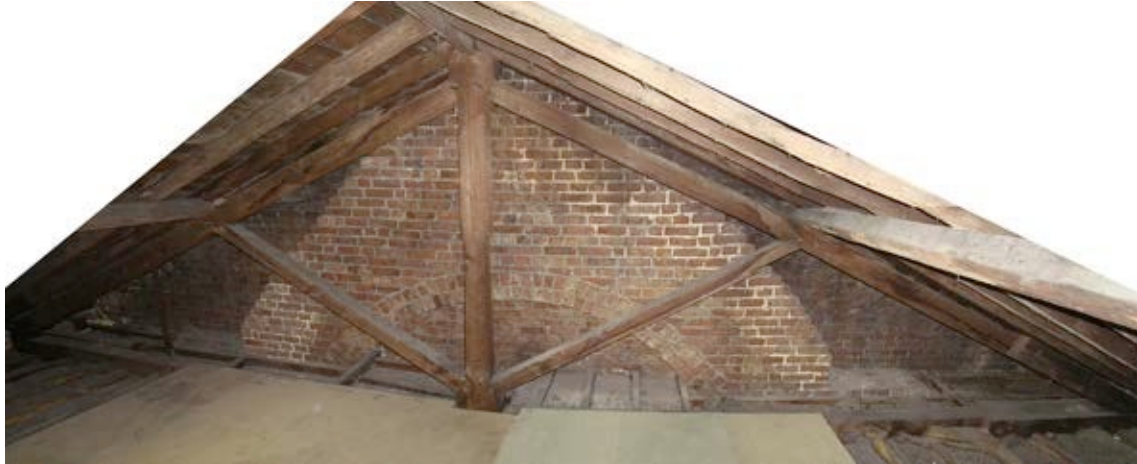
fig.9 Original Kingpost truss adjacent to chimney stack

The building's original roof comprises three separate spaces; Above both first floor bedrooms (03 & 04, adjacent to party wall with no 10), sits a large, hipped loft space. This encompasses a unified chimneystack along the party wall with an exposed brickwork arch. Support for the roof seems to have originally been via two timbers, king post trusses spanning from the ridge to the front and rear walls of the house. While that adjacent to the chimney breast is no doubt original with existing *mortice & tenon* joists secured with separate wooden pegs, a replacement built from modern machined timber and mechanical fixings has been built upon what seems to be the original lower tie beam section.

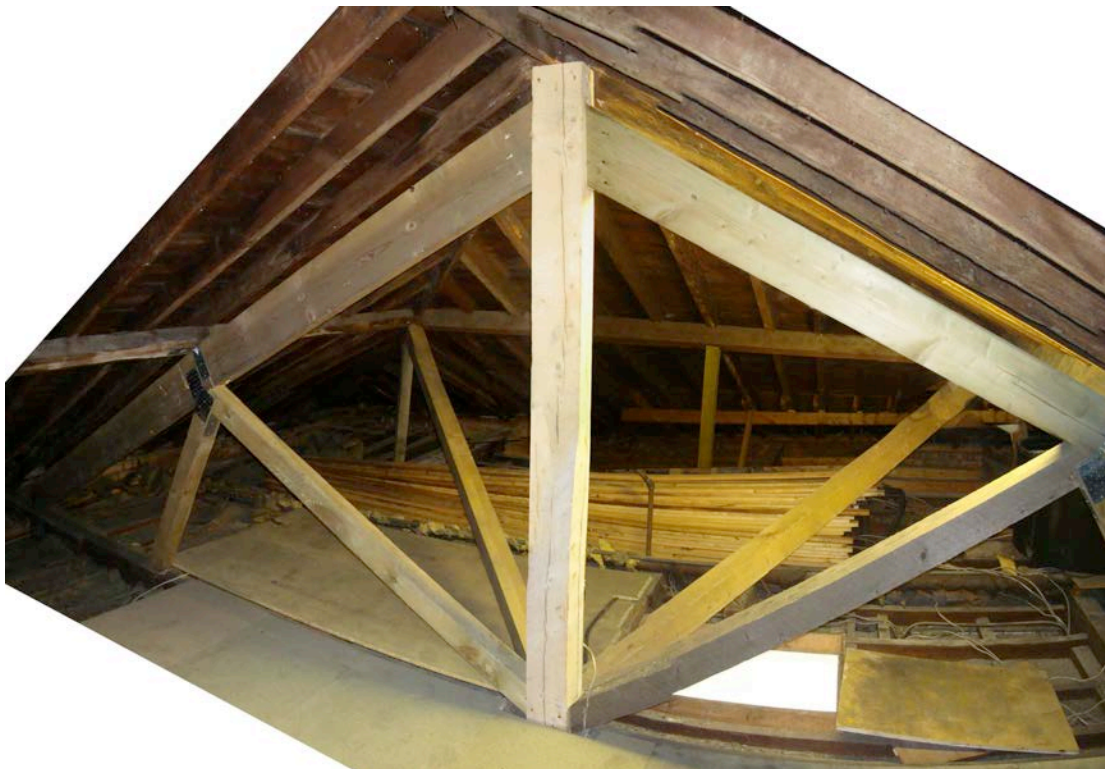
fig.9a Modern timber truss replacement

Similar examples of repair are evident elsewhere within the space with secondary timber supports and courses of modern brickwork visible around the loft perimeter.

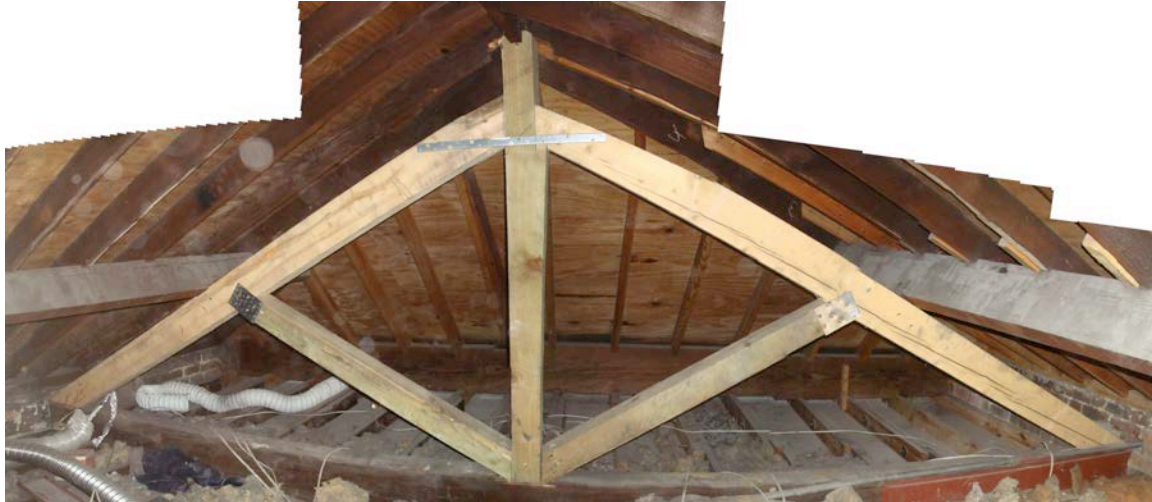
fig.10 Modern timber truss replacement

Above bedroom 01 and those adjacent bathrooms sits a second hipped, loft space smaller and lower than that outlined above. Extensive remedial work seems to have been carried out here. Two modern machined, timber trusses have been built onto what may have been original tie beams. Where the ends of these meet the supporting masonry walls, modern, galvanised steel angles have been bolted on presumably to strengthen against decay. Original purlin beams span across the tops of the trusses with original rafters cut and spliced with modern timber around the perimeter where again, they meet modern wall plates and masonry walls. Modern sarking board sits between these rafters and the external weather proofing. Lastly a small Velux rooflight has been installed to the roof's southeast facing pitch.

The creation of a new room within this space would require removal of the modern replacement truss we document above (fig.10). Because of its limited historical importance or indeed design worth, we feel this is entirely warranted. Replacement structural support would come in the form of five steel rafters supporting a new ridge beam beneath the existing and original ridge board and existing purlins. The nature of this structure would allow it to carry the load of the existing roof, transferring this down to the solid front and rear walls. No load bearing would therefore be required of the party wall, original chimney brickwork nor crucially the remaining original truss, all of which would remain undisturbed. From this new structure, insulation and dry lining may be hung avoiding the need to fix back to those original timbers above.

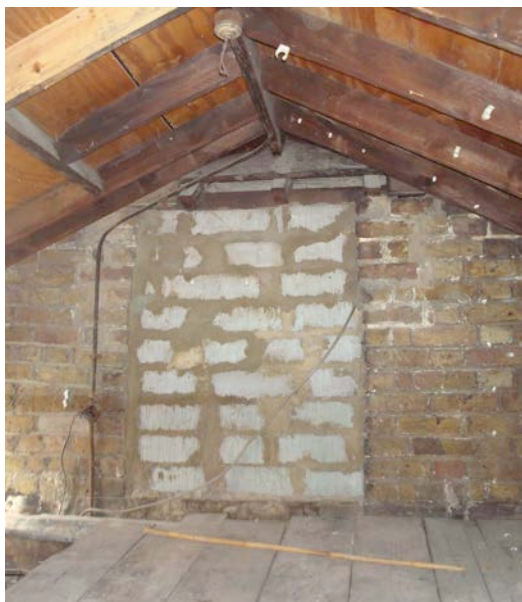
fig.11 Boundary wall to 11a within roof space

This space abuts a third roof space above no 11a via a modern block work wall though no inspection beyond this has been possible. Similarly, this is also finished in slate and lead though it sits at a higher level to either of no 11's roofs.

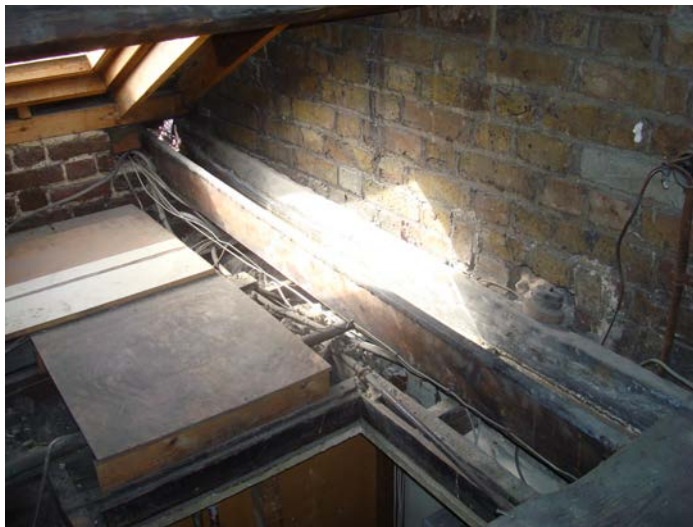
fig.11a Ingress of lead gutter along the now party wall

A further example of significant intervention exists in this space. A formed lead gutter appears to pass internally through at joist level, alongside the party wall (shared with no 11a) and to egress towards the flank wall. It presumably outlets into the visible, high-level upvc gutter on that elevation (fig.11b).

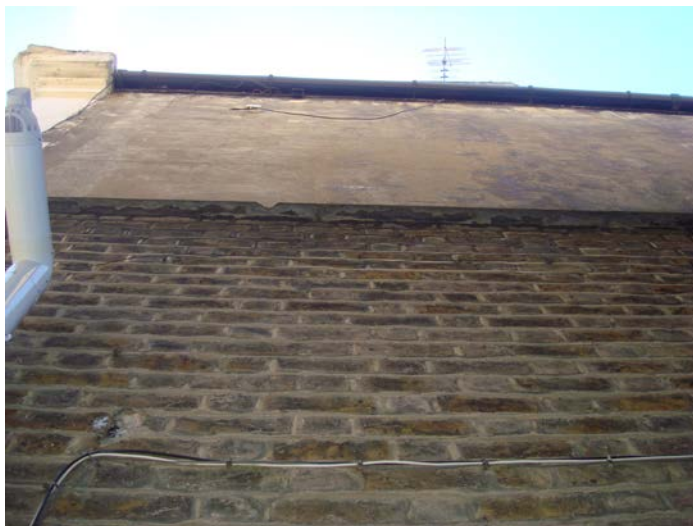
fig.11b High level gutter to side elevation of no 11.

Since no rainwater downpipes exist elsewhere to no 11's elevations we believe this to be the principle flow of rainwater from no 11's roof. It was perhaps installed following sub-division of the original villa so that neither property contained trespassing drainage. We also believe that this unsatisfactory method may have led to long term leakage throughout both loft spaces perhaps explaining the level of modern remedial work which is now apparent in either.

In any case we strongly feel the arrangement cannot be left in its current form. We therefore propose altering the falls to those lead soakaways, reversing the water flow so that it can join the same high level gutter via the bay flat roof (see proposed roof plan & side elevation). To aid this we suggest replacing the upvc gutter with a cast iron one in line with original pipework elsewhere. Equally we suggest relocating the existing cast iron hopper to simplify that elevation somewhat.

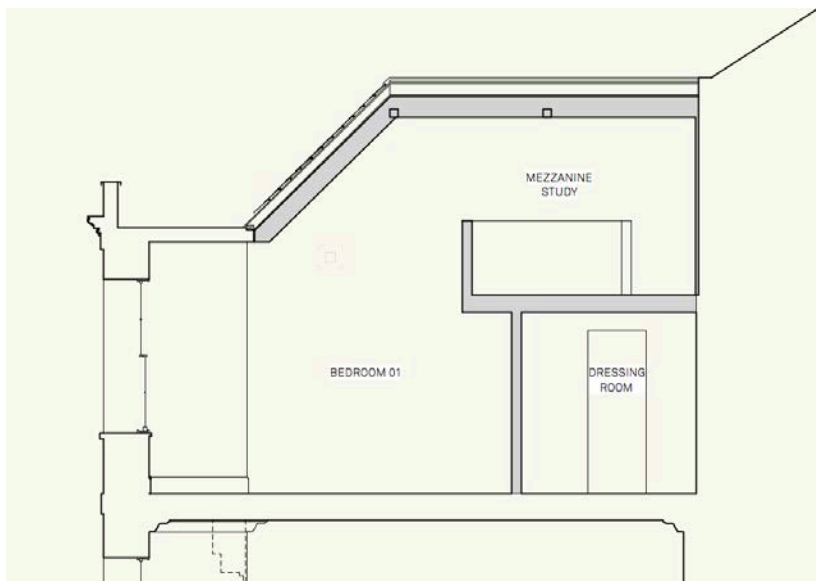
fig.15 Extract from proposed first floor & mezzanine section.

Nevertheless we feel the introduction of a second stair with the same design ethos as that in the landing is still appropriate. This would be located alongside a solid and perhaps unoriginal party wall (now shared with no 11a) and again we would seek to set the inside stringer away from this so to avoid any loading or fixing. Matching lightweight timber panelling would make up the stair balustrade in the same way.

Creating a room above, as with bedroom 05 would require the removal of those modern timber trusses currently supporting the roof. Again due to what we believe are relatively recent installations, we don't feel the loss of these or their design to be an issue. Replacement structure would come in the form of two sets of steel rafters supporting a ridge beam and original ridge board above. A fifth rafter would follow the pitch of the front roof slope and permit secondary timber hip rafters and joists between. Modern insulation and gypsum could then be fixed to these rather than those original roof timbers above.

To enable the mezzanine relationship to the bedroom 01 below, the study would require the existing ceiling above to be removed throughout. Made up from a combination of modern gypsum boards, few original joists and more modern timber replacements this does not seem an example of noteworthy historic fabric. Similarly no cornices or decorative features currently exist within bedroom 01 and so we feel that its removal in order to permit the introduction of a revitalised space is justified.
