JULIAN HARRAP

1-2 LINCOLN'S INN FIELDS, LONDON

HISTORIC BUILDING IMPACT ASSESSMENT

JANUARY 2013 REVISION D (JANUARY 2014)

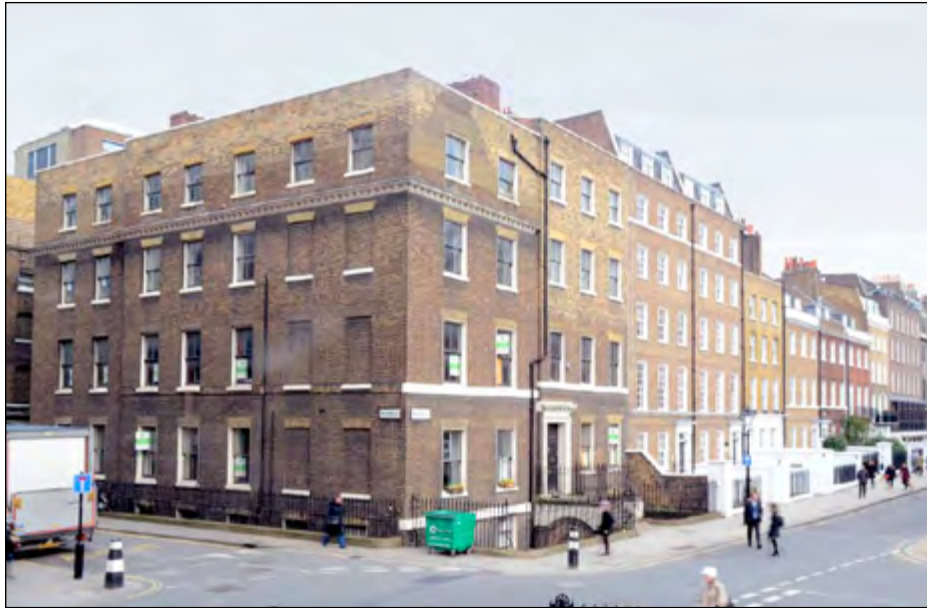
Figure 3: South & West Elevations of 1-2 Lincoln's Inn Fields (©DCA).

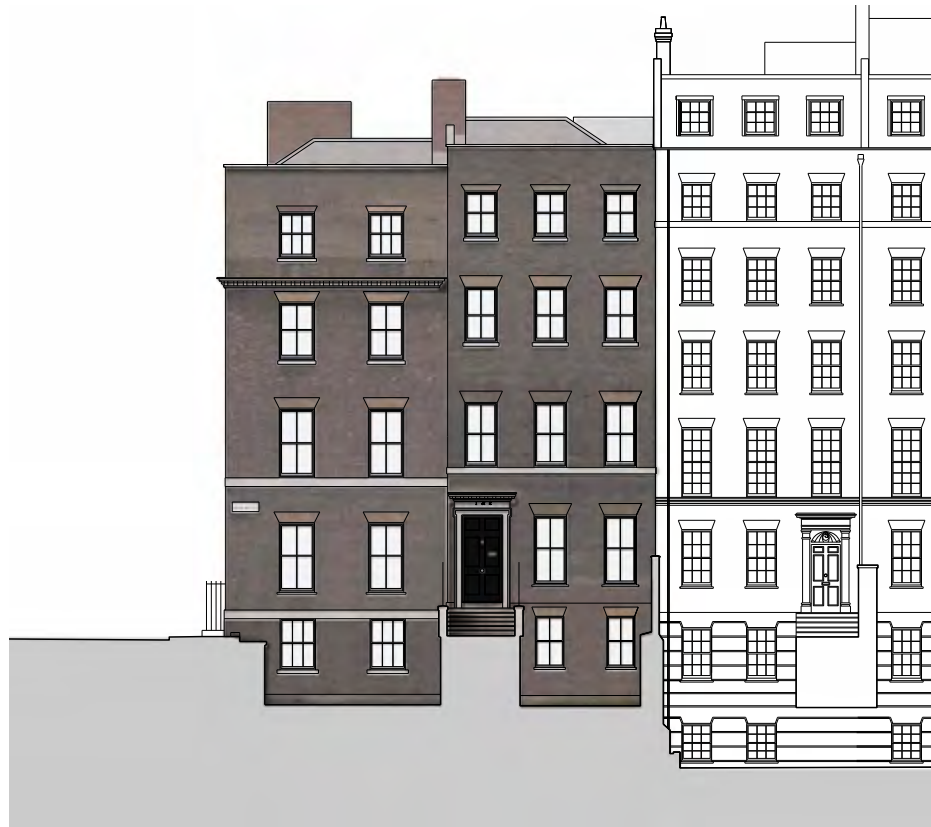
Figure 4: South Elevation of 1-2 Lincoln's Inn Fields, as proposed (©DCA).

The external facades will be carefully repaired and redecorated, but essentially the public elevations will remain largely the same. Therefore the works will have a positive effect on the adjoining buildings and the Bloomsbury Conservation Area generally. The only major changes to the exterior will be: -

2. Reinstating the stone entrance steps;
3. Reinstating and repairing the stone coping stones to the Front Area railings;
4. Removal of the modern brickwork in-filling the arches forming the bridge to front door;
5. Removal of the rainwater pipe from the front elevation;
6. Replacing the existing composite slates to the roofs with real slate;
7. Third Floor extension to the Whetstone Park Elevation (this extension is over the rear room of No. 2); and
8. Extension into the former lightwell to the North Elevation of No. 2 to become the new lift shaft and provided a rear access door to Whetstone Park.

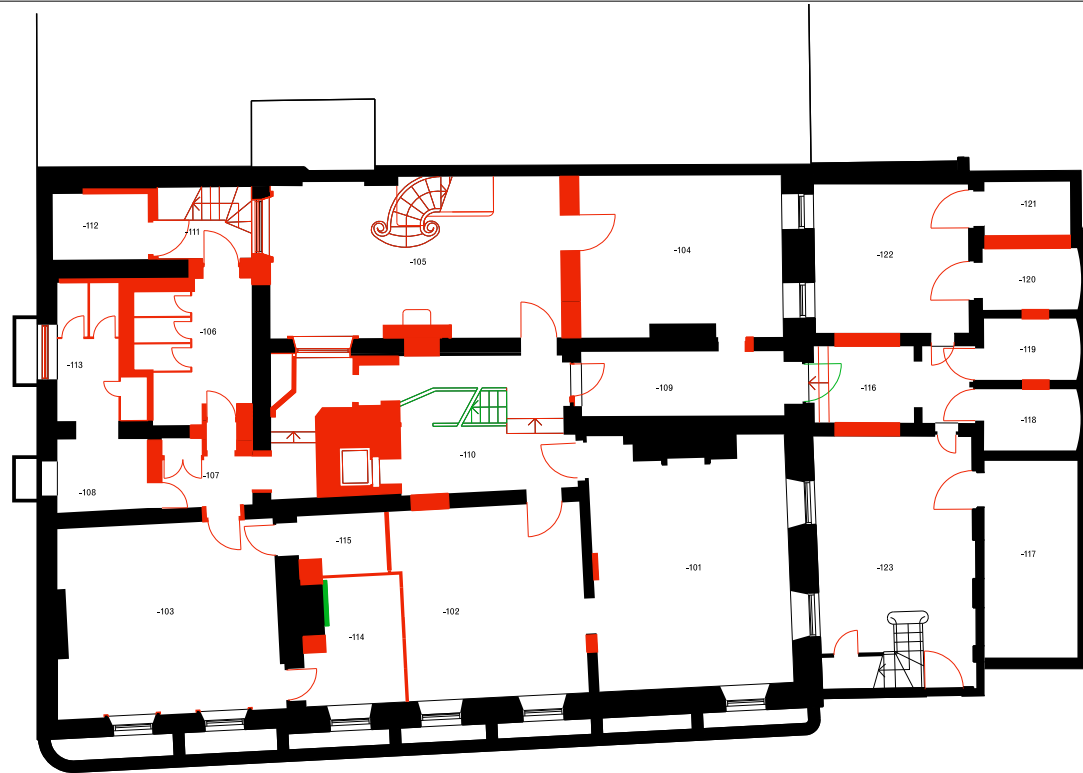
Figure 5: Existing Basement Floor Plan (with room numbers) (©DCA).

David Chipperfield Architects have prepared an analysis of the existing fabric which will be removed or repositioned as part of the proposals. The existing drawings, Figures 5, 24, 45, 59 & 77, illustrate the elements to be removed in red. As the percentage of building fabric to be removed is low we would argue that the works do not cause “substantial harm or loss” to the building as a whole. However, the Local Authority have invited the Design Team to consider the proposals in line with the Planning Policy Statement (PPS5) HE9.2, which states that “Where the application will lead to substantial harm to or total loss of significance, local planning authorities should refuse consent unless it can be demonstrated that:

The proposals involve the enlargement of the Staircase Hall, northwards using the space currently occupied by the lightwell, as illustrated in Figures 5 & 6, 24 & 25, 45 & 46, 59 & 60 and 77 & 78. The principles of repositioning the staircase and extending the landings is illustrated in DCA's schematic drawing, Figures 157 & 158.

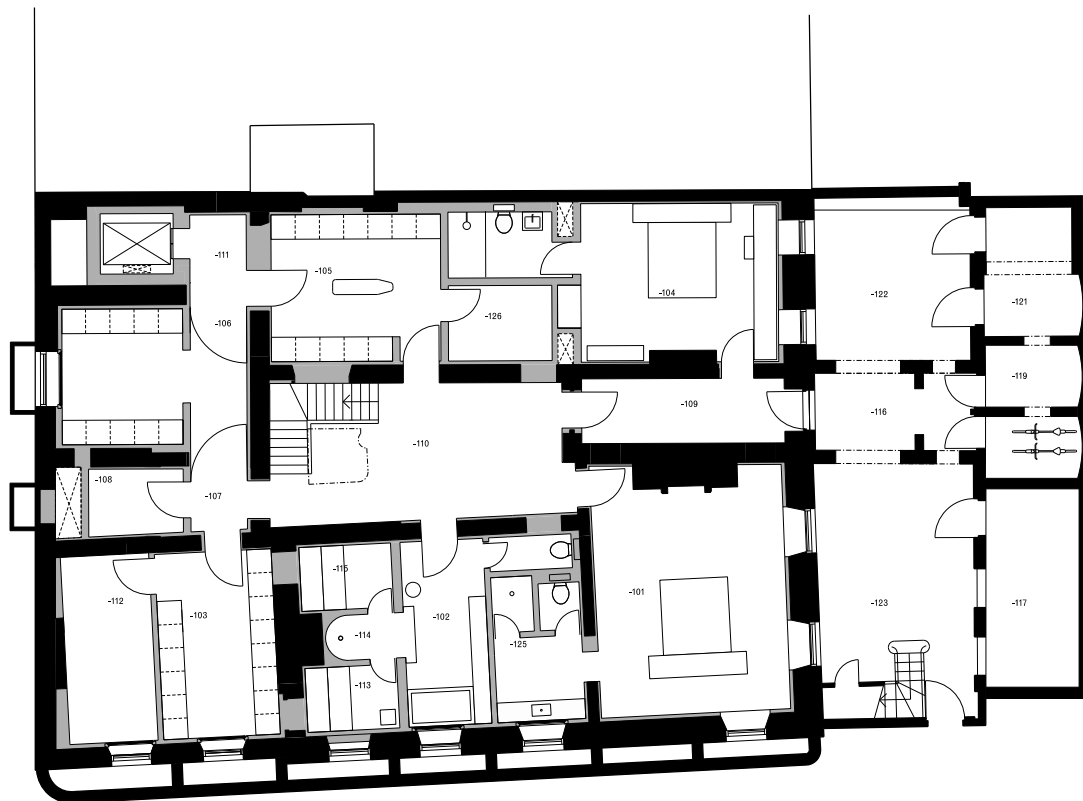
Figure 6: Basement Floor Plan (new work light grey) (©DCA).

The proposal for the basement is to convert these rooms to service spaces which will service the principal rooms above. The proposed scheme includes a catering and preparation kitchen with associated stores, staff facilities, a guest bedroom and plant rooms to serve the whole house. DCA's proposed Basement Floor Plan shows that while the proposals make modifications to the existing fabric, the historic plan form is still intelligible.

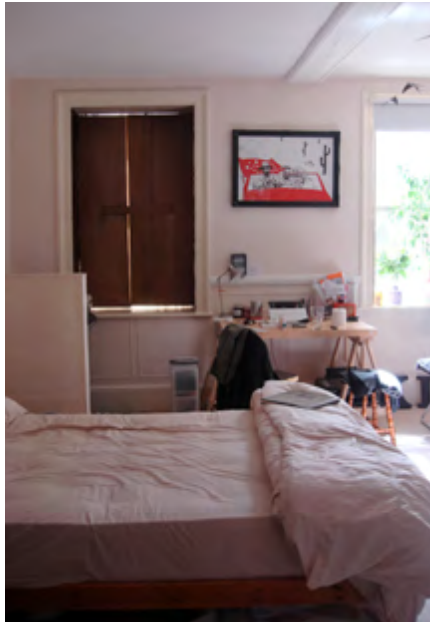
Figure 10: Room -104.

1. North Wall: it is proposed that there will be a the vertical service riser through the front portion of the house, in line with the existing spine wall. This location has been carefully sited to consider the floors above, this position causes least disruption to the principal rooms and avoids rooms with panelling and features. In positioning it in this location, the wall currently separating Rooms -104 and -105 will have to be substantially removed, to create the void, a thinner wall re-built.

2. West Wall: Proposed door to Corridor -109: This doorway survives on the corridor side, although appears to have been blocked up on the room side. It's reinstatement to the room will cause minimal disruption to the historic fabric.

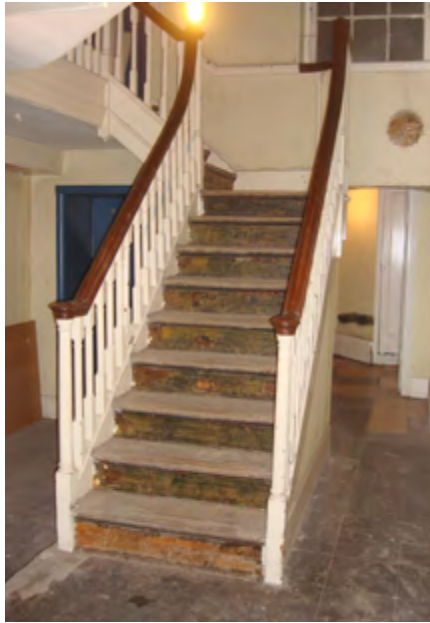
Figure 15: Room -110 Basement Stair.

2. North Wall: lift will be completely removed. As illustrated in the Humbert & Flint drawing of 1962, the lift shaft replaced a stack of closet blocks off the main staircase. The construction which survives appears to date from the 1960's. Its removal could be seen as a heritage gain.

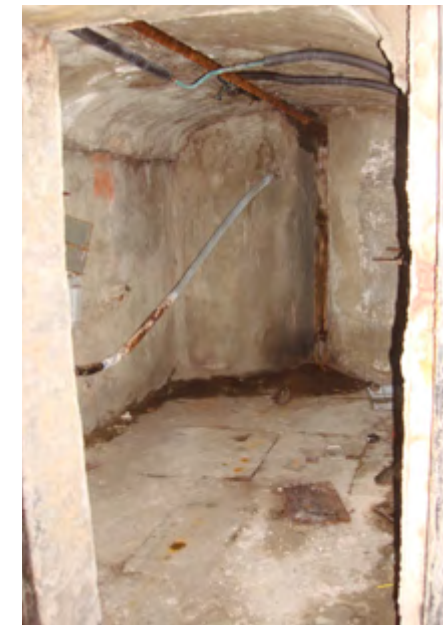
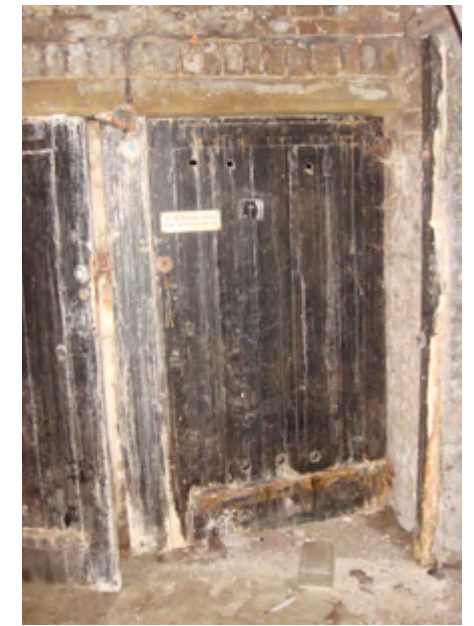
Figure 20: Room -119.

Figure 21: Door to Room -118.

1. The wall between the Cellars -120 & -121 will be removed to provide a larger cellar to accommodate the modern plant to serve the house. The vaulted ceilings of each cellar will be retained in-site and a new steel beam inserted, to pick up the load. There is no historical argument for this alteration but it could be argued that the rest of the property benefits from the repositioning of the services in this location and it saves altering the main house to accommodate modern services.

2. New doorway openings will be formed in the walls between Cellars -118, -119 & -120, for ease of access. While this is a new intervention, there are other historical examples of openings between vaults in buildings of this period.

3. North Wall: Doors and existing ironmongery will be repaired, overhauled and redecorated. New louvres will be cut into these doors to provide ventilation for the new plant.

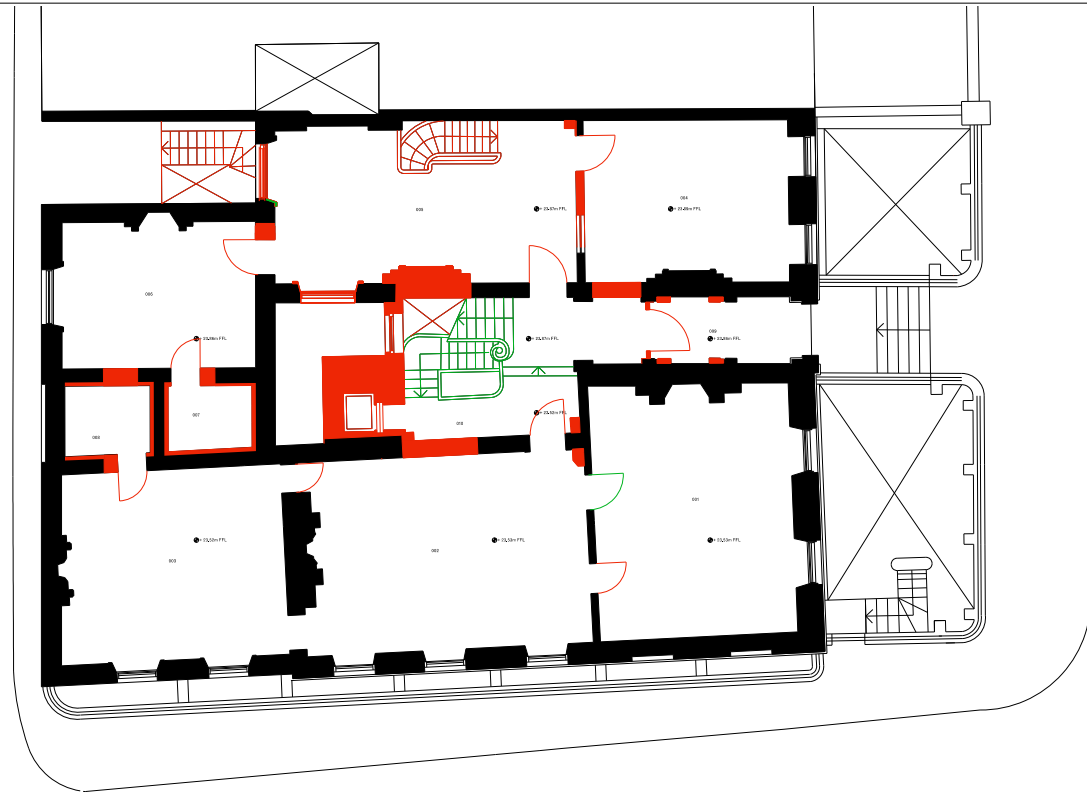
Figure 24: Existing Ground Floor Plan (with room numbers) (©DCA).

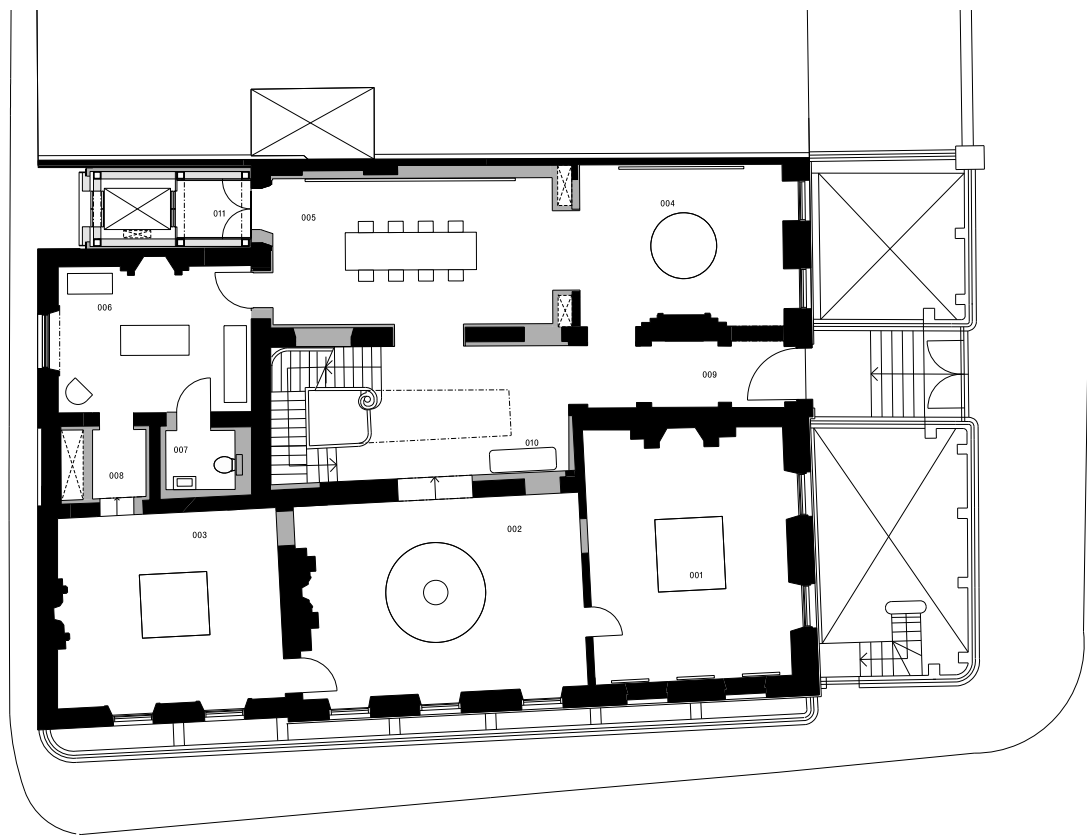
Figure 25: Ground Floor Plan (new work light grey) (©DCA).

The proposal for the ground floor is to convert these rooms to a reception room, office, screening room and reading room. The principal rooms will be carefully repaired while the middle room of No. 2 will be altered to create a new library. The proposal includes the re-configuring of the main staircase. The wall between the staircase and lightwell will be removed and the existing staircase will be carefully dismantled and re-configured further to the north. DCA's proposed Ground Floor Plan shows that while the proposals make modifications to the existing fabric, the historic plan form is largely unaltered with the exception of the lightwell.

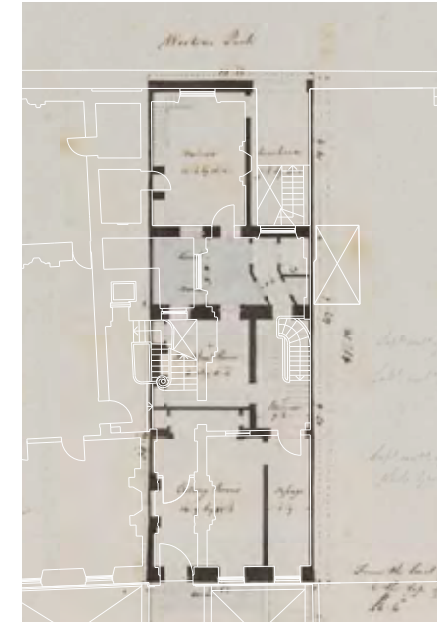
Figure 36: Soane Plan of 1792, overlaid with modern plan.

The room survives as a long, thin space which acts more as a circulation space rather than a room. It is a consequence of the 1840's reconstruction of the house and bears little resemblance to the rear room of the 1740's house, as recorded by Soane in 1792 (Figure 36). The proposal acknowledges its use as circulation space and aims to improve connectivity to the adjacent rooms while also converting this space to a library so that it has a function.

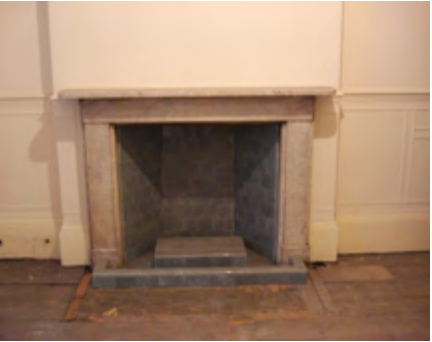
Figure 39: Room 006, fireplace.

- 1. Walls: the plastered surfaces will be fully repaired, particularly where modern fittings have been removed.
- 2. The window and shutters will be overhauled and repaired, including installing draft strips to the window.
- 3. Fireplaces: The existing fireplace will be repaired and be cleaned by a specialist conservator.

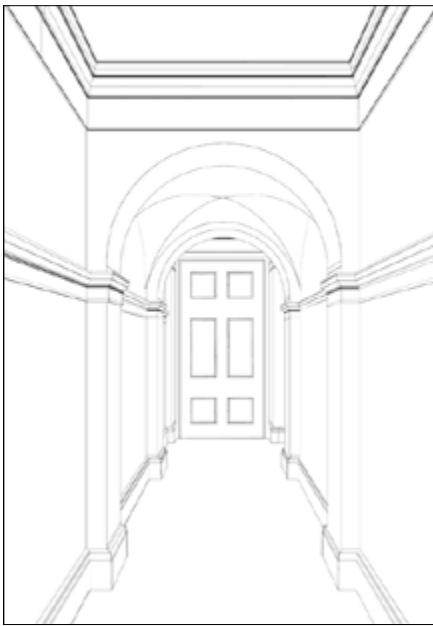
Figure 42: Room 009, as Proposed ©DCA.

1. East Wall: It is proposed that a new opening is formed into Room 004, see note 2 of Room 004.
2. East Wall: It is proposed that the inner pilasters which support the inner arches and walls forming the middle ceiling pan to the Entrance Hall arrangement will be taken out and made good in plaster. The arches springing from all pilasters will be enlarged so that they are semi-circular in elevation, rather than flat arches, as existing, this is in combination with the proposed works to the ceiling, see Figure 42.

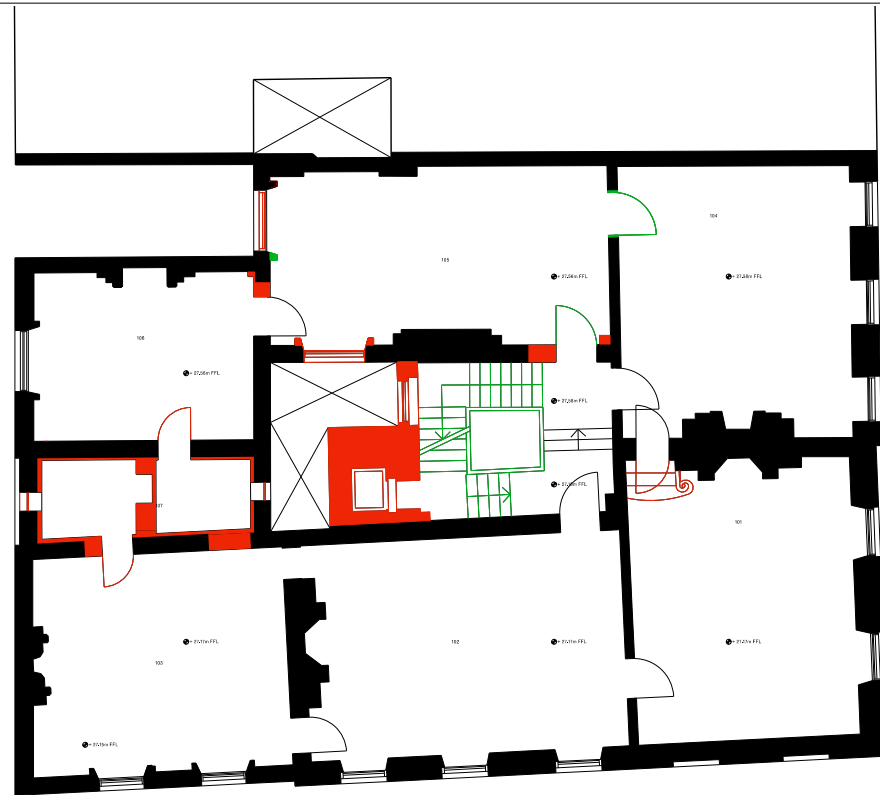
Figure 45: Existing First Floor Plan (with room numbers) (©DCA).

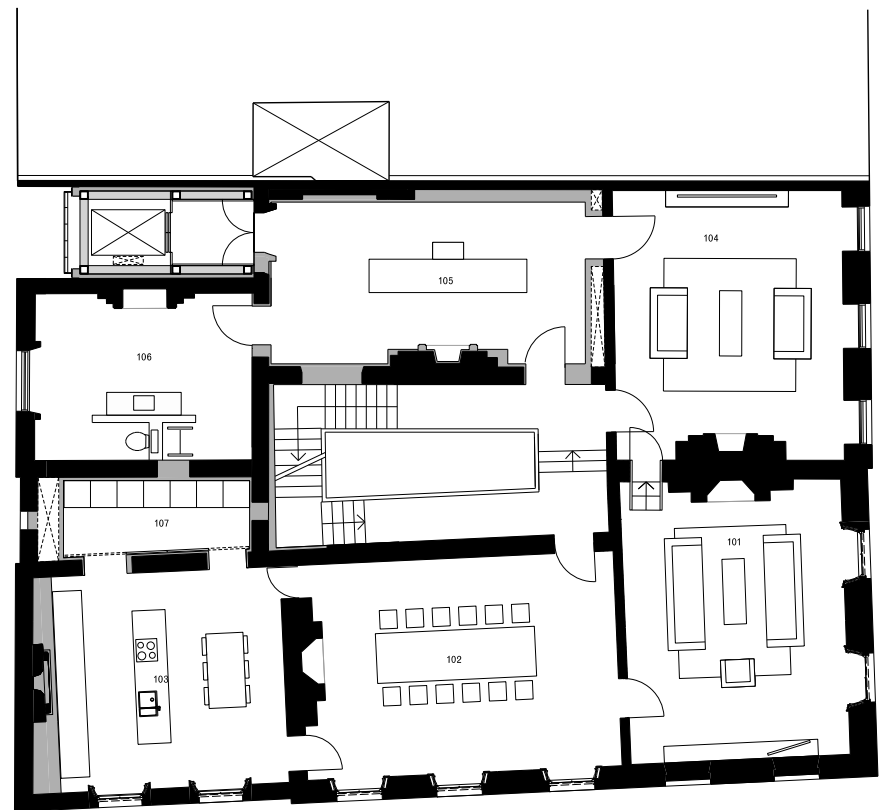
Figure 46: First Floor Plan (new work light grey) (©DCA).

The proposal for the first floor is to convert these rooms to the main living room, drawing room, dining room, kitchen and office. The principal rooms will be carefully repaired while the middle room of No. 2 will be altered and fitted out to create a new library. The proposal includes the re-configuring of the main staircase. The wall between the staircase and lightwell will be removed and the existing staircase will be carefully dismantled and re-configured further to the north. DCA's proposed First Floor Plan shows that while the proposals make modifications to the existing fabric, the historic plan form is largely unaltered with the exception of the lightwell.

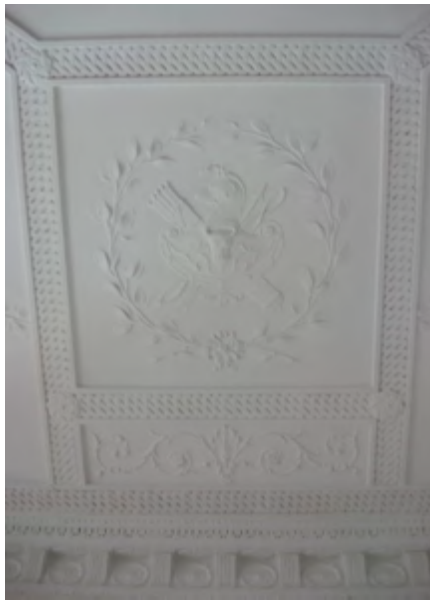
Figure 53: Room 104, Detail of ceiling decoration.

6. Ceiling: The existing ceiling will be carefully repaired and restored by a specialist. Areas where the mouldings have been lost due to the insertion of modern partitions will be reinstated. Trials of gentle paint stripping will be undertaken, to investigate if areas with excessive paint build up can be removed without damage.

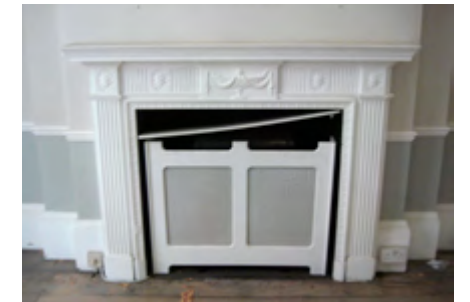
Figures 56 (above): Room 106, Existing fireplace.

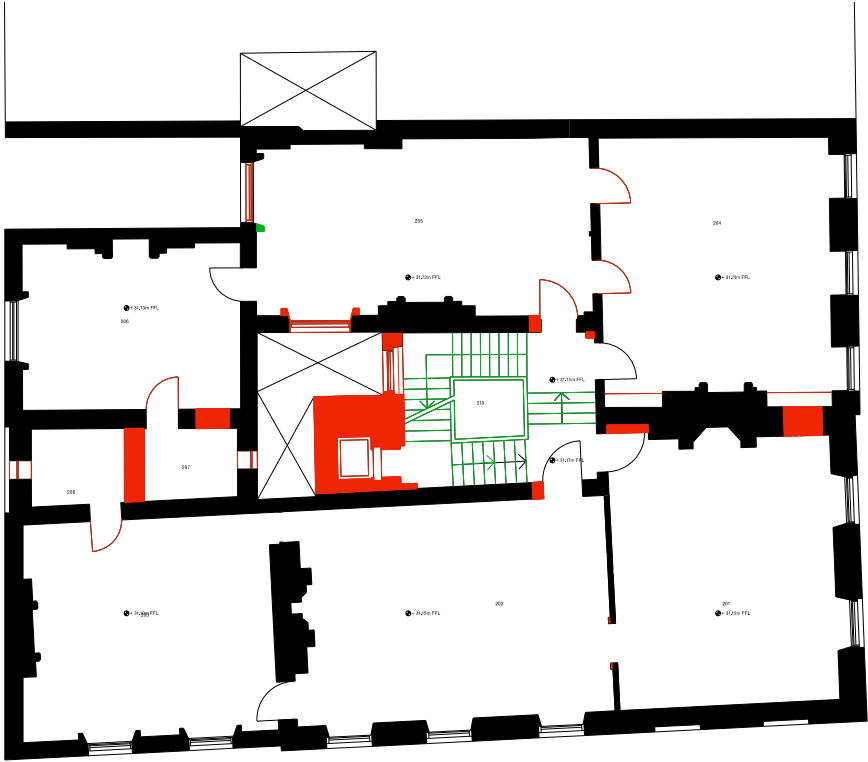
Figure 59: Existing Second Floor Plan (with room numbers) (©DCA).

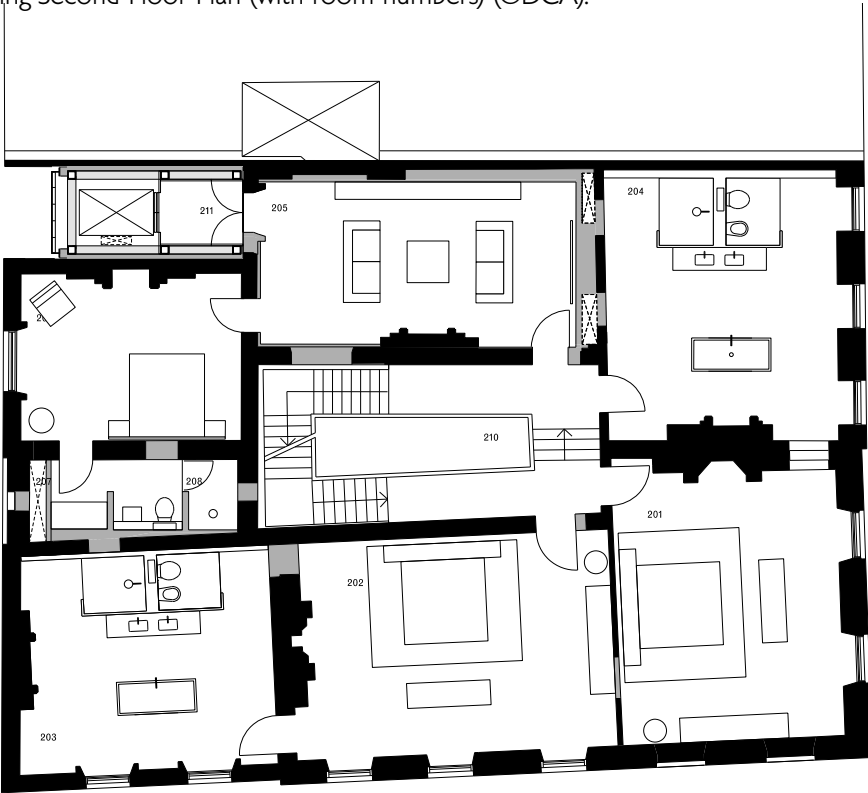
Figure 60: Second Floor Plan (new work light grey) (©DCA).

The proposal for the second floor is to convert these rooms to bedrooms with en-suite bathrooms and a television room. The principal rooms will be carefully repaired while the middle room of No. 2 will be altered and fitted out to create a new television room. The proposal includes the re-configuring of the main staircase. The wall between the staircase and lightwell will be removed and the existing staircase will be carefully dismantled and re-configured further to the north. DCA's proposed Second Floor Plan shows that while the proposals make modifications to the existing fabric, the historic plan form is largely unaltered with the exception of the lightwell.

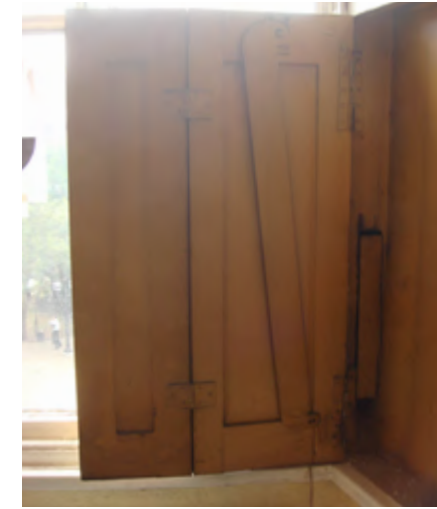
Figure 63: Room 201, window shutters.

3. Walls: the existing high-level faux panelling will be removed and the plastered surface beyond carefully repaired.
4. South Wall: Windows and shutters will be overhauled and repaired, including installing draft strips to the windows.
5. South Wall: Windows new moulded timber architraves, based on a historic pattern elsewhere in the building will be reinstated at these two windows.
6. Cornice: The plastered cornice will be reinstated / repaired where it has been damaged by the modern insertion of partitions.
7. Ceiling: The plastered ceiling will be carefully consolidated and repaired, where modern partitions have been removed.
8. Fireplaces: The existing fireplace will be repaired and be cleaned by a specialist conservator..

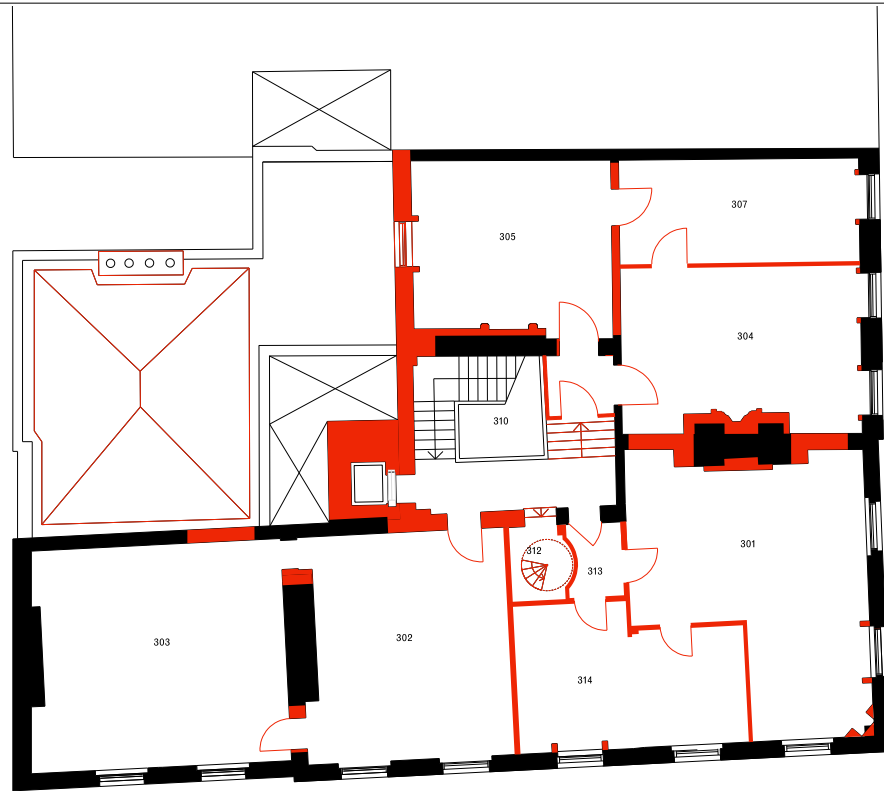
Figure 77: Existing Third Floor Plan (with room numbers) (©DCA).

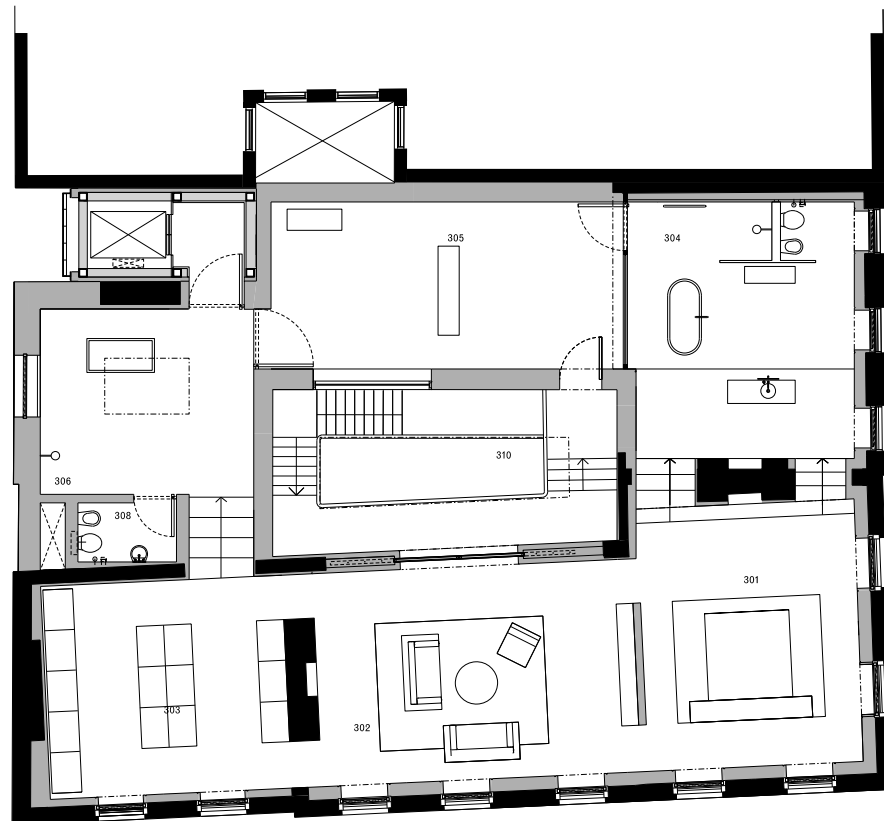
Figure 78: Third Floor Plan (alterations in red, new work light grey) (©DCA).

In reflection of the Statement of Significance, the proposals for the third floor are slightly more radical than the lower floors. The proposal is to convert these rooms to the principal bedroom suite, and a roof terrace. As illustrated in David Chipperfield Architect's proposed Third Floor plan (Figure 78), most of the partitions forming the separation to these rooms will be dismantled, to form a new open plan space. The south, west and the north walls of No. 1 will be retained unaltered, the chimney breast will be retained (except that of Room 305).

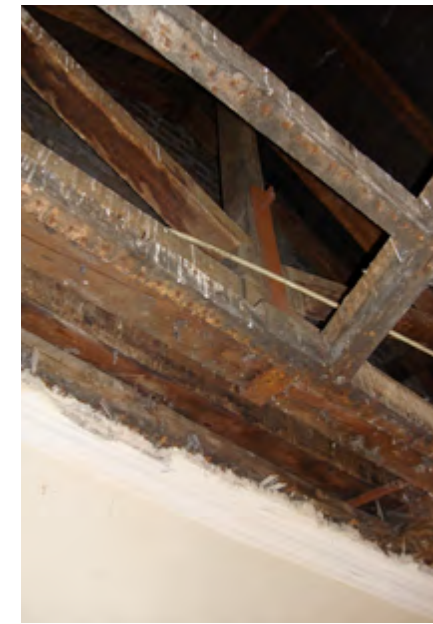
Figure 94: Room 303, Roof structure.

The timber trusses forming the main roof structure dates from the 1840's, if not later. The shaping of the timber, ridge board and iron straps suggest that it is not of 18th century construction. The rafters appear to be re-used timber, some have evidence of plaster traces and nails on the surface suggesting that they previously supported a lath and plaster finish in another location. There appears to be a roofing felt between the rafters. The orthogonal secondary beams supporting the ceiling bearer appear too regular and even to be 18th century structural members, however the timber ceiling bearers and diagonal secondary beams could date from the 1730's. The varying lengths of timber used to create the ceiling structure is consistent with 18th century construction.

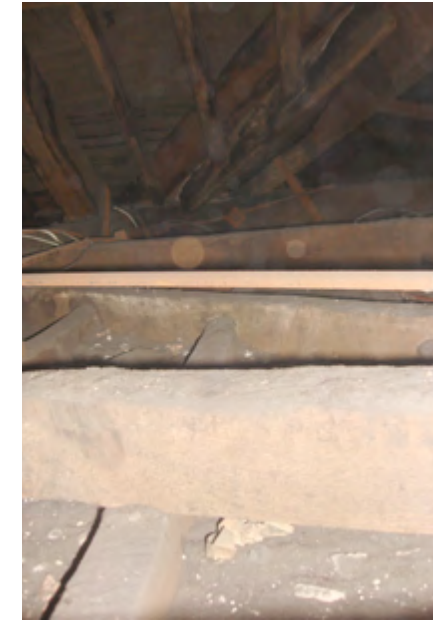
Figure 100: Room 304, Roof structure.

The roof structure above this room, matches that as described in Room 303. This will be retained in the proposed scheme.

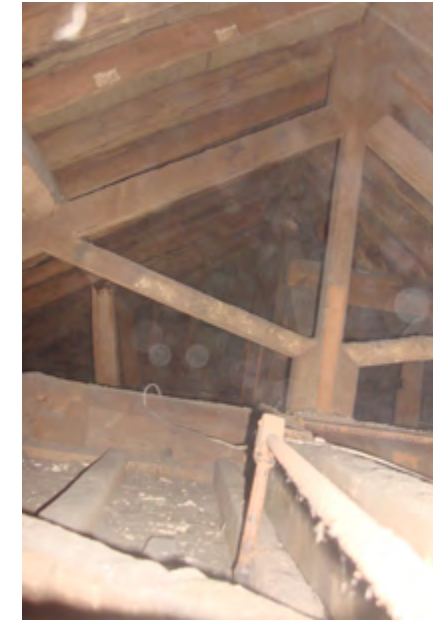
Figure 104: Room 305, roof structure.

The roof structure above this room, matches that as described in Room 303.

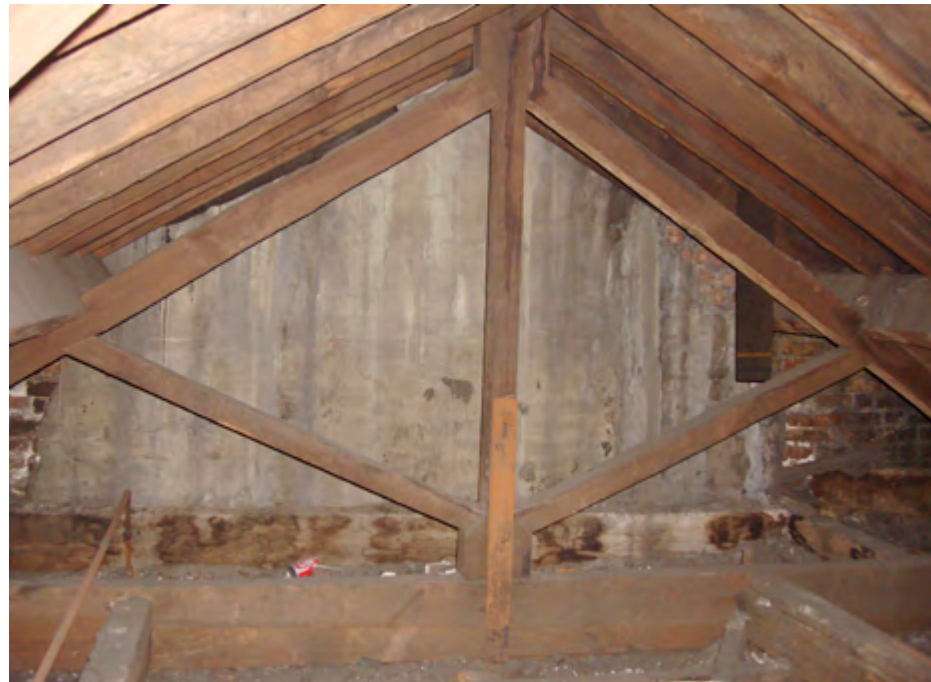
Figure 118 (above): King Post Truss from Roof of No. 1.
Figure 119 (below): Roof structure looking over the Front Roof of No. 1.

The main roof structure is formed by king post trusses, which are regularly spaced along the 'L' shaped roof plan. The trusses incorporate a deep tie beam which is secured with a metal strap (see Figure 118). The members of the trusses are all softwood timber and appear to be machine cut, they probably date from the 1840's if not later.

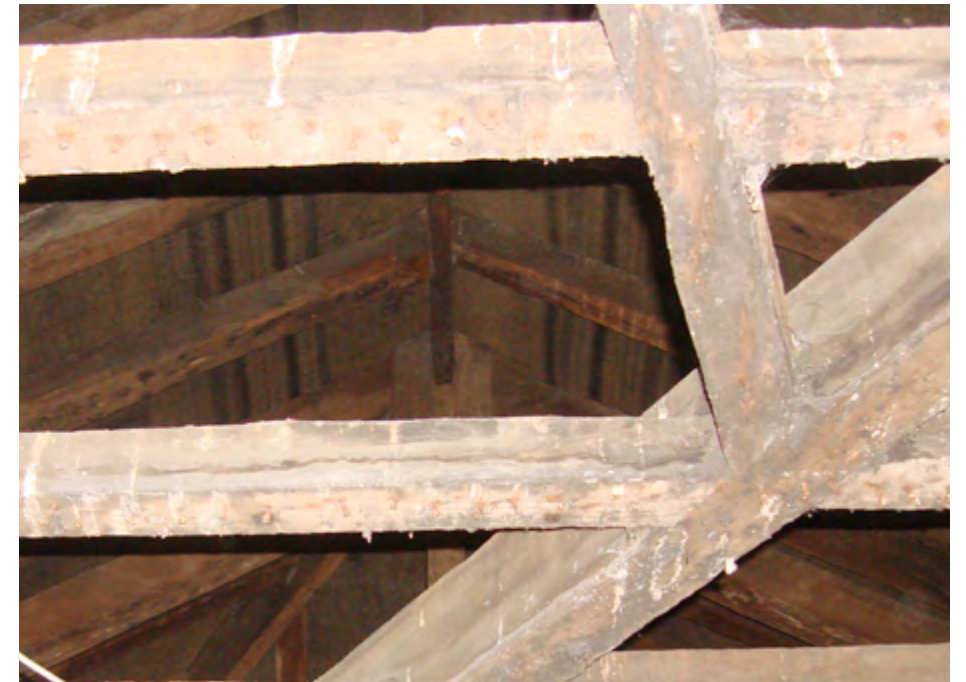
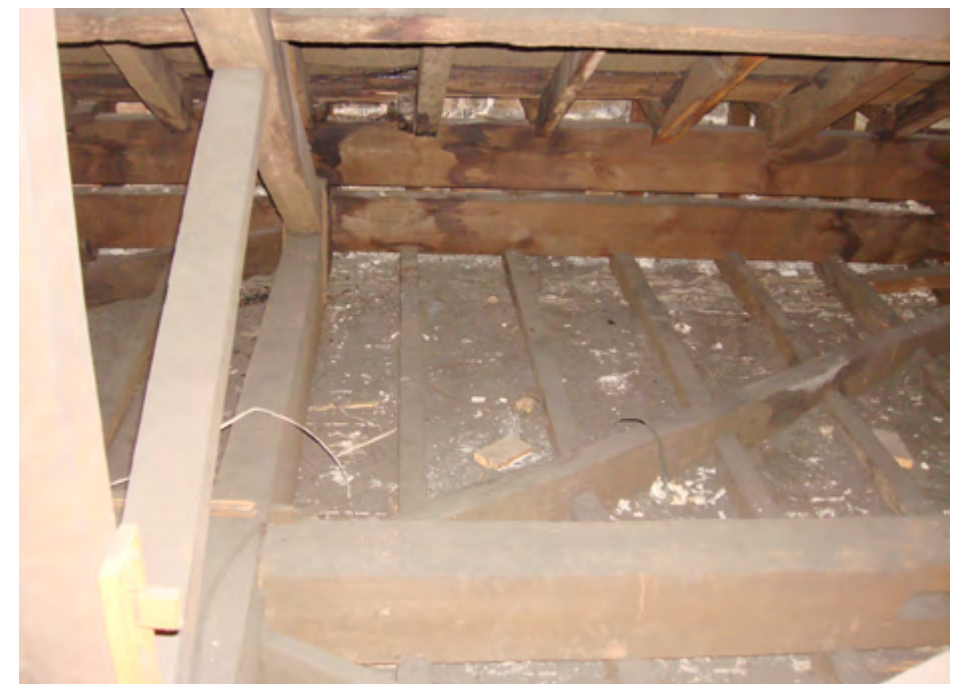
Figure 120 (above): Rafters showing reused timbers, above Room 303, Roof of No. 1.
Figure 121 (below): Roof structure looking south over the Front Roof of No. 1.

The bottom of the rafters are supported off and notched over a substantial softwood timber beam in line with the masonry walls, this is directly positioned above the wall-head plate, which is also of softwood timber, see Figure 121. Dragon ties are positioned at the corner angles of the roof. All these timber elements appear to be very regular machine cut and must date from the 1840's at the earliest.

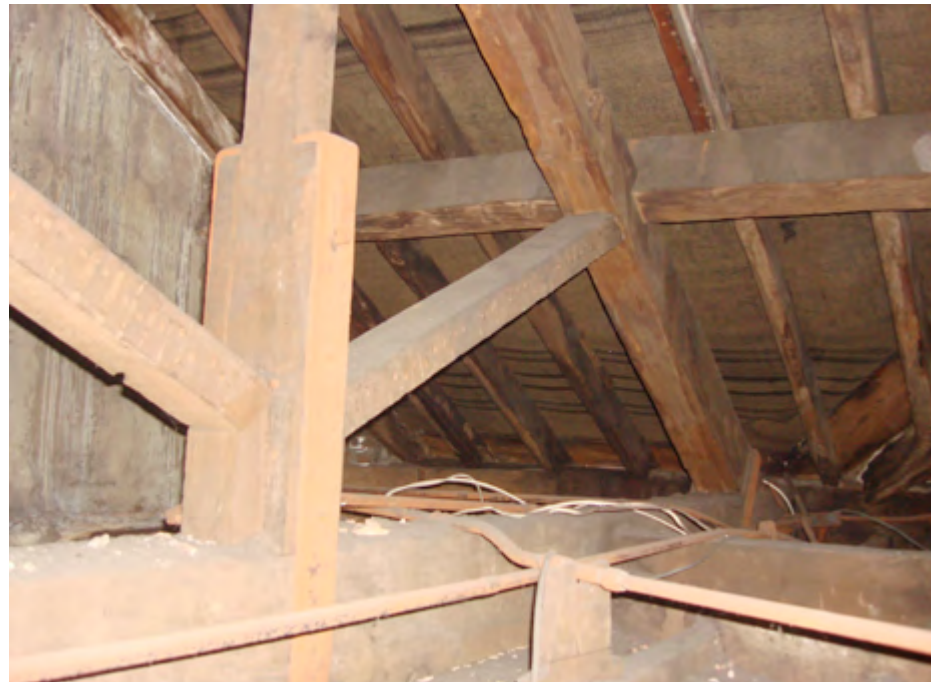
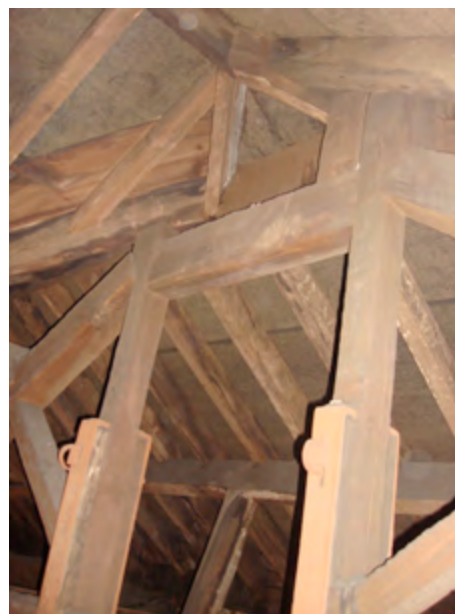
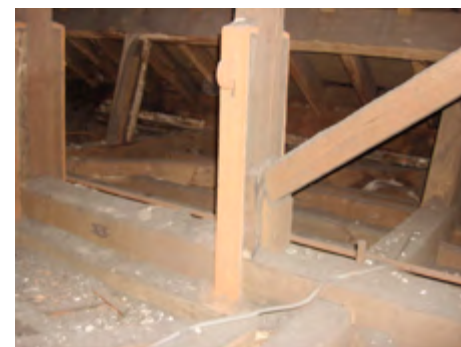
Figure 122 (above): King Post Truss from Front Roof of No. 2.
Figure 123 (below left): Upper section of Queen Post Truss from Front Roof of No. 2.
Figure 124 (below right): Lower section of Queen Post Truss from Front Roof of No. 2.

former fixings which may be from a previous construction, see Figure 122, the other elements of the truss appear to be machine cut and probably date from the 1840's

The queen post truss is mainly fabricated from machine cut timber, suggesting it dates from the 1840's at the earliest, see Figure 123 & 124.

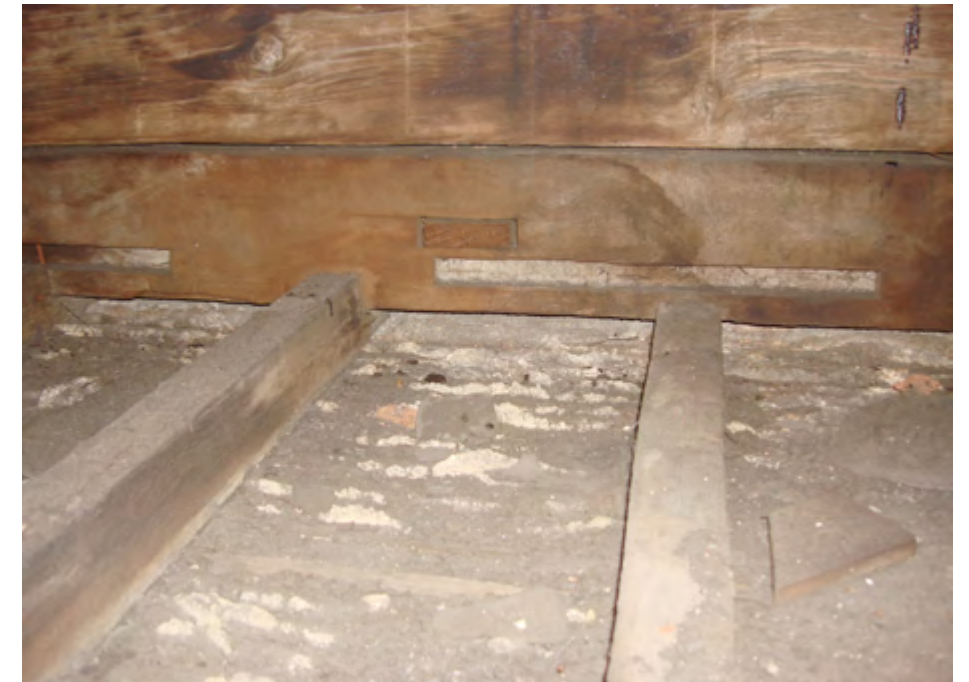
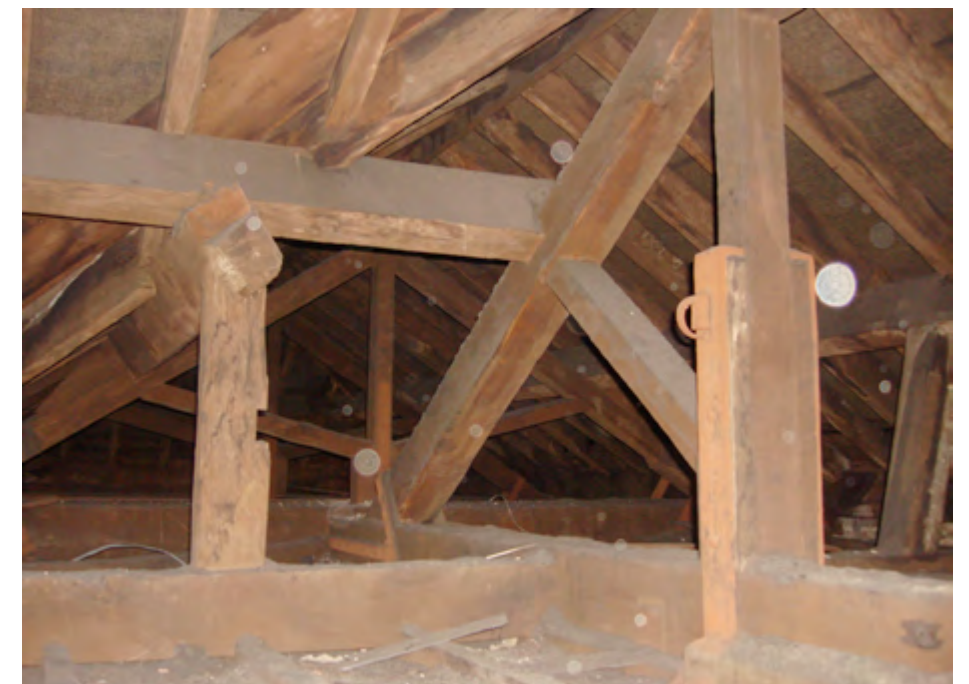
Figure 125 (above): Wall-head plate to south side of Front Roof of No. 2.
Figure 126 (below): Attached roof construction over Room 305 of No. 2.

As in the roof construction of No. 1, the rafters are supported on a substantial timber beam, which is in line with the wall-head plate beneath. The wall-head plate displays signs of being reused from another location, see Figure 125.

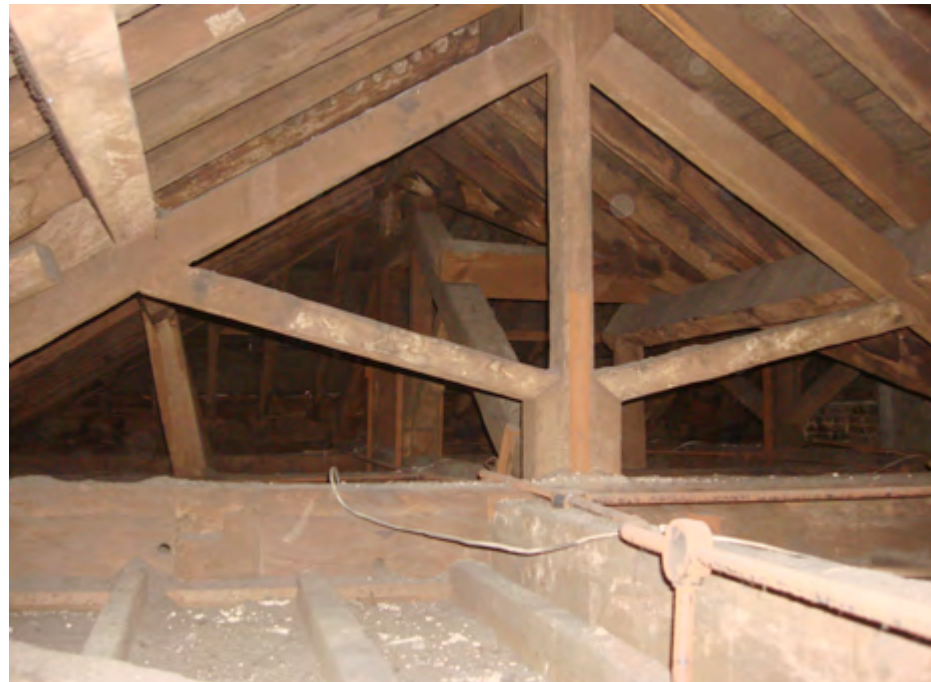
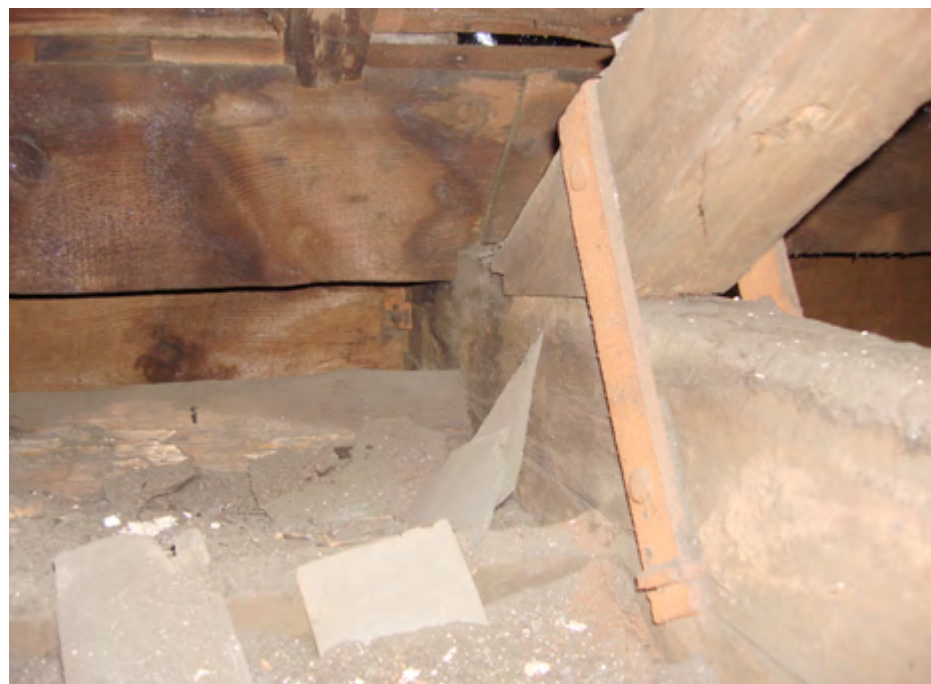
Figure 127 (above): King Post Truss southern end above Room 305, No. 2 Roof.
Figure 128 (below): King Post Truss and wall-head plate junction above Room 305, No. 2 Roof.

The roof construction is similar to that used on the front roof of No. 2 and the roof of No. 1. The roof is constructed from two king post trusses, which are fabricated from softwood timber sections, which appear to be machine cut, suggesting that they date from the 1840's, if not later, see Figure 127 & 128. The elements are secured together with metal straps, which match the standard pattern used on the other roofs.
