JULIAN HARRAP

1-2 LINCOLN'S INN FIELDS, LONDON

HISTORIC BUILDING IMPACT ASSESSMENT

JANUARY 2013 REVISION D (JANUARY 2014)

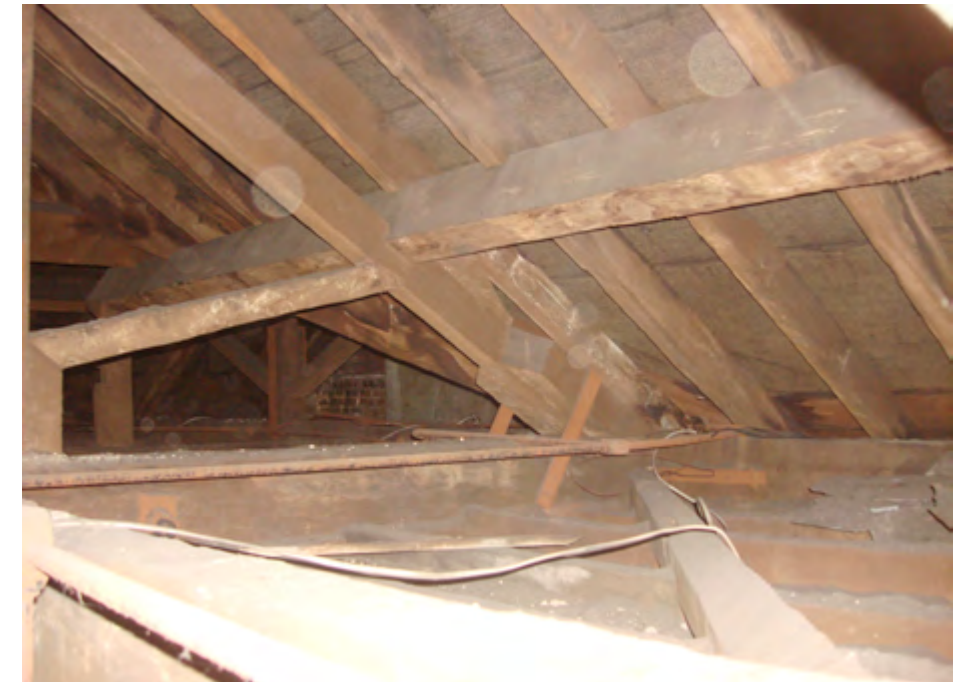
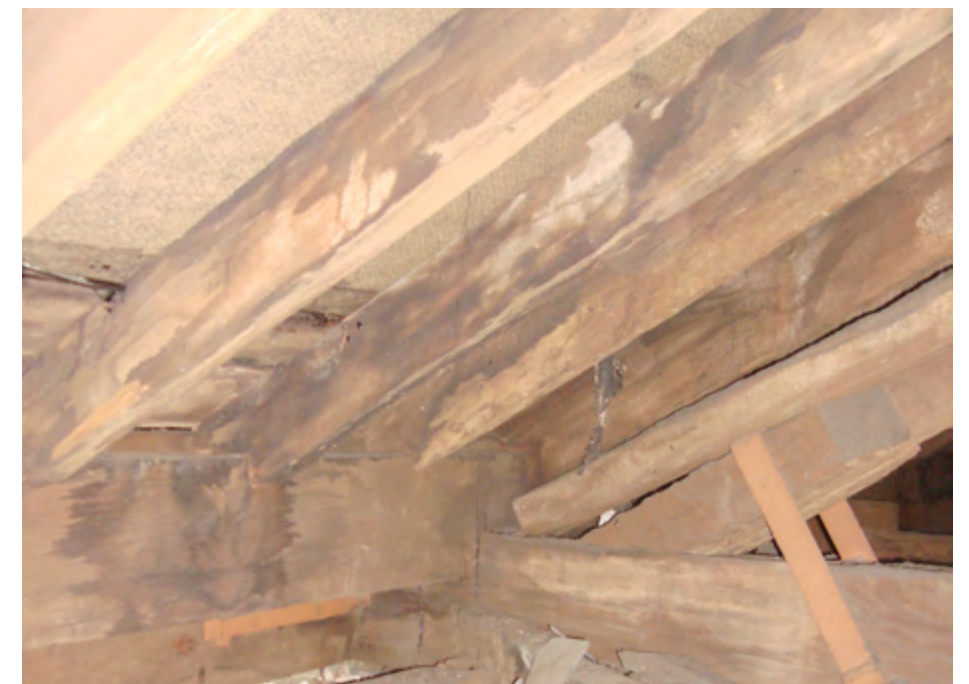
Figure 129 (above): King Post Truss & purlin southern end above Room 305, No. 2 Roof.
Figure 130 (below): Rafters above Room 305, No. 2 Roof.

The purlins appear to be fabricated from machine cut softwood timber, they are approximately 102 x 200mm deep. They are notched over the trusses and held in position on the king post trusses with softwood timber purlin cleats, as similar to the construction of the other roofs, see Figure 129.

The purlins support thirty-two softwood timber rafters, see Figure 130, most of them appear to be machine cut and must date from the 1840's at the earliest. Only four rafters appear to be reused sections of timber, they have evidence of previous fixing holes and plaster traces suggesting that they previously supported a lath and plaster finish in another location. A small number of the rafters have been replaced in modern times. The rafters are connected to a softwood timber ridge-board. Between the rafters is the underside of a modern roofing felt.

The bottom of the rafters are supported off and notched over a substantial softwood timber beam in line with the masonry walls, this is directly positioned above the wall-head plate, also of softwood timber, see Figure 130. Dragon ties are positioned at the corner angles of the roof, see Figure 131. All these timber elements appear to be regular machine cut timber and must date from the 1840's at the earliest. This construction matches the other roofs.

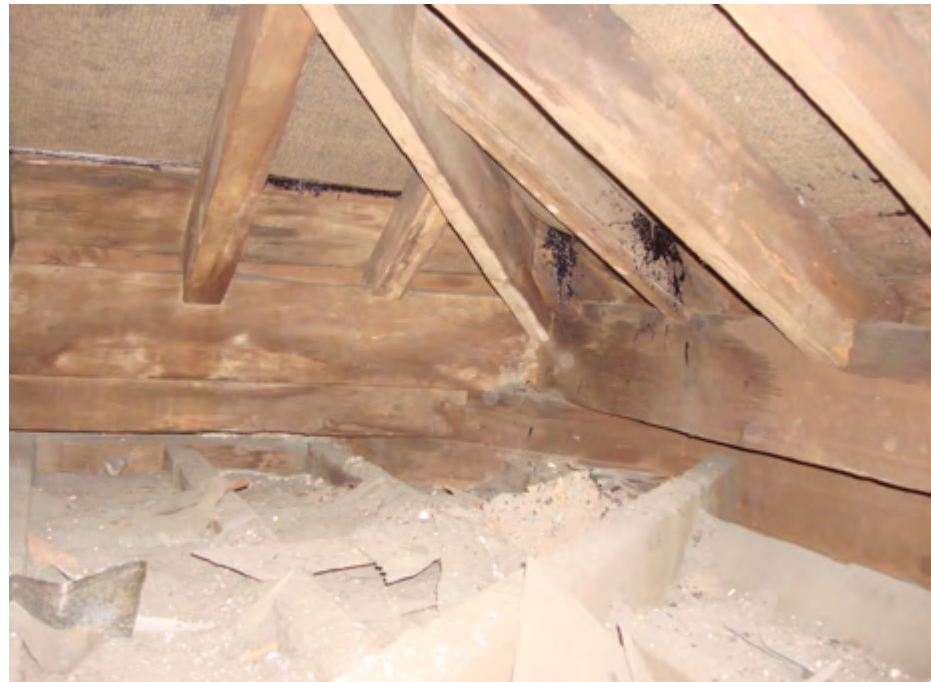
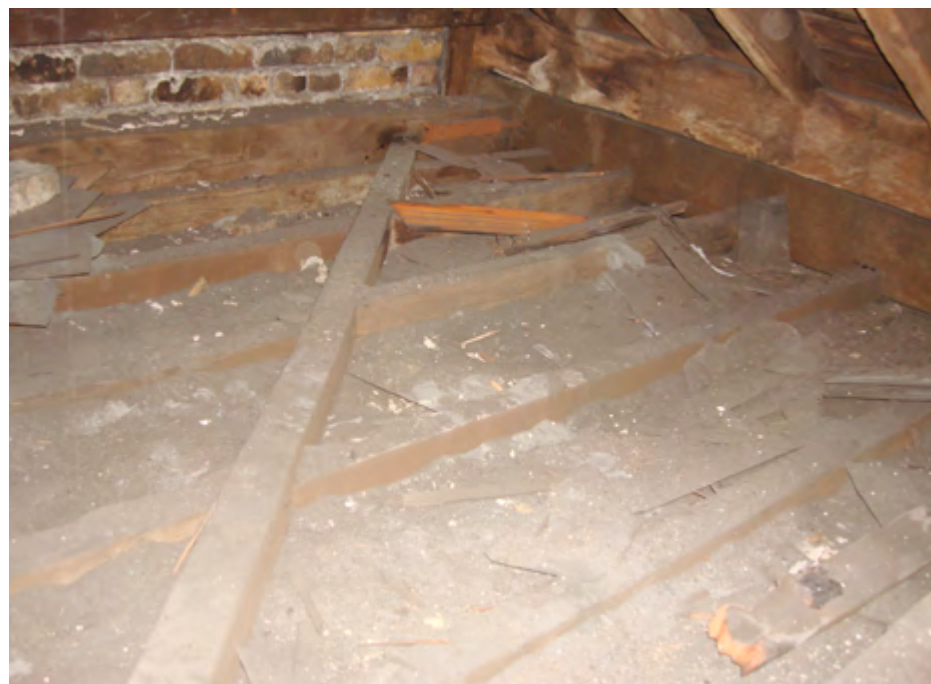
Figure 131 (above): Dragon tie above NE corner of Room 305, No. 2 Roof.
Figure 132 (below): Ceiling bearers above Room 305, No. 2 Roof.

The lath and plaster ceilings of the room beneath is supported off softwood timber ceiling bearers, of mostly machine cut timber dating from the 1840's, see Figure 132. Of the area that was accessible only one ceiling bearer appeared to be a reused section of timber with old nails evident. The ceiling bearers appeared to have a mortise and tenon joints to connect them to the main collar beams. They are simply notched under and nailed to the diagonal beams which connect, in turn, to the wall-head plates and collar members of the truss. These diagonal beams all appeared to be machine cut softwood timber, dating from the 1840's.

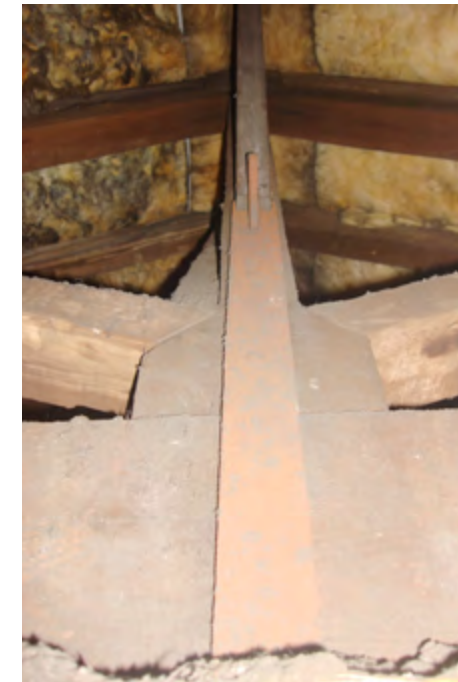
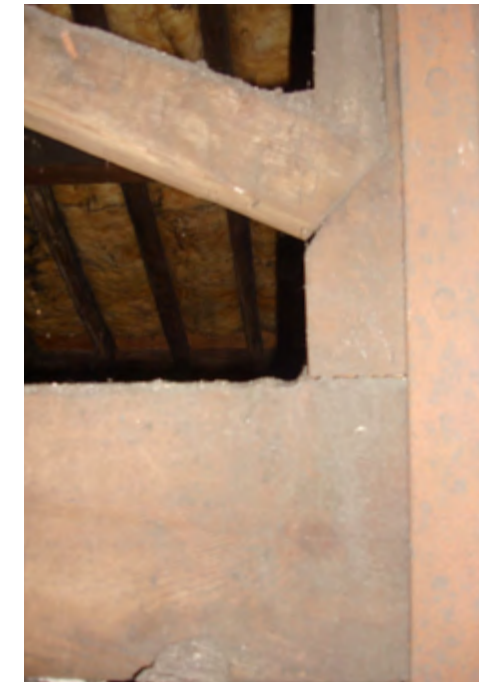
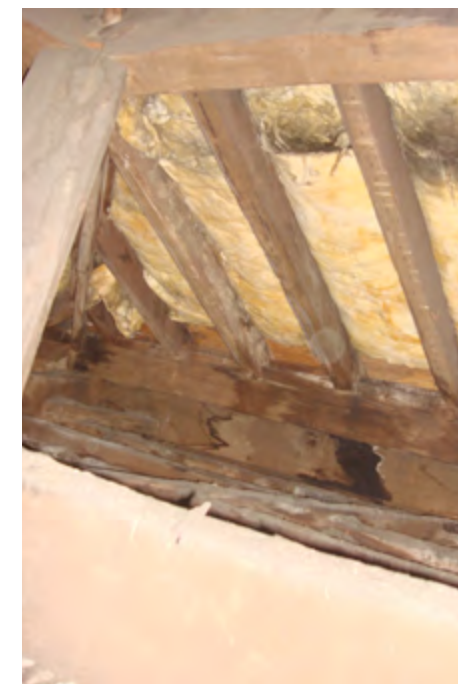
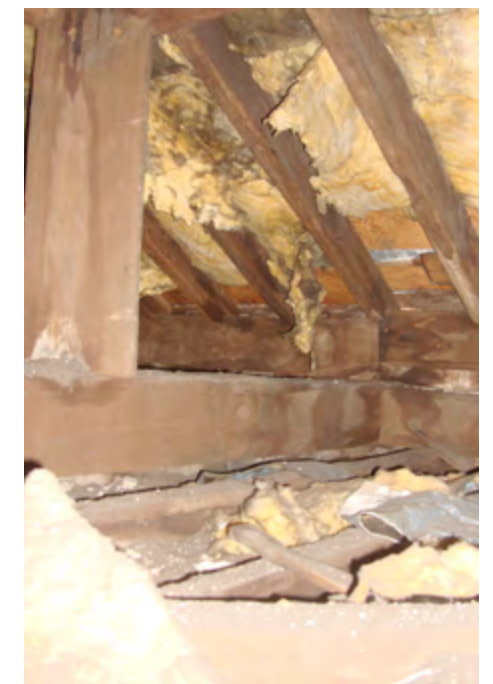
Figure 133 (above): King Post Truss above Room 206, No. 2 Roof.
Figure 135 (below): Purlin, rafters, wall-head plate from south side above Room 206, No. 2 Roof. .

Figure 134 (above): King Post Truss above Room 206, No. 2 Roof.
Figure 136 (below): Rafters, wall-head plate from north side above Room 206, No. 2 Roof. .

The purlins appear to be fabricated from machine cut softwood timber, see Figure 135. They are notched over the trusses and held in position with softwood timber purlin cleats, as similar to the construction of the other roofs. Additional support to the purlins is provided at the corners, where they are also supported by diagonal softwood timber struts, which are attached to the secondary beams beneath, see Figure 136.

The purlins support softwood timber rafters, all of them appear to be machine cut and must date from the 1840's at the very earliest, see Figure 136. The rafters are connected to a softwood timber ridge-board. Hung between the rafters is modern mineral wool insulation. Where it has been disturbed on a small portion of the north face, it is possible to view modern softwood timber roof boarding and the underside of the slates. There is also a trace of an earlier roof board, which appears as if it could date from the 19th century.

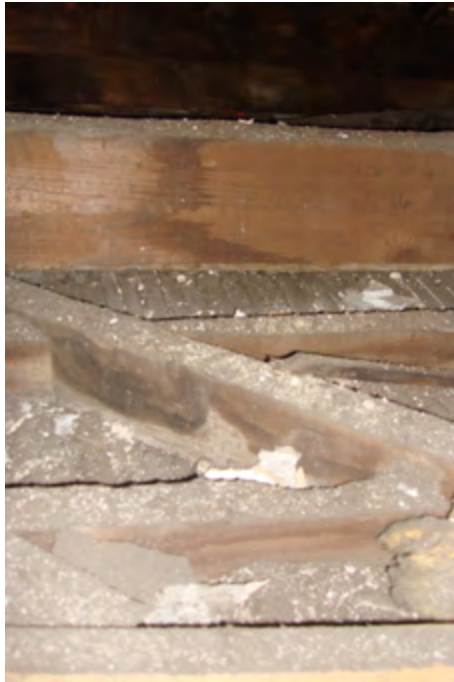
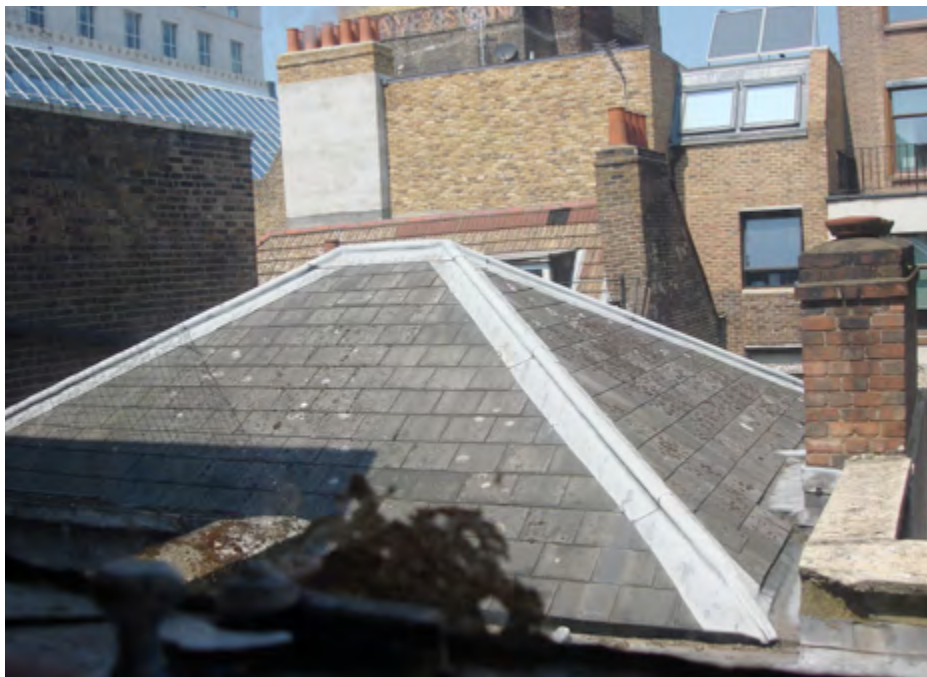
Figure 137 (above): Ceiling bearers above Room 305, No. 2 Roof.

Figure 138 (below): No. 2 Roof over Room 305.

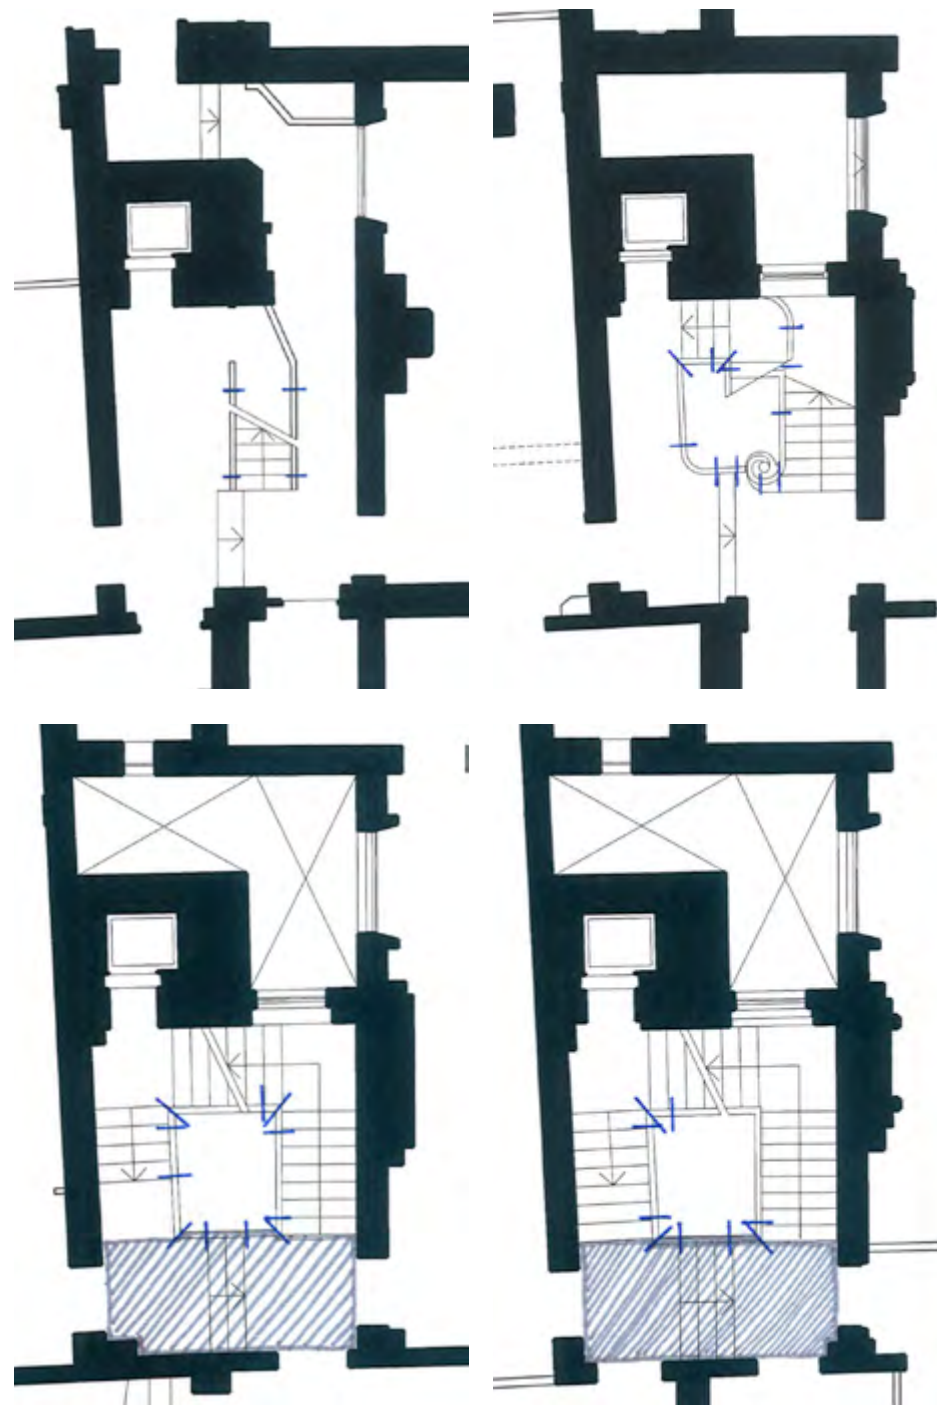
Figure 139 (above): Basement Staircase.
Figure 141 (below): First Floor Staircase.

1.4.2 Ditto note 1.2.2 (reference Figures 139 & 140).

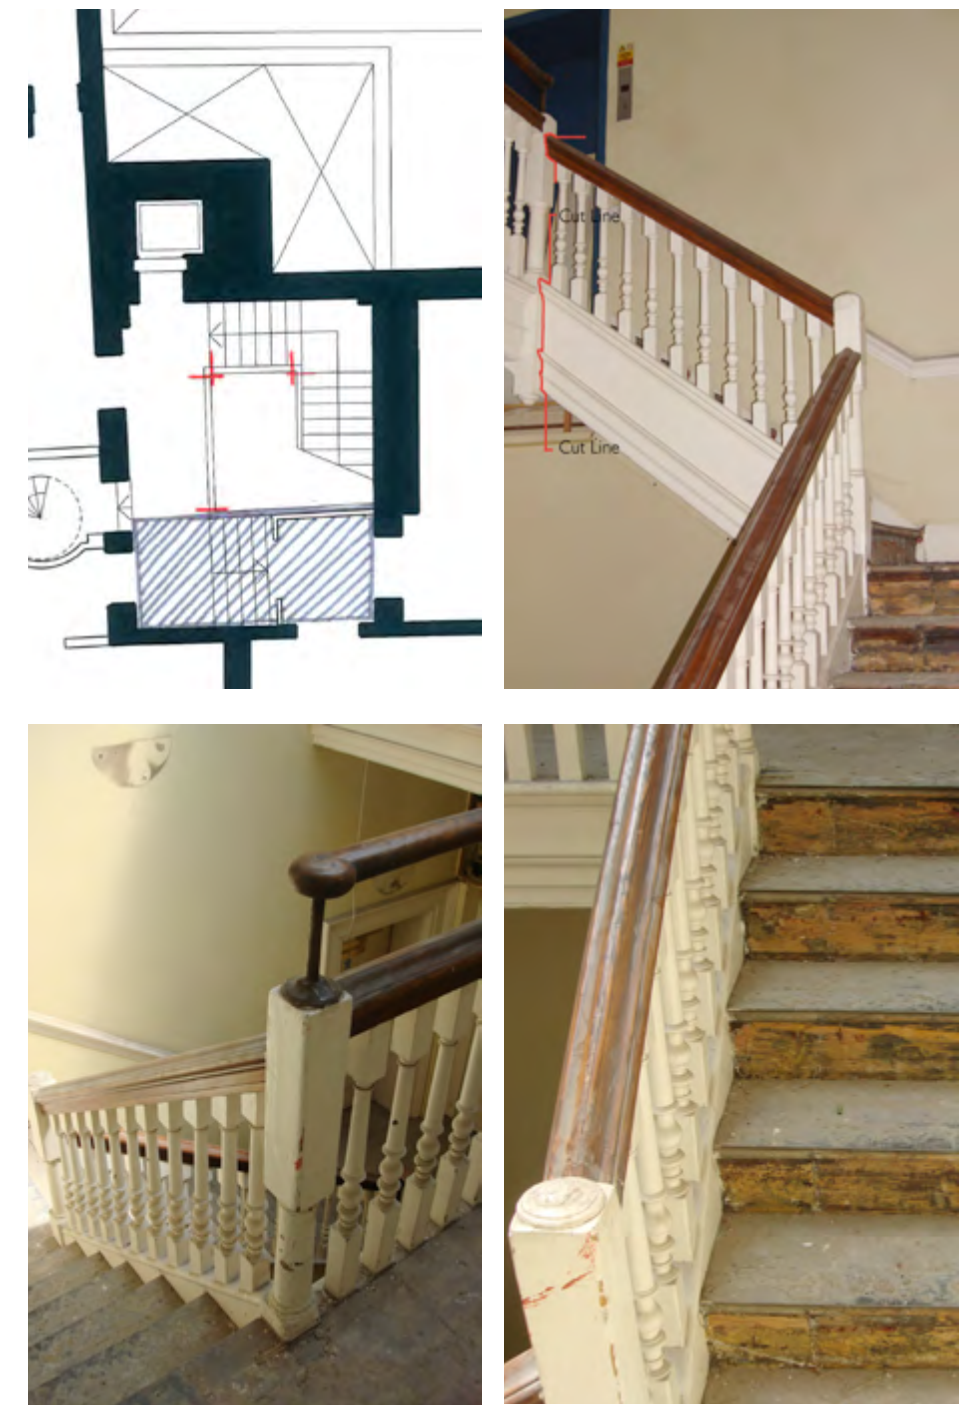
Figure 143 (above): Third Floor Staircase.
Figure 144 (below): Third Floor West Landing detail.

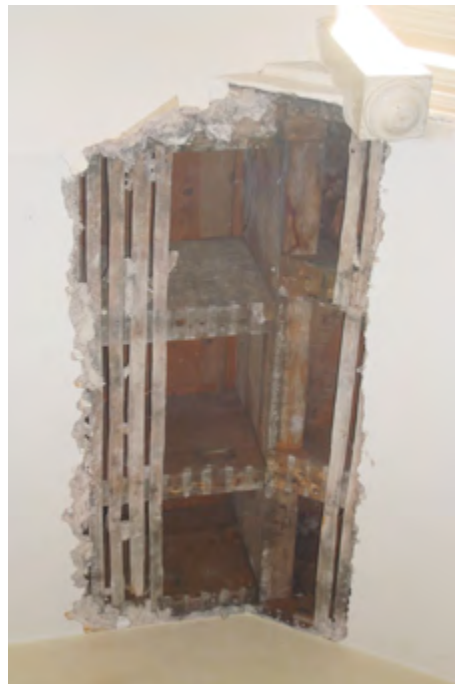
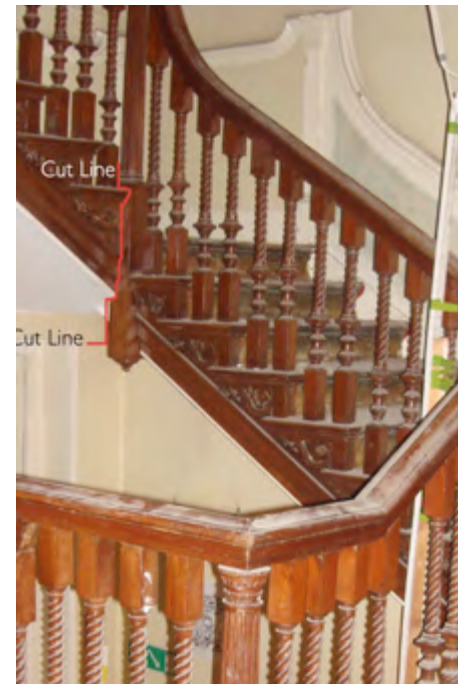
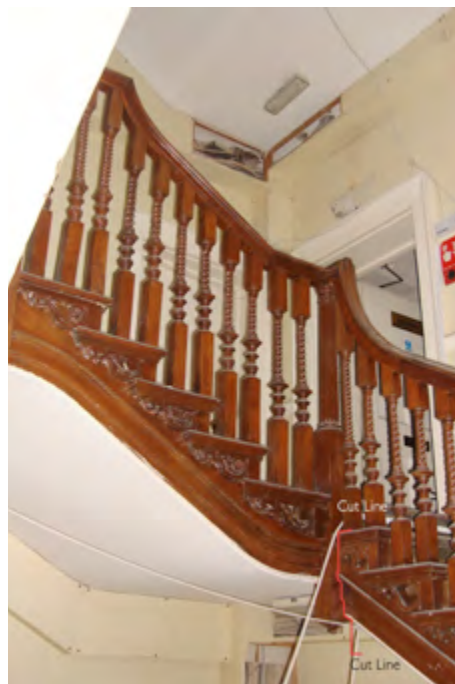
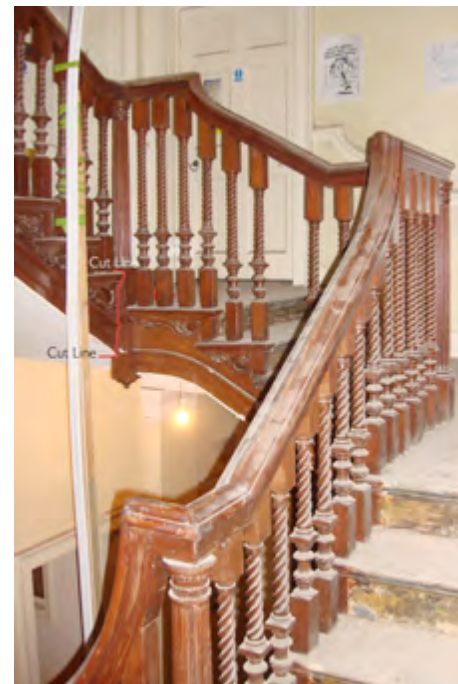
Figure 147 (above): Second to Third Floor Stairs, Underside of North-East Landing.
Figure 148 (below): First to Second Floor Stairs, South-East Landing.

Figure 149 (above): First to Second Floor Stairs, North-East Landing.
Figure 150 (below): Ground to First Floor Staircase South-East & South West Landings.

1.1.14 Carefully detach the beams forming the half landings, label up and package for reinstatement. Where the beams are cantilevered from the adjoining walls, they may have to be cut out, Figure 147.

1.2.8 Ditto note 1.1.12 (reference Figures 148 - 150).

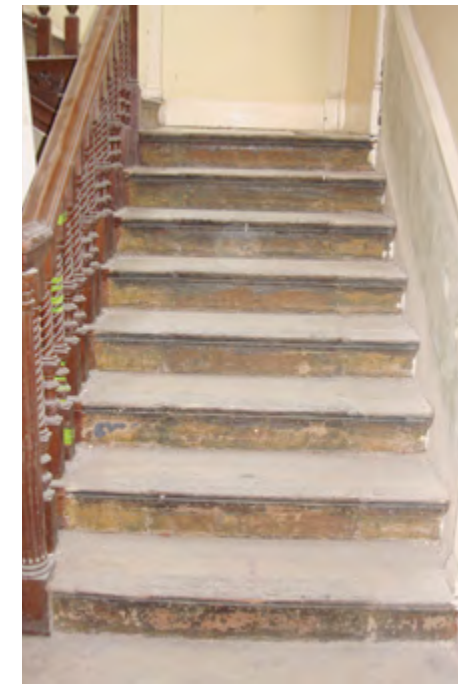
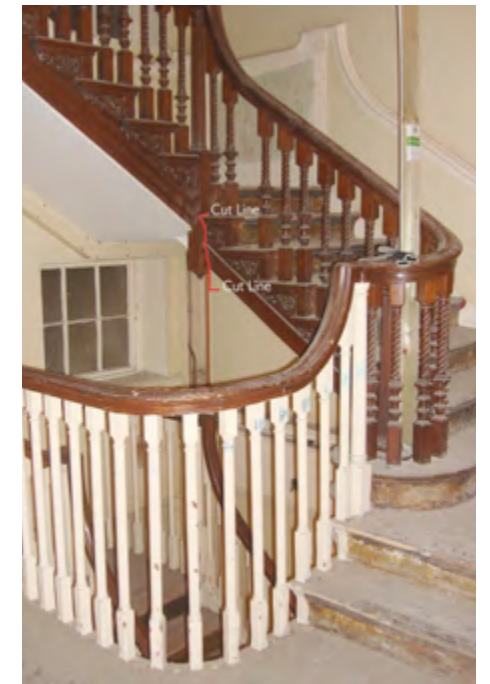
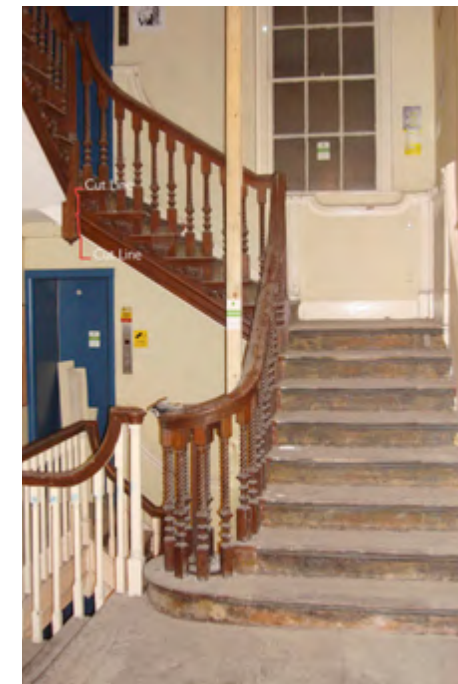
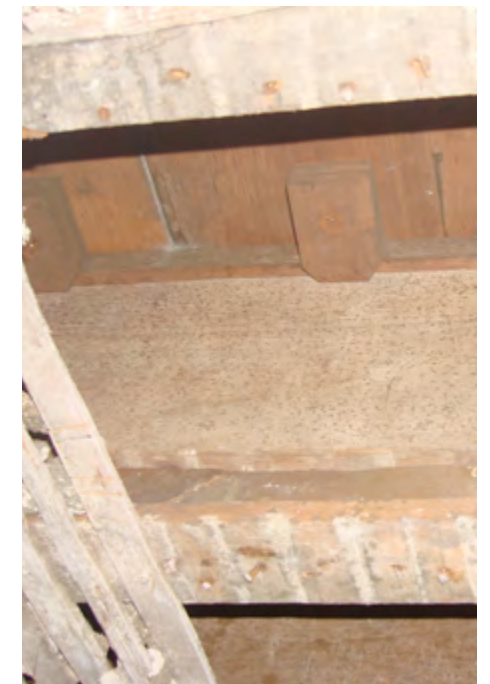
Figure 150 (above): First to Second Floor Stairs, East Flight.
Figure 151 (below): Ground to First Floor Stairs.

Figure 152 (above): Ground to First Floor Stairs.
Figure 153 (below): Ground to First Floor Stairs, North-East Landing opening up work.

1.3.5 Ditto note 1.1.12 (reference Figures 151 & 152).

1.3.6 Ditto notes 1.1.13 to 1.1.15 (reference Figures 153).

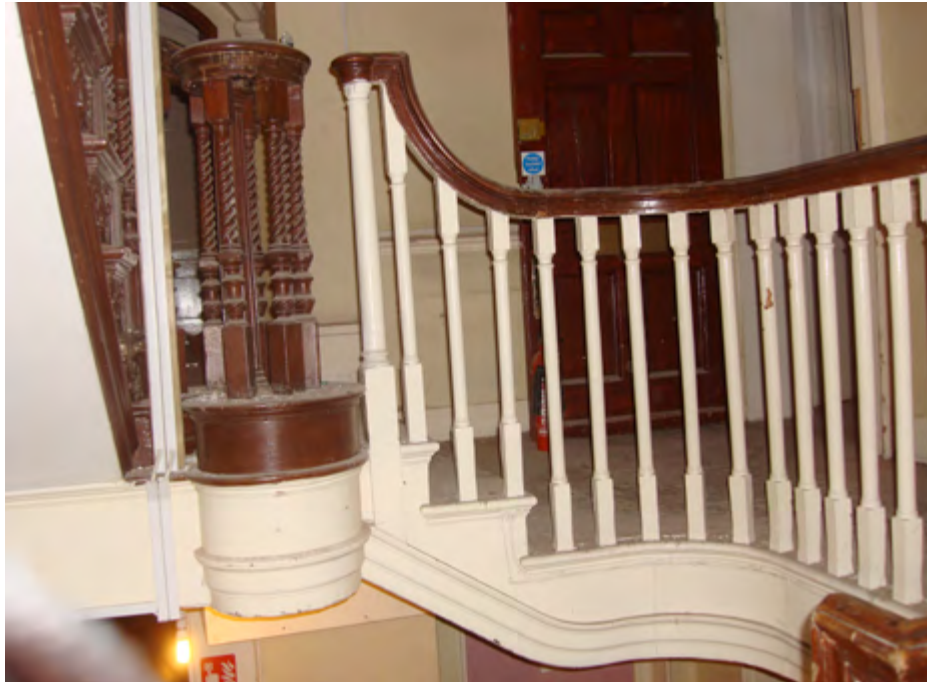
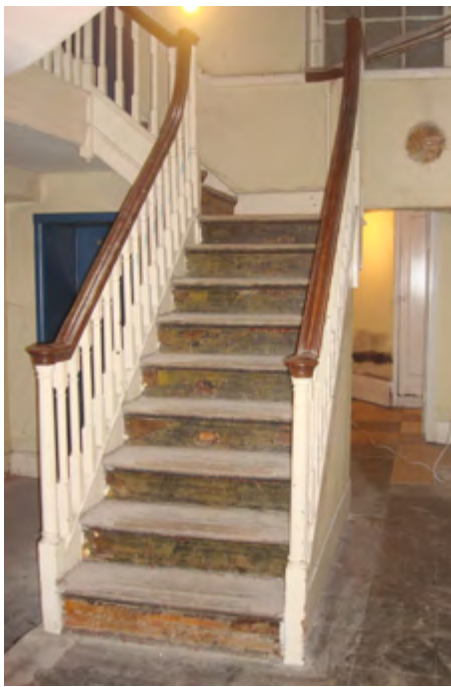
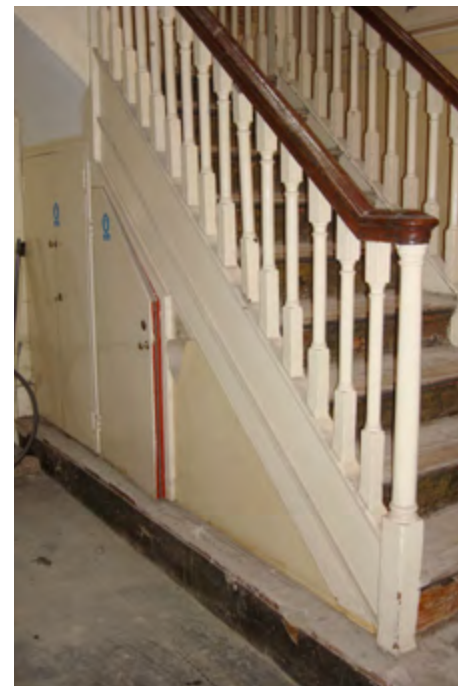
Figure 154 (above): Ground Floor Landing.
 Figure 155 (below left): Basement Stairs.
 Figure 156 (below right): Basement Stairs.

1.4.7 Ditto note 1.1.12 (reference Figures 155 & 156).

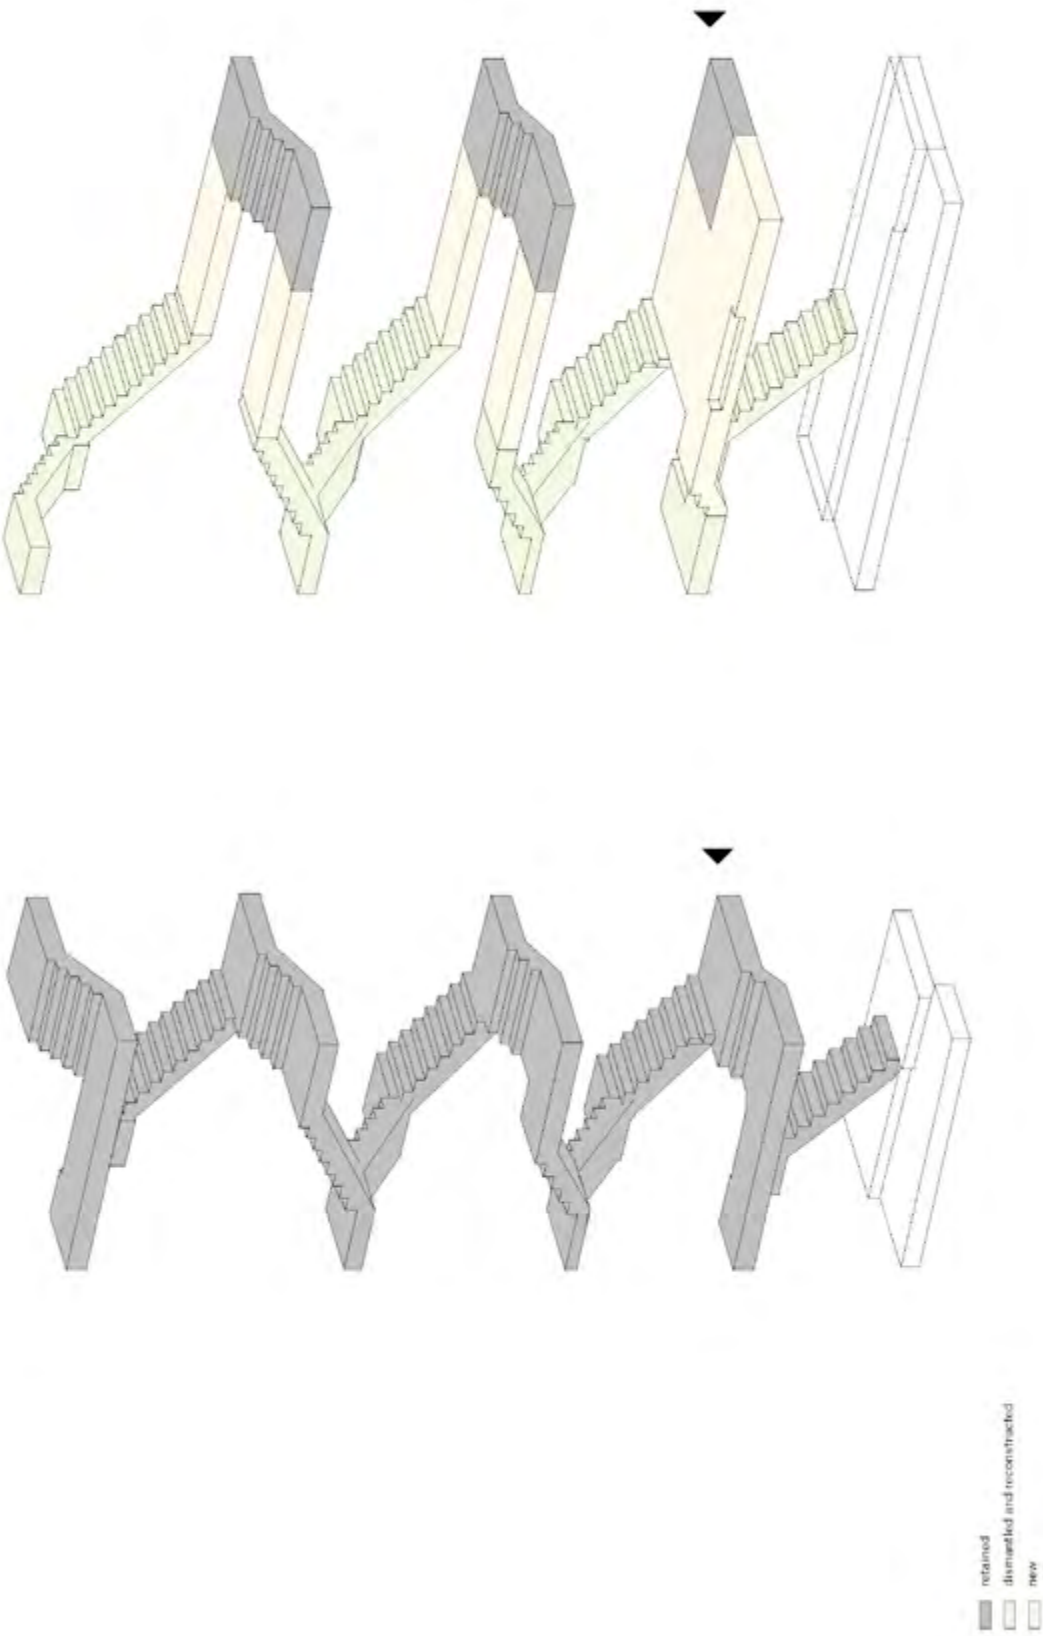
Figure 157: David Chipperfield Architect's schematic diagram of reconstructing the existing staircase.

The proposals involve the enlargement of the Staircase Hall, northwards using the space currently occupied by the lightwell, as illustrated in Figures 5 & 6, 24 & 25, 45 & 46, 59 & 60 and 77 & 78. The principles of repositioning the staircase and extending the landings is illustrated in DCA's schematic drawing, Figures 157 & 158.

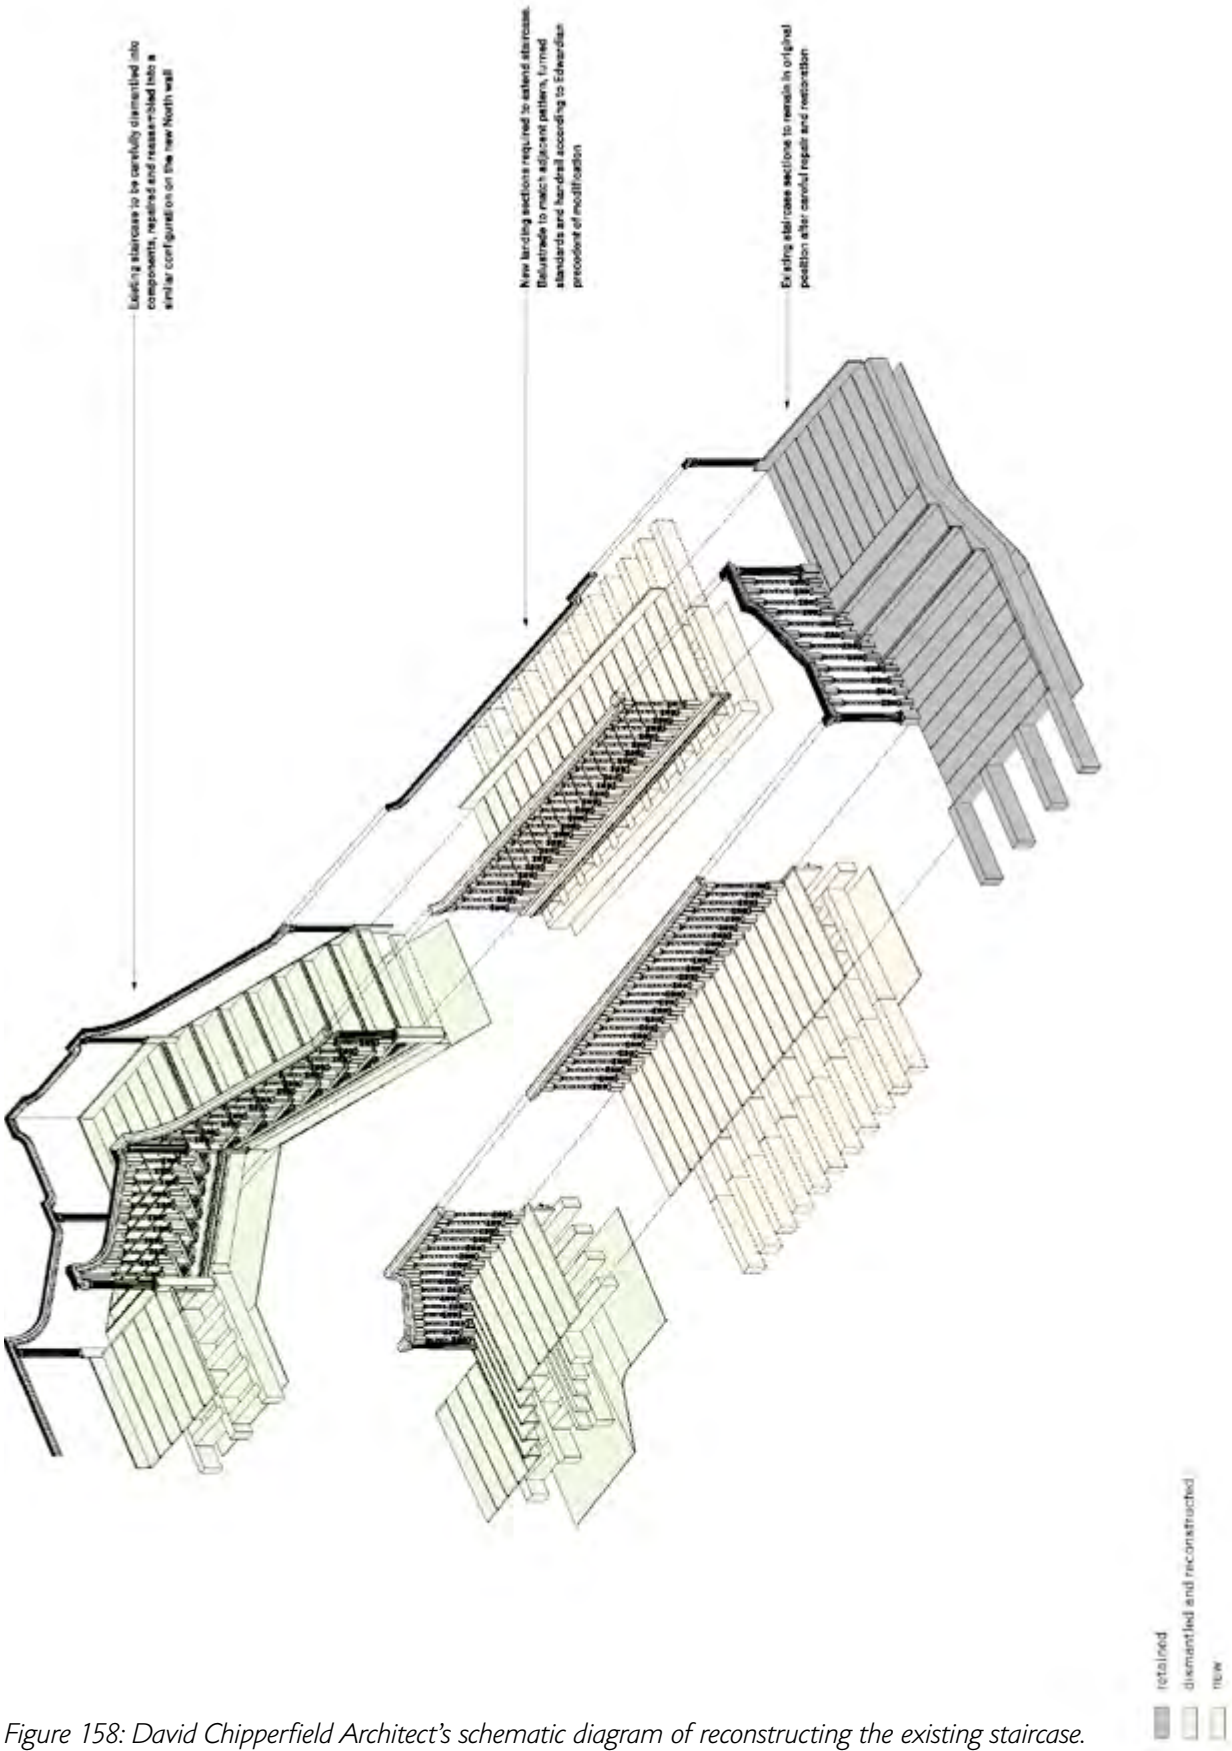
Figure 158: David Chipperfield Architect's schematic diagram of reconstructing the existing staircase.

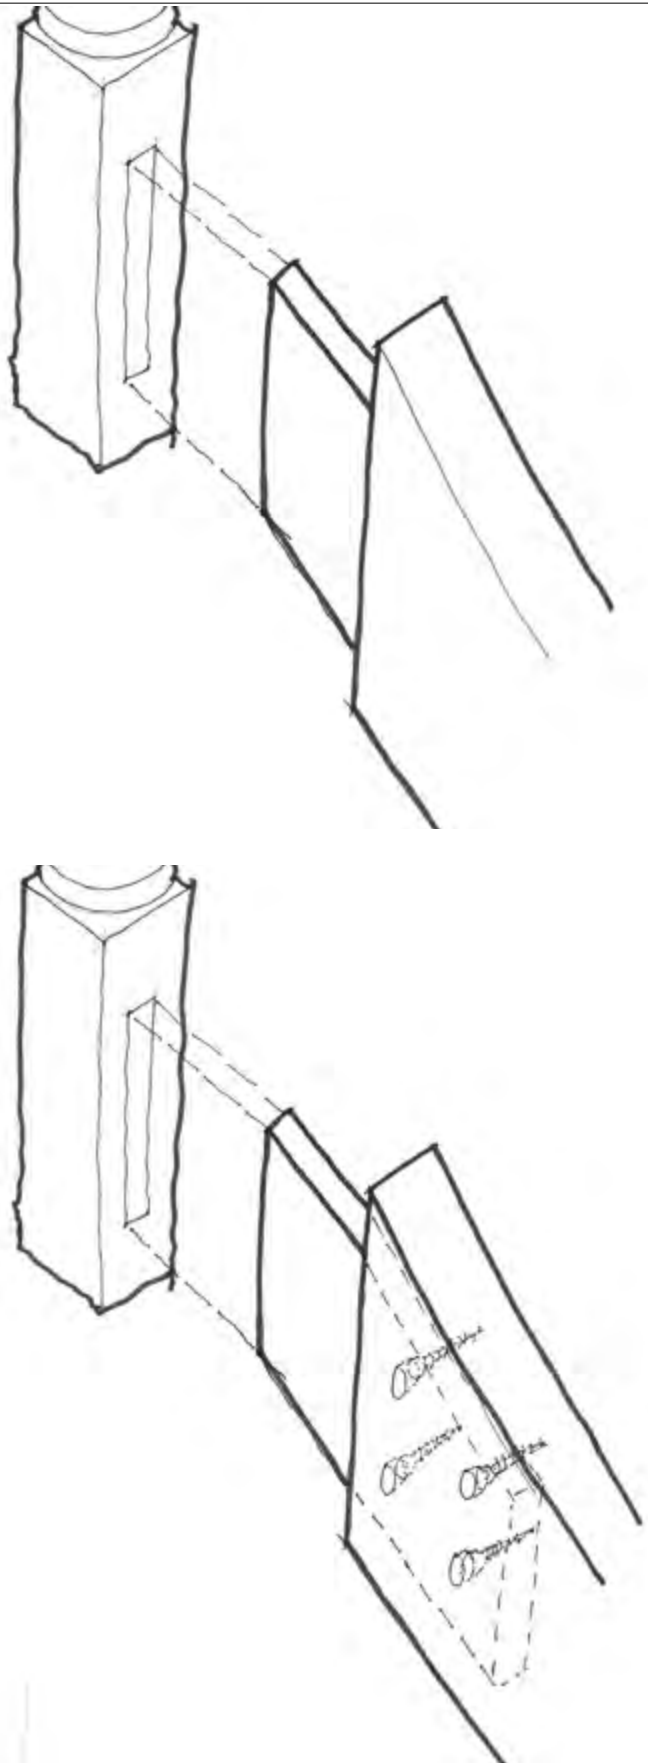
Figures 160 & 161: Sketch of existing mortise and tenon joint between newel and string and proposed repair.

The Staircase will be recreated using timber structure matching the existing method of construction. Where existing joints have been cut to dismantle the structure, mortise and tenon joints will be re-formed so that the structure is constructed in a similar way as it was originally, the Figures 160 & 161 specify how this might be done. The details of the reconstructed staircase will be worked up with the specialist joiner and approved by the Conservation Architect prior to works being carried out.
