### Rear Elevation: Demolitions

8 Rothwell Street		Drawing Number: 1506_L502
Stage 0 Draft - 08.01.16	Planning Draft F 06.06.16	Proposed Rear Elevation
Strip-out A 16.02.16		
Planning Draft B 02.03.16		
Technical Draft C 17.03.16		
Planning D 25.03.16		
Est Repairs Pricing E 08.04.16		
Drawn by: LK	Date: 06.06.16	Rev: F
		1:50 @A3

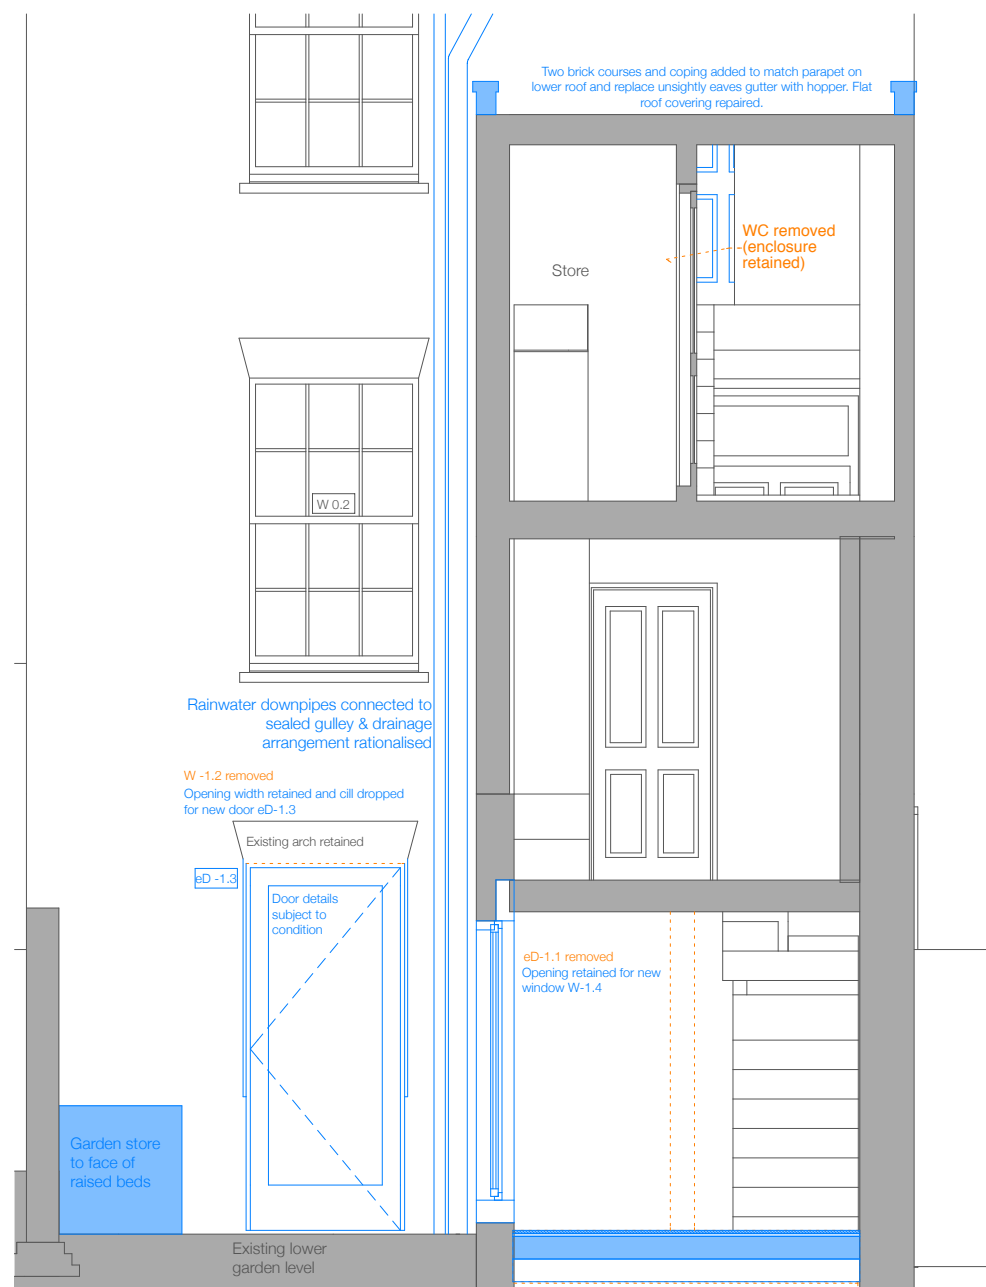
B.2 Rear (North) elevation through lower garden level and historic additions

The proposed alterations at the rear are primarily at the basement where windows and doors are reconfigured to suit the new layout of the basement (kitchen, dining, WC) serving the new single family dwelling. A minor alteration at 1st floor level is proposed to suit the reconfiguration of the 1st floor half-landing. Otherwise, windows are retained as existing and the original features and finishes are restored with upgraded fittings and services to suit the needs of the reversion to a single family dwelling house.

The flat roof coverings to the historic additions to the main house will be repaired including flashings and copings. It is also proposed to create a small brick parapet (2 courses and coping) to the 1st floor roof that will match the lower roof. This will remove the unsightly eaves gutter and allow a metal hopper to match the rest of the drainage design. The butterfly main roof will be repaired as per notes on the proposed roof plan.

Brick retaining walls (approximately 1m high) will be constructed to the perimeter of the excavated garden at the edge of the raised beds thus avoiding work at the boundary walls which are not to be altered although some local repointing and repair may be required. A low external store will be incorporated into the line of the raised beds. Timber trellising will form part of client's new garden planting design.
