# Hydrogeological, Geotechnical & Ground Movement Assessment

of proposed development at

**4 The Hexagon  
Fitzroy Park  
Camden  
London  
N6 6HR**

LBH4391a Ver 1.1

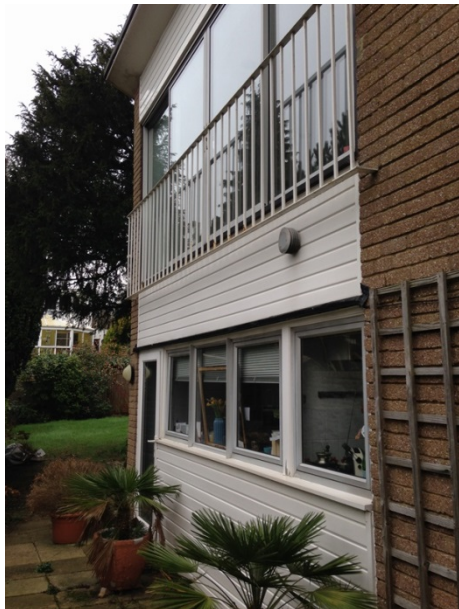
Rear view of property showing the lower ground floor at approximately garden level

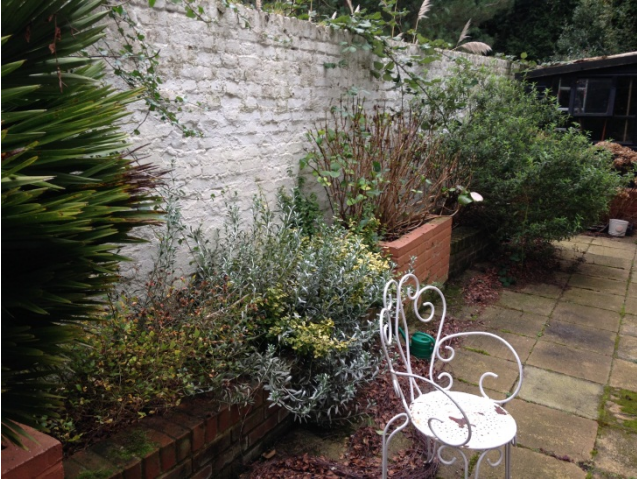
**View of original Victorian brick garden wall running along the southern boundary of the site**

In addition, the investigation also suggests that the southeastern boundary wall and old Victorian wall also appear to be supported by strip foundations at a depth of around 0.6 and 0.65m respectively, bearing upon similar soils beneath the existing building.

To the southwest, the new development will abut the old Victorian garden wall. However, it would appear that this is founded at a level below that of the intended excavation.
