ARBORICULTURAL DEVELOPMENT STATEMENT

Site:
17 Boscastle Road,
London

ARBORICULTURAL DEVELOPMENT STATEMENT
Arboricultural Implications Assessment and Method Statement
guided by recommendations within BS5837:2012

The proposal is for the demolition of an existing detached garage and construction of a new residential dwelling at 17 Boscastle Road, London, NW5 1EE.

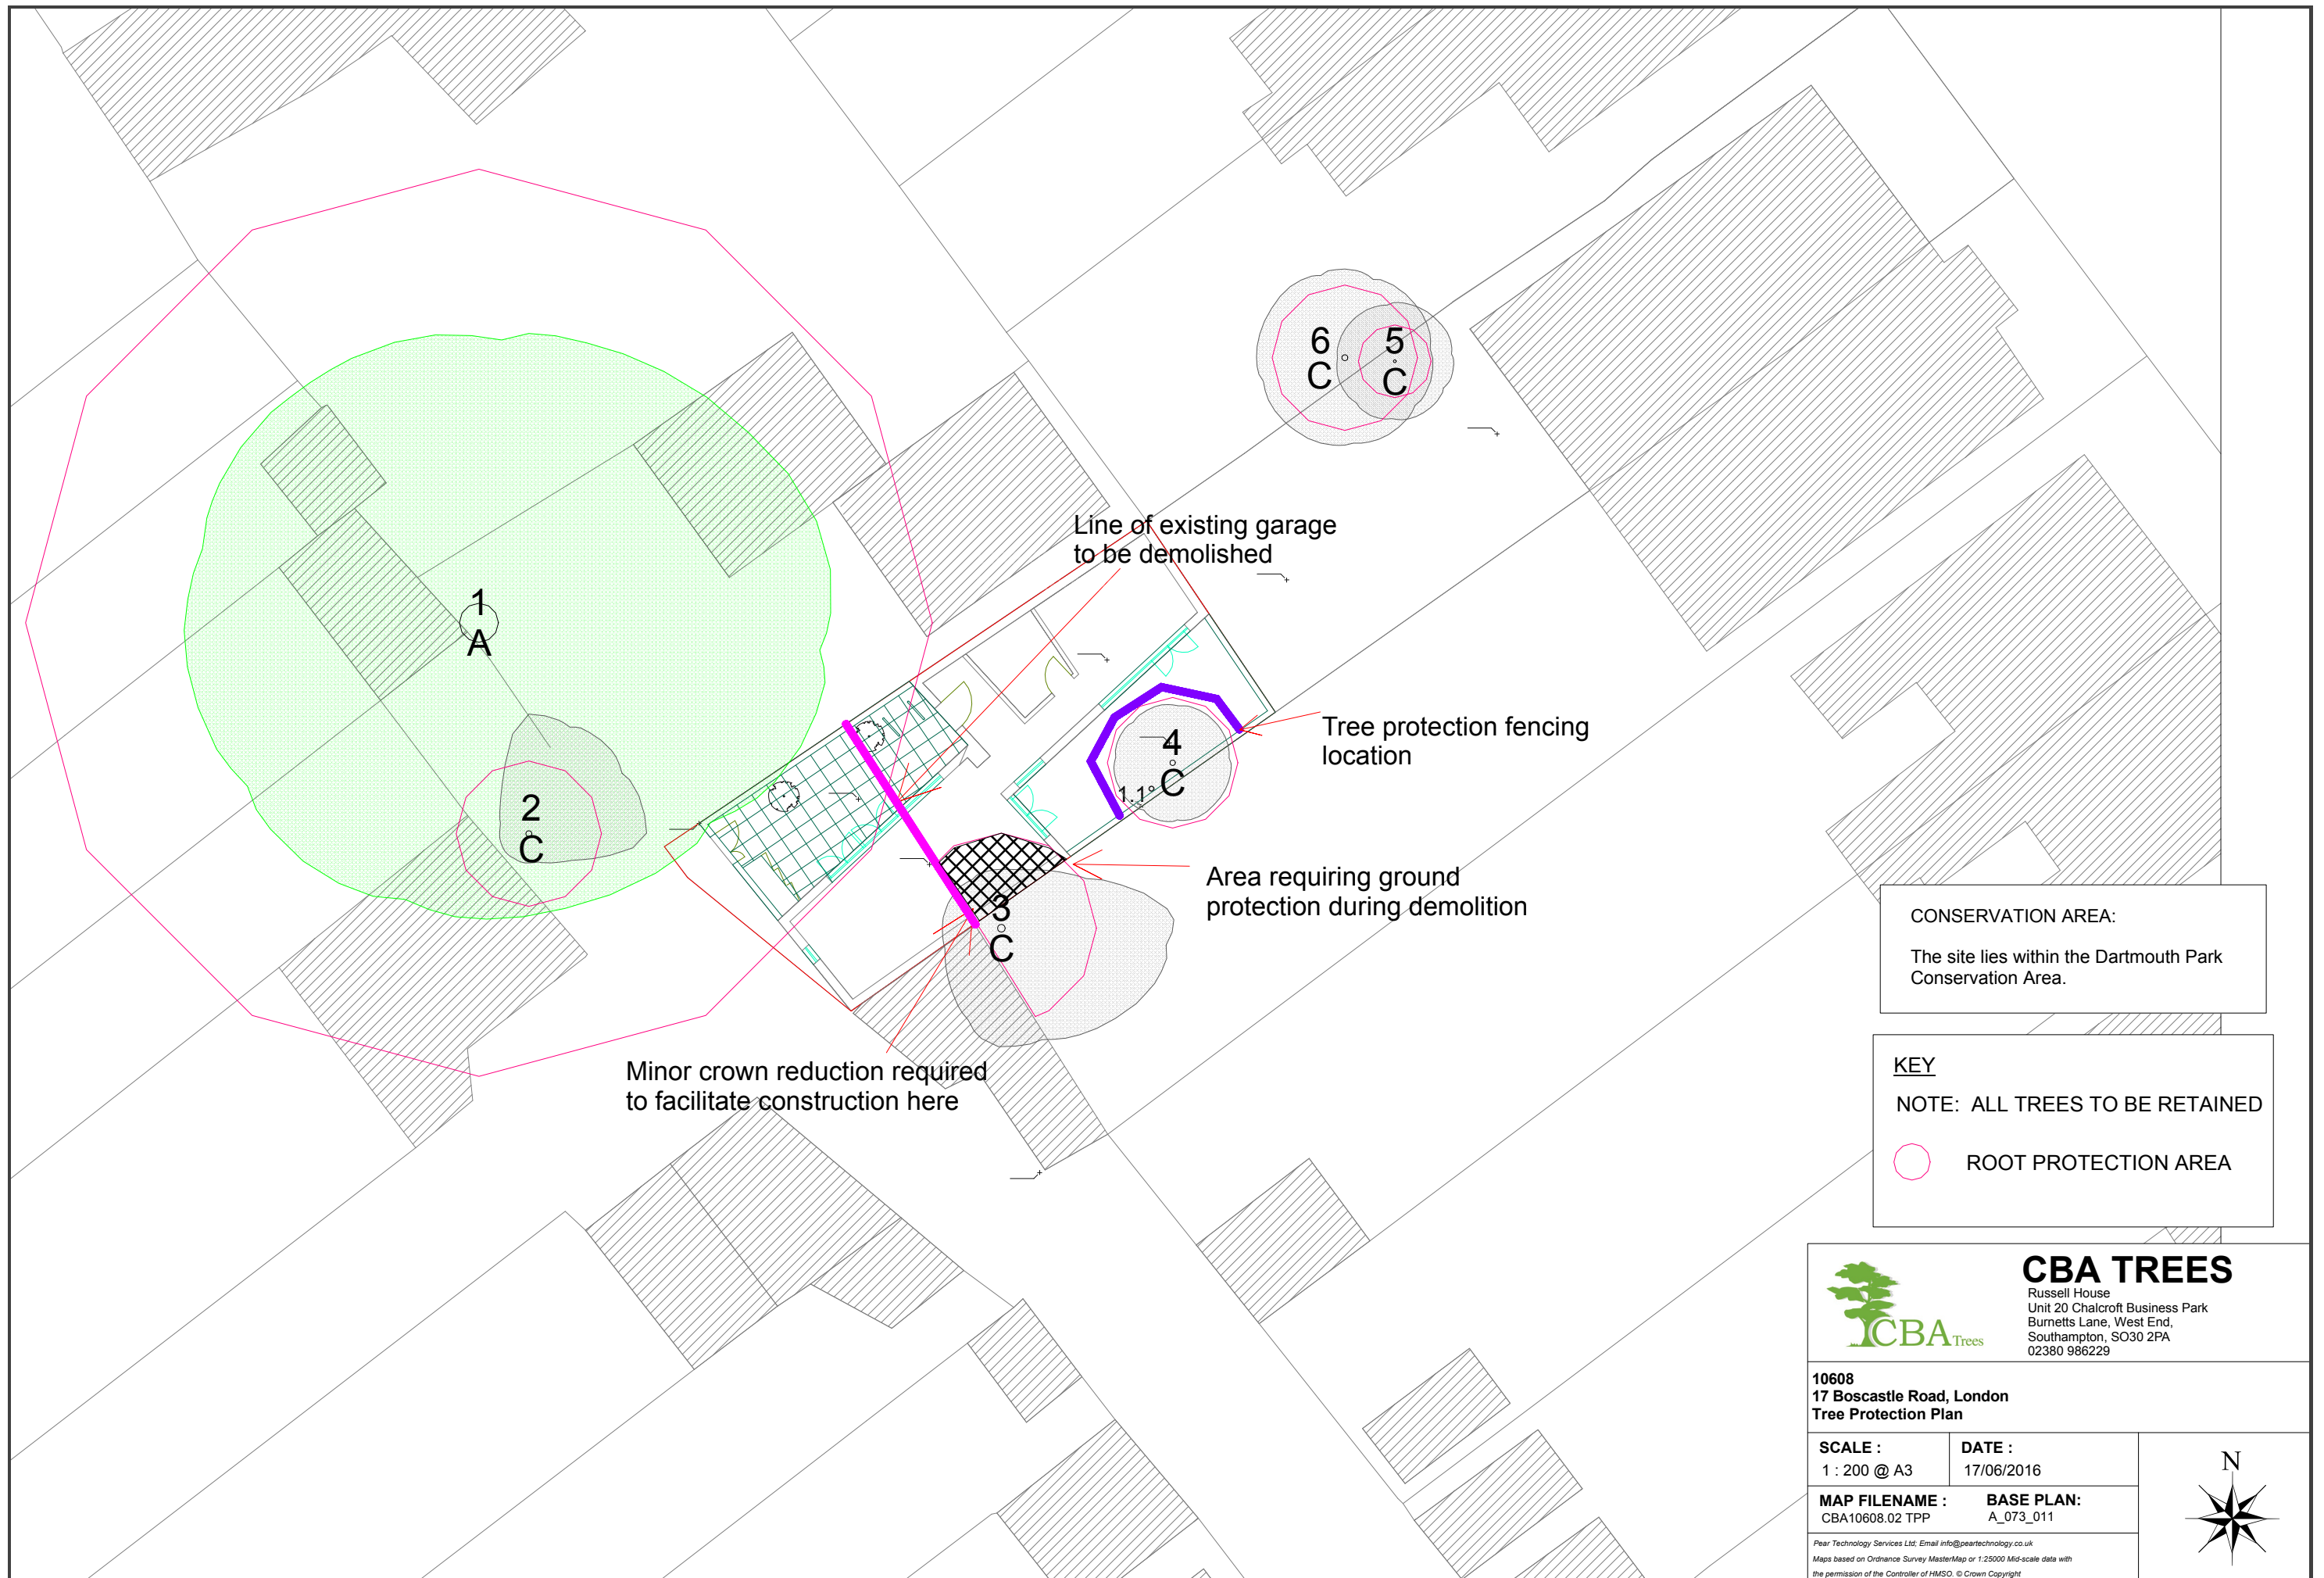
CONSERVATION AREA:
 The site lies within the Dartmouth Park Conservation Area.

KEY
 NOTE: ALL TREES TO BE RETAINED
 ○ ROOT PROTECTION AREA

This Arboricultural Development Statement (ADS) will demonstrate the protection measures for the trees and should be read in association with the Tree Protection Plan CBA10608.02 TPP, which identifies tree retention measures. It follows the initial tree survey, implications assessment and on-going discussions to minimise the impact upon the existing tree stock.
