Appendix B. Ground Movement Assessment

115-119 Goldhurst Terrace, London NW6

Damage Category Assessment

1.0 Introduction

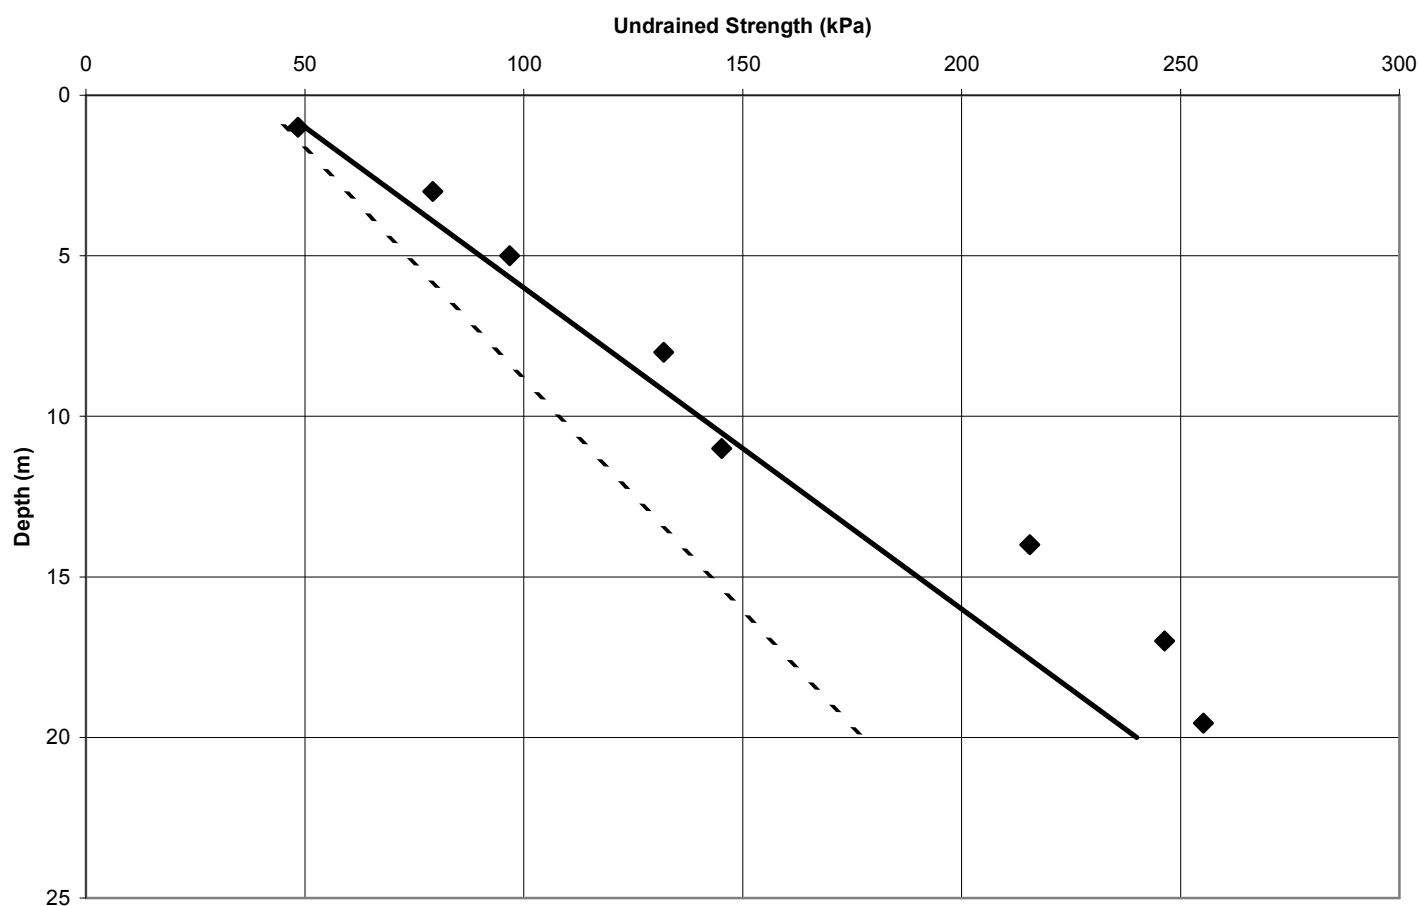
Undrained Strength vs Depth

Figure 3 –Undrained strength vs depth (London Clay)

Standard Penetration Tests (SPT) were undertaken in BH1. The results of these tests (the SPT 'N' value) can be correlated with the bulk undrained strength of the London Clay (S_u) using the method of Stroud (Ref 1). Based on previous experience a correlation factor, f_1 , of 4.4 has been adopted and the resulting undrained strength values are plotted in Figure 3.

The trend line fitted to the data in Figure 3 (solid line) has the equation:-
