NO.11 THE GROVE, HIGHGATE N6
DESIGN, ACCESS AND HERITAGE STATEMENT
06 JULY 2016

This document supports planning application and Listed Building consent for proposed works to No. 11 The Grove, Highgate London N6.

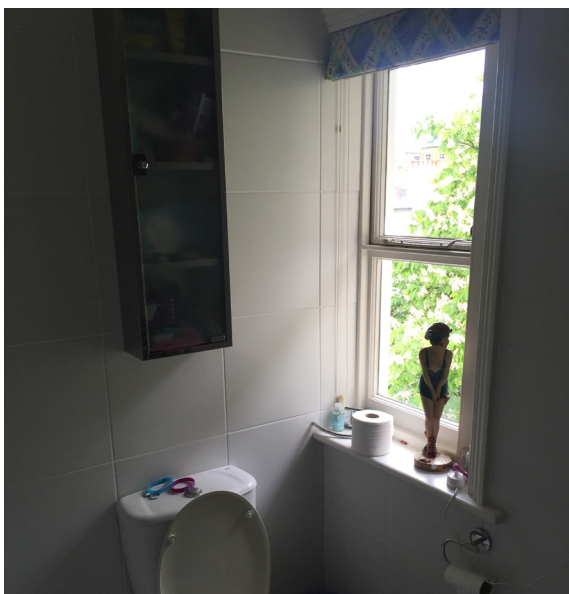
Fig. 8_ Split bathroom window

Bathroom was subdivided to create 2 bathrooms better suiting the hostel use. The casement window to the front has been split between the two bathrooms

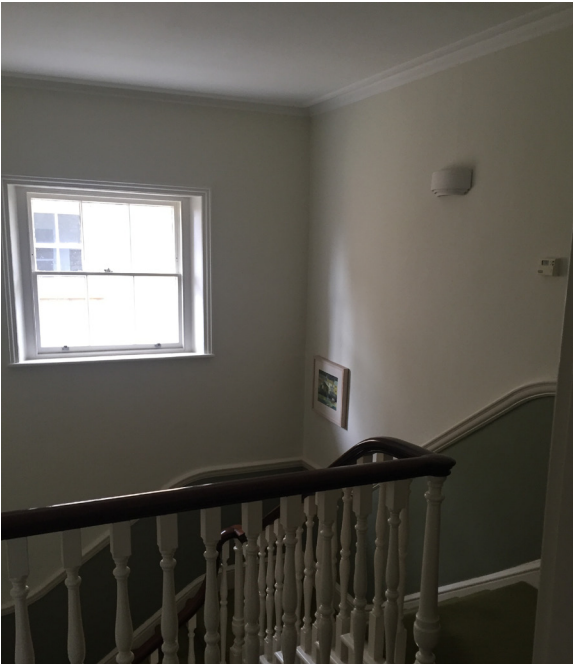
Fig. 10_ Stair well at top floor

The stair well is quite dark in spite of the north facing windows. The light has been reduced by the new building on the adjacent property to the north.

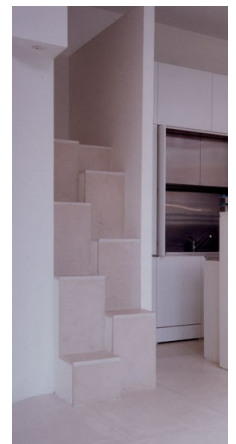
Fig.19_ 'Hit and Miss' stair

The proposals create a new bedroom suite with a main sleeping area at 2nd floor level and dressing room ensuite at loft level accessed by a set of 'Hit and Miss' stairs.

New 'hit and miss' stair installed where the hatch currently is with wardrobe beneath.

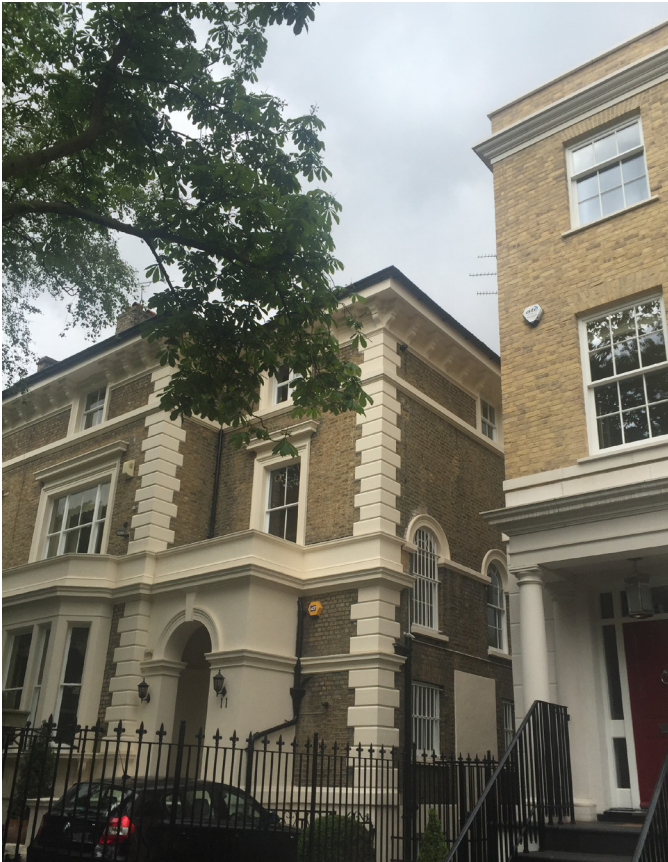
Fig. 21_ New rooflight not visible from street

The new rooflight would protrude up from the existing sloping roof but such that it would not be visible from The Grove (see Fig. 21).

The rooflight would be lead clad to match existing dormer.
