**BUILDING DAMAGE ASSESSMENT**  
**for the site at**  
**1 ELSWORTHY TERRACE,**  
**LONDON, NW3 3DR**  
**on behalf of**  
**MRS MIRYAM CAROLINE NOURANI**

<b>Report:</b>	<b>BUILDING DAMAGE ASSESSMENT</b>
<b>Site:</b>	<b>LAND AT REAR OF 1 ELSWORTHY TERRACE</b>
<b>Client:</b>	<b>MRS MIRYAM CAROLINE NOURANI</b>
<b>Date:</b>	<b>15/06/2016</b>
<b>Reference:</b>	<b>GE11003 – BDAV1JT160615</b>
<b>Version:</b>	<b>1.0</b>
<b>Prepared by:</b>

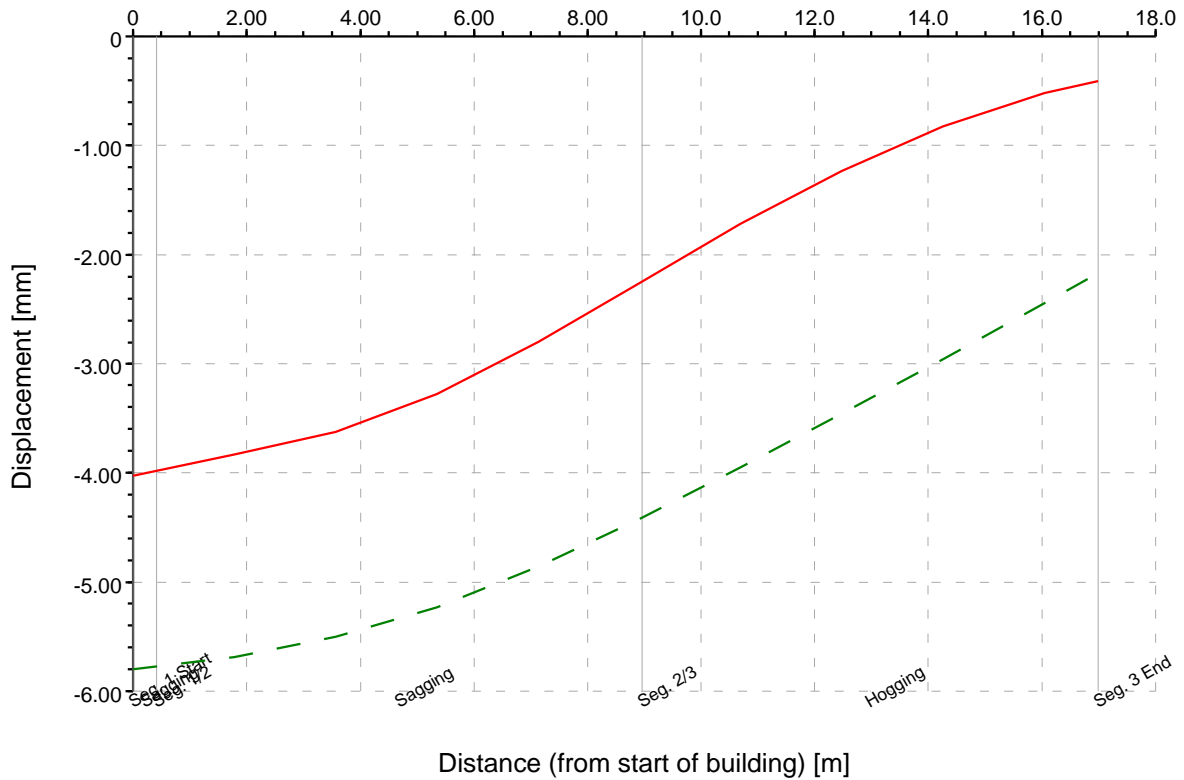
Movements Due to Wall Installation & Excavation

Structure 2: No. 23 Elsworthy Road/Front Facade Wall, Offset 1: 0.000m

- Vertical Displacement
- - - Horizontal Displacement (along the building)

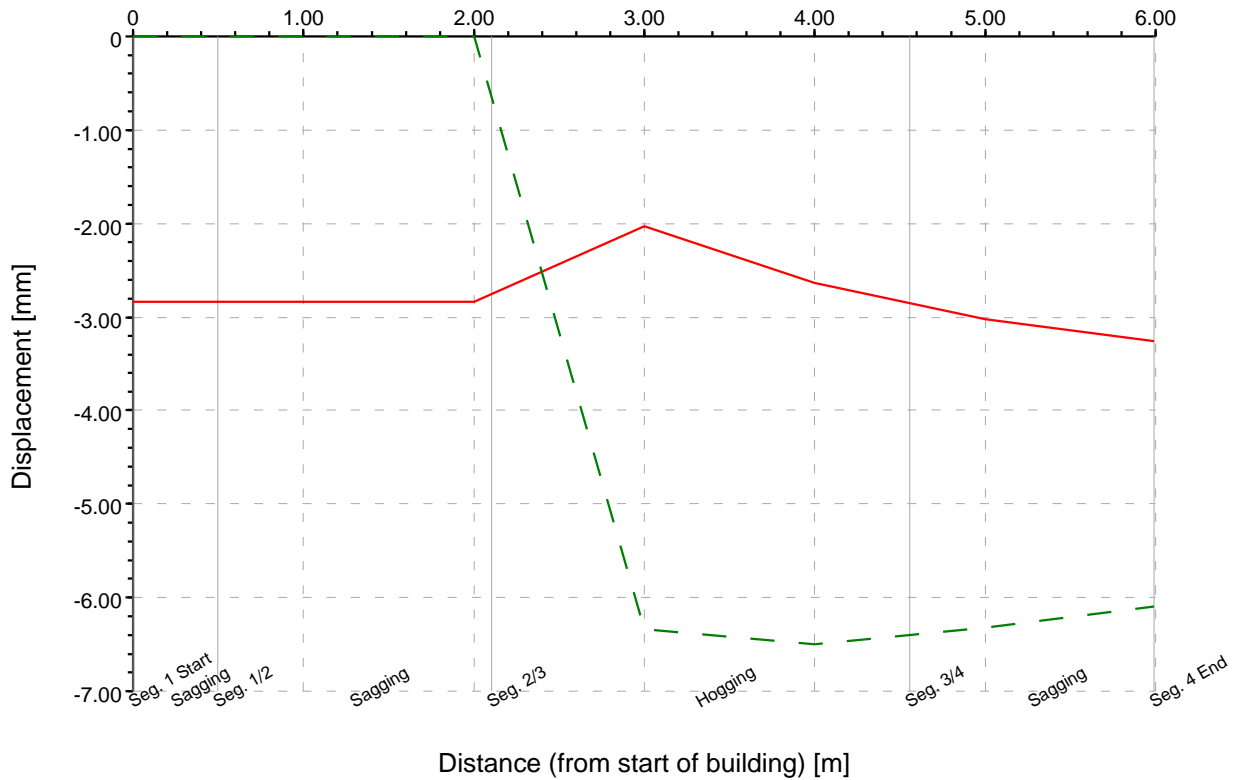
Movements Due to Wall Installation & Excavation

Structure 9: No. 23 Elsworthy Road/Garage Party Wall, Offset 1: 0.000m

- Vertical Displacement
- - - Horizontal Displacement (along the building)

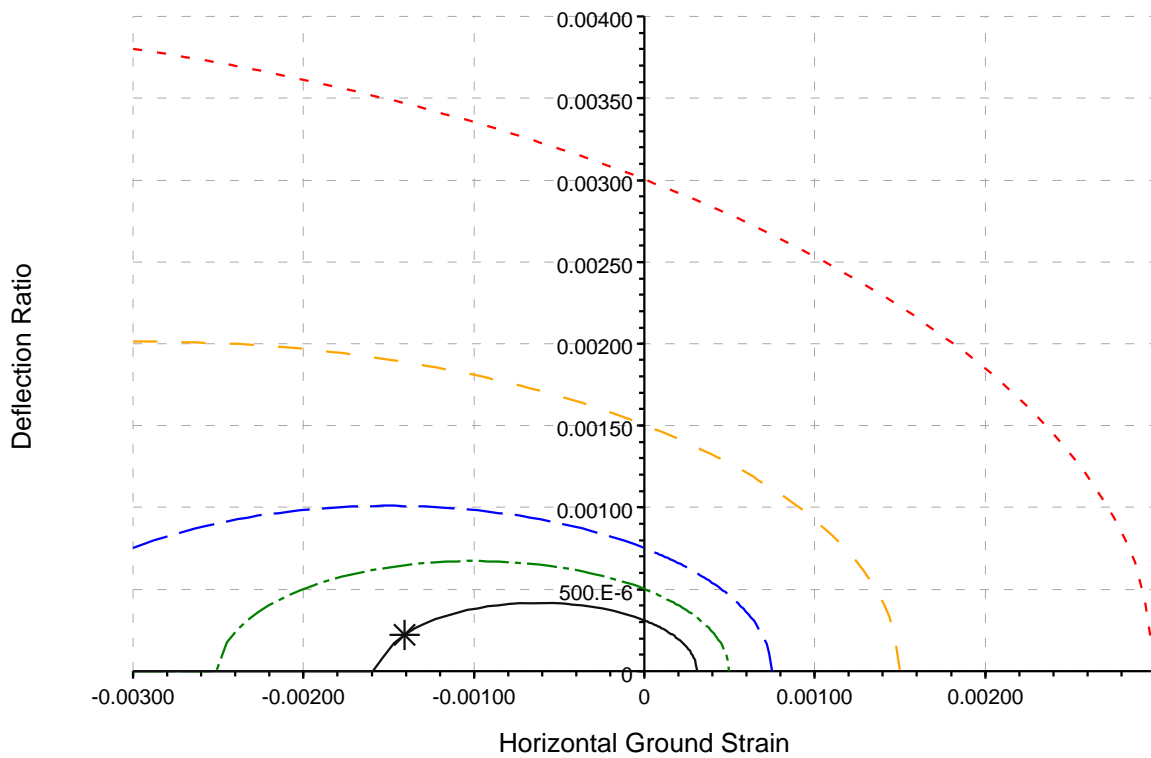
**Building Damage Interaction Chart**

Structure 1: No. 23 Elsworthy Road/Party Wall, Segment 1: length 2.450 m

- - - Cat. 0 (Negligible) to 1 (Very Slight)
- - - Cat. 1 (Very Slight) to 2 (Slight)
- - - Cat. 2 (Slight) to 3 (Moderate)
- - - Cat. 3 (Moderate) to 4 (Severe)
- Max Strains (-0.001552) (0.000310)
- \* Result (-0.001408, 0.000223 - Cat. 0)

Building damage interaction charts, for each of the structures listed in the table above are presented in Figures 17-28.

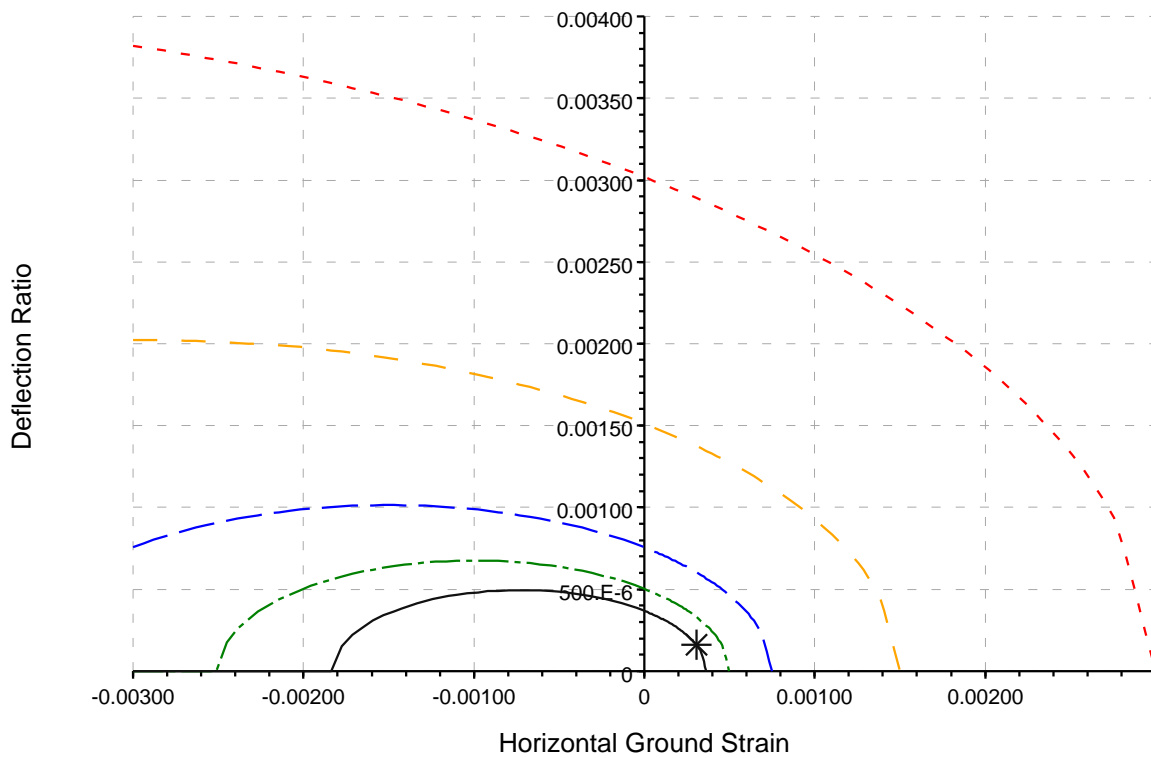
### Building Damage Interaction Chart

Structure 6: No. 1 & 2 Elsworthy Terrace/Party Wall, Segment 1: length 3.272 m

- - - Cat. 0 (Negligible) to 1 (Very Slight)
- - - Cat. 1 (Very Slight) to 2 (Slight)
- - - Cat. 2 (Slight) to 3 (Moderate)
- - - Cat. 3 (Moderate) to 4 (Severe)
- Max Strains (-0.001831) (0.000366)
- \* Result (0.000306, 0.000161 - Cat. 0)

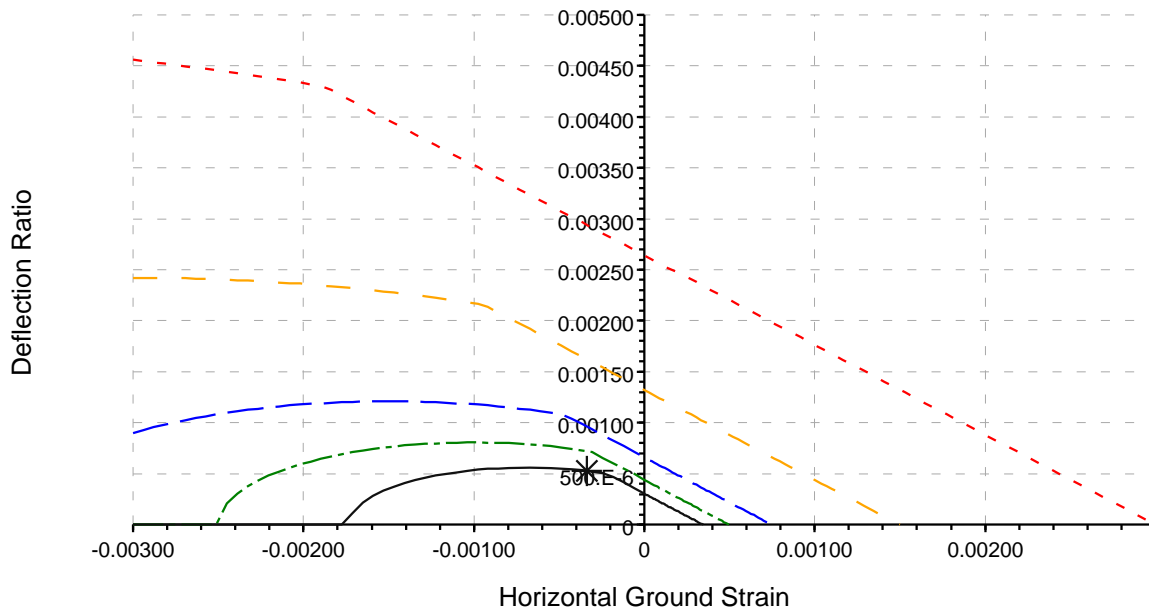
### Building Damage Interaction Chart

Structure 11: No. 23 Elsworthy Road/Garage Side Wall, Segment 2: length 2.126m

- - - Cat. 0 (Negligible) to 1 (Very Slight)
- - - Cat. 1 (Very Slight) to 2 (Slight)
- - - Cat. 2 (Slight) to 3 (Moderate)
- - - Cat. 3 (Moderate) to 4 (Severe)
- Max Strains (-0.001736) (0.000347)
- \* Result (-0.000339, 0.000526 - Cat. 0)

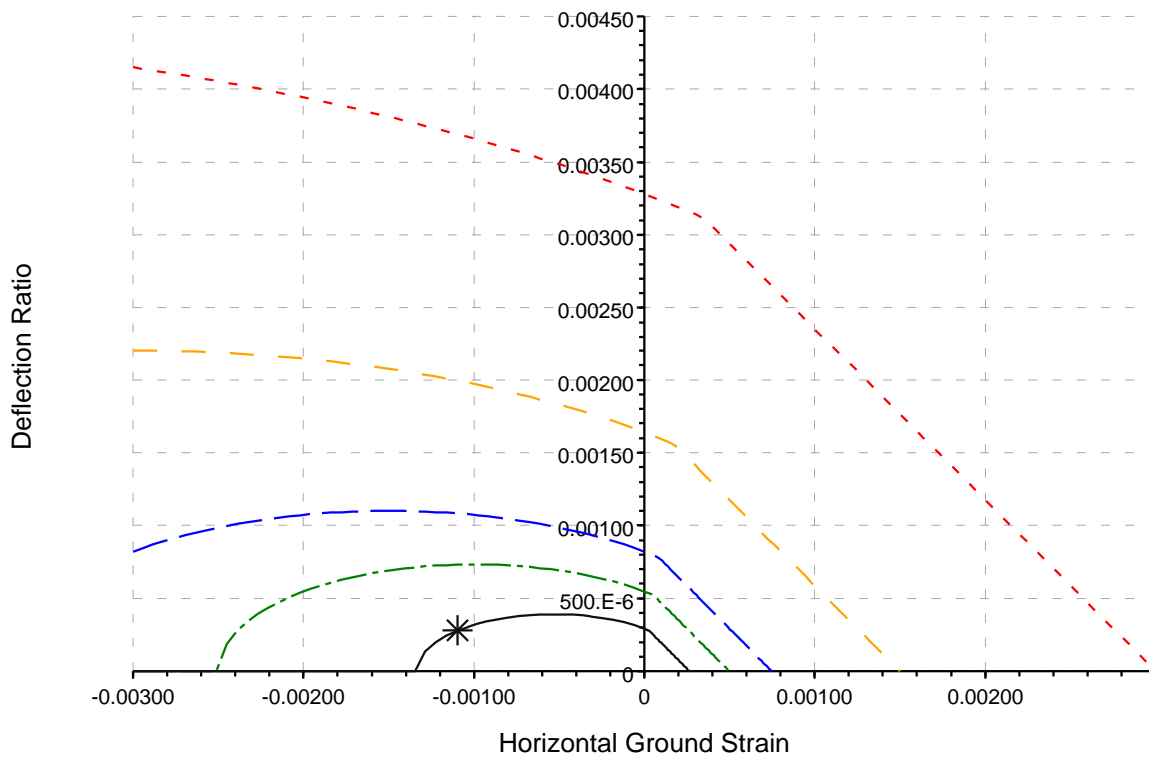
**Building Damage Interaction Chart**

Structure 12: No. 23 Elsworth Road/Garage Rear Wall, Segment 1: length 2.899 m

- - - Cat. 0 (Negligible) to 1 (Very Slight)
- - - Cat. 1 (Very Slight) to 2 (Slight)
- - - Cat. 2 (Slight) to 3 (Moderate)
- - - Cat. 3 (Moderate) to 4 (Severe)
- Max Strains (-0.001335) (0.000267)
- \* Result (-0.001098, 0.000278 - Cat. 0)
