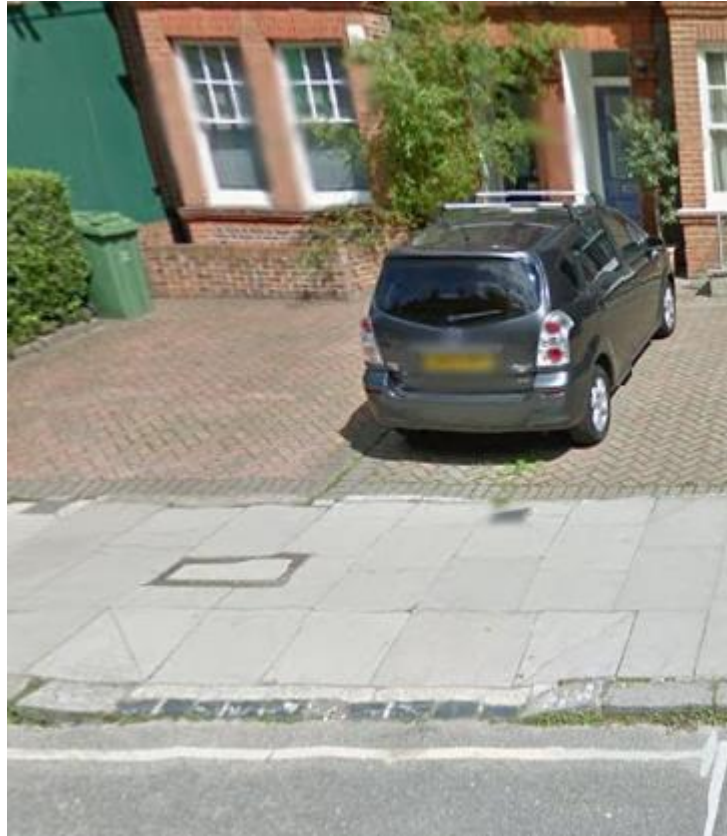
*Figure 26: Street level view showing kerb raised above road*

- Excess flow from Goldhurst Terrace will move, owing to the slight fall on the road outside.
- This flow would travel in the direction away from the front elevation of the property owing to the site being on a slightly higher level than the opposite side of the street, and the raised level of the pavement above the road (see photo below).
