**BASEMENT IMPACT ASSESSMENT
69 KENTISH TOWN ROAD
LONDON
NW1 8NY**

Basement Impact Assessment
69 Kentish Town Road
London
NW1 8NY

Rose & Associates have been commissioned to prepare a Basement Impact Assessment report to accompany a Planning application for the extension of an existing basement to 63 Kentish Town Road, London NW1 8NX. The semi-basement forms part of an extensive refurbishment to this existing property.

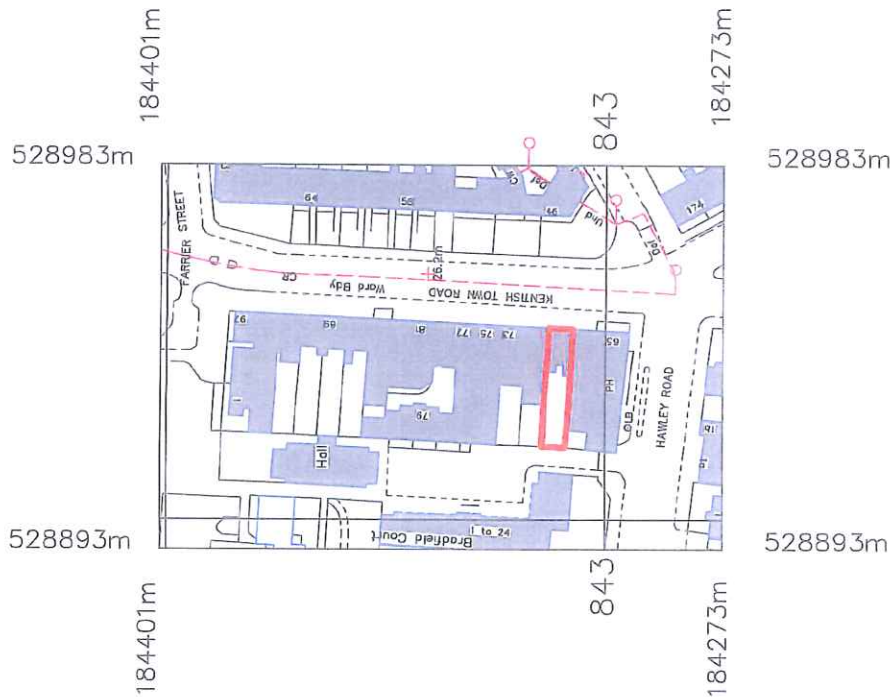
The site is located at 69 Kentish Town Road, London NW1 8NX on a general flat site as shown on the block plan shown below:-

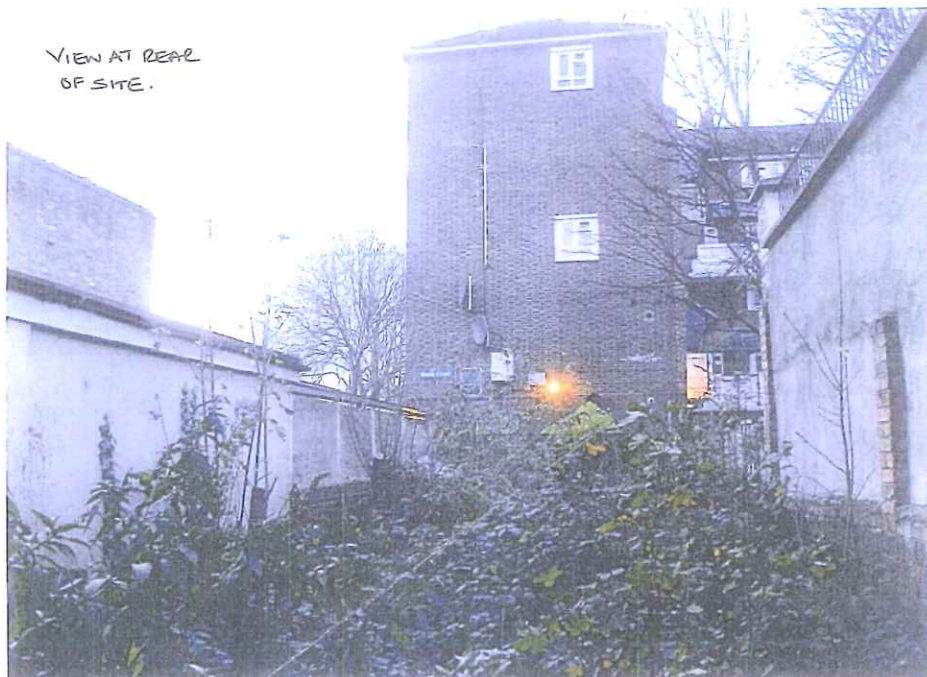
Note in the neighbouring plot (71) is an existing tree close to the rear garden boundary wall. The proposed rear extension will still be approximately 9 meters from this tree. The proposed construction therefore lies outside of this tree protection zone.

It is envisaged the foundations will comprise a reinforced concrete raft forming the basement floor slab which in turn will support reinforced concrete retaining walls. The walls will be cast in short sections akin to traditional underpinning, using the neighbouring soil as the back shutter. This technique will minimise lateral movement in the adjoining soils to within Burland's category of damage 2.
