Interior restoration

1-2 LINCOLN'S INN FIELDS

JULIAN HARRAP
 ARCHITECTS LLP

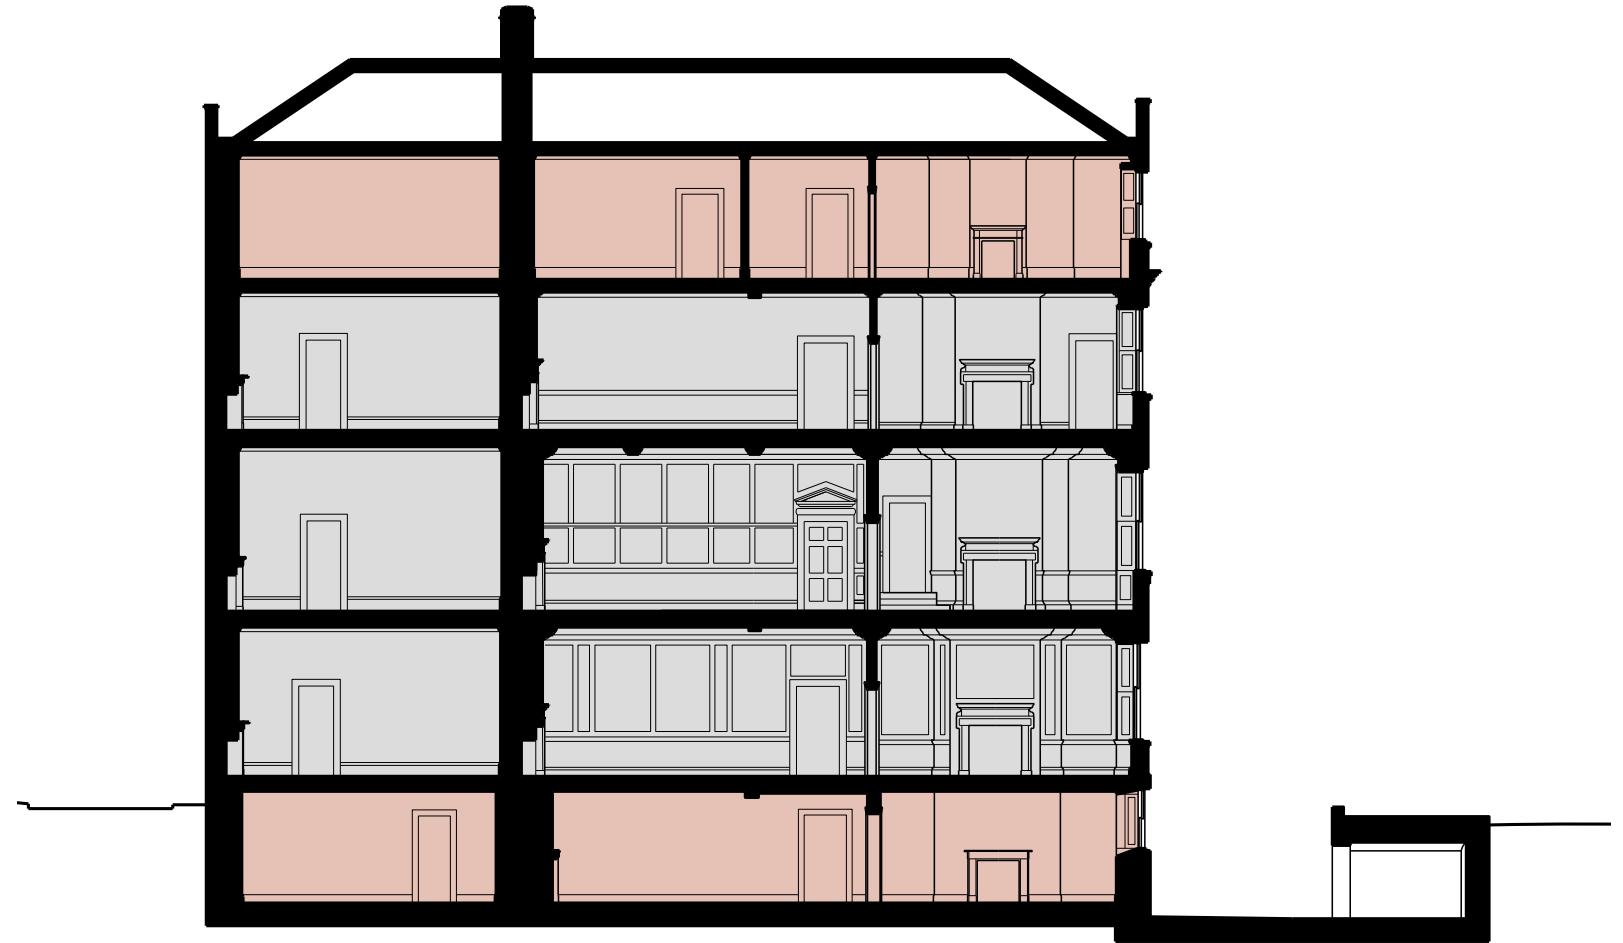
Section DD presenting areas of important historic fabric and areas for new architectural intervention.

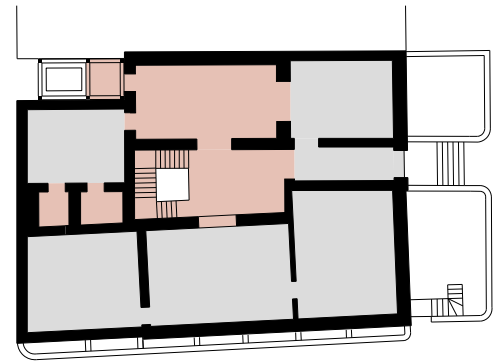
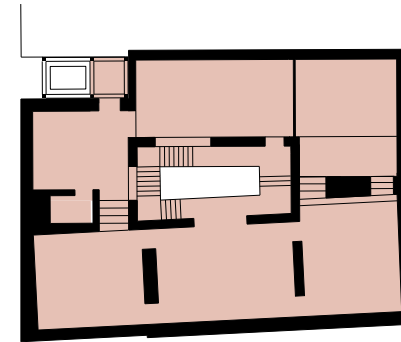
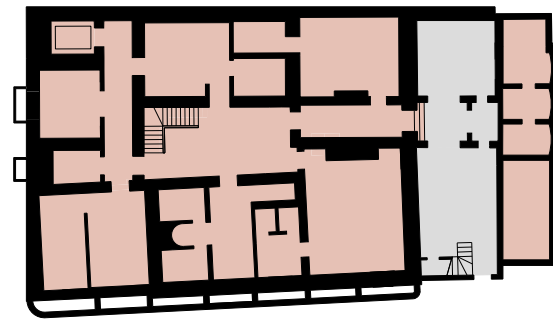
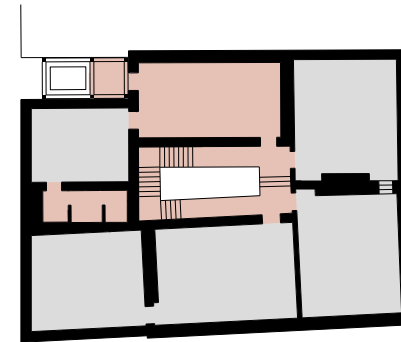
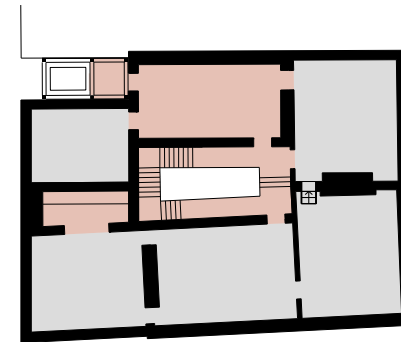
- Full restoration of historic fabric
- Restoration with new intervention

Schematic plans presenting areas of important historic fabric and areas for new architectural intervention.

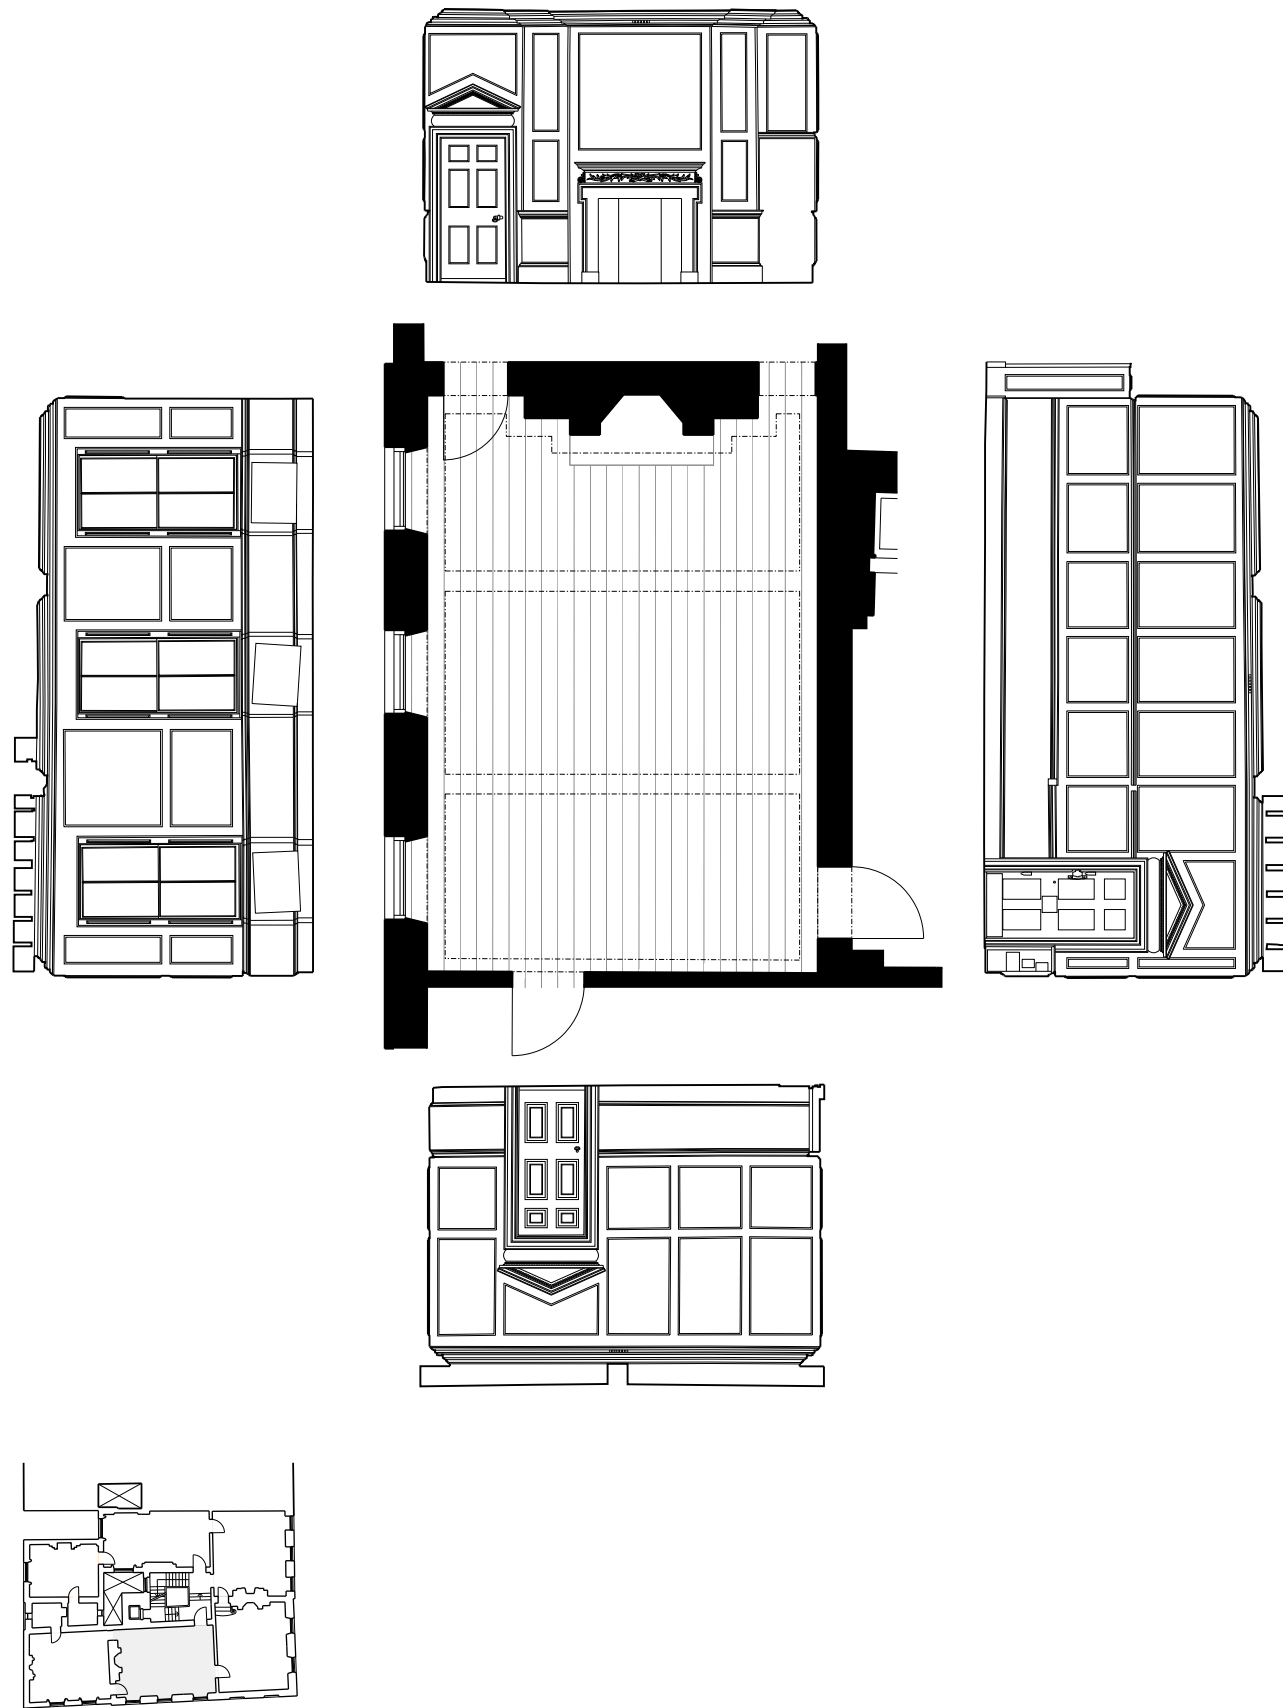
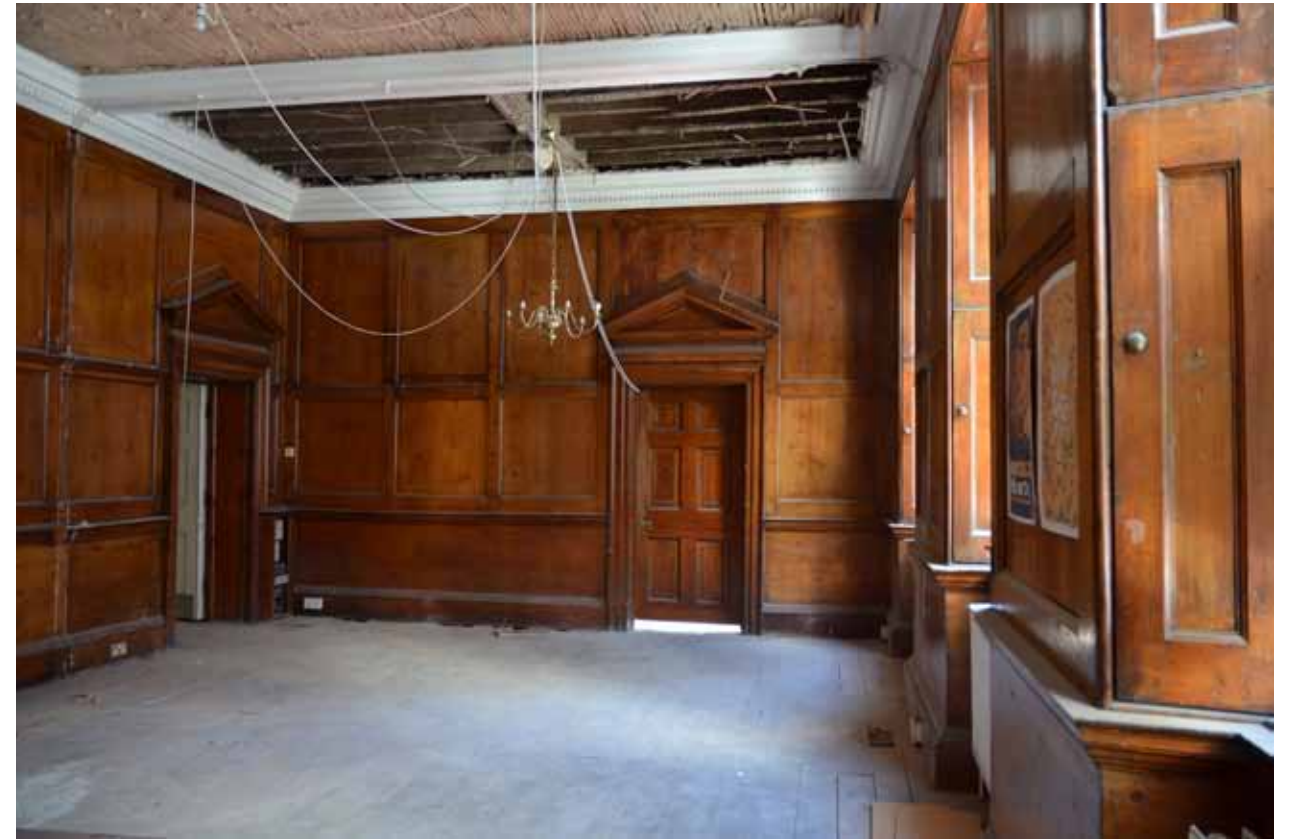
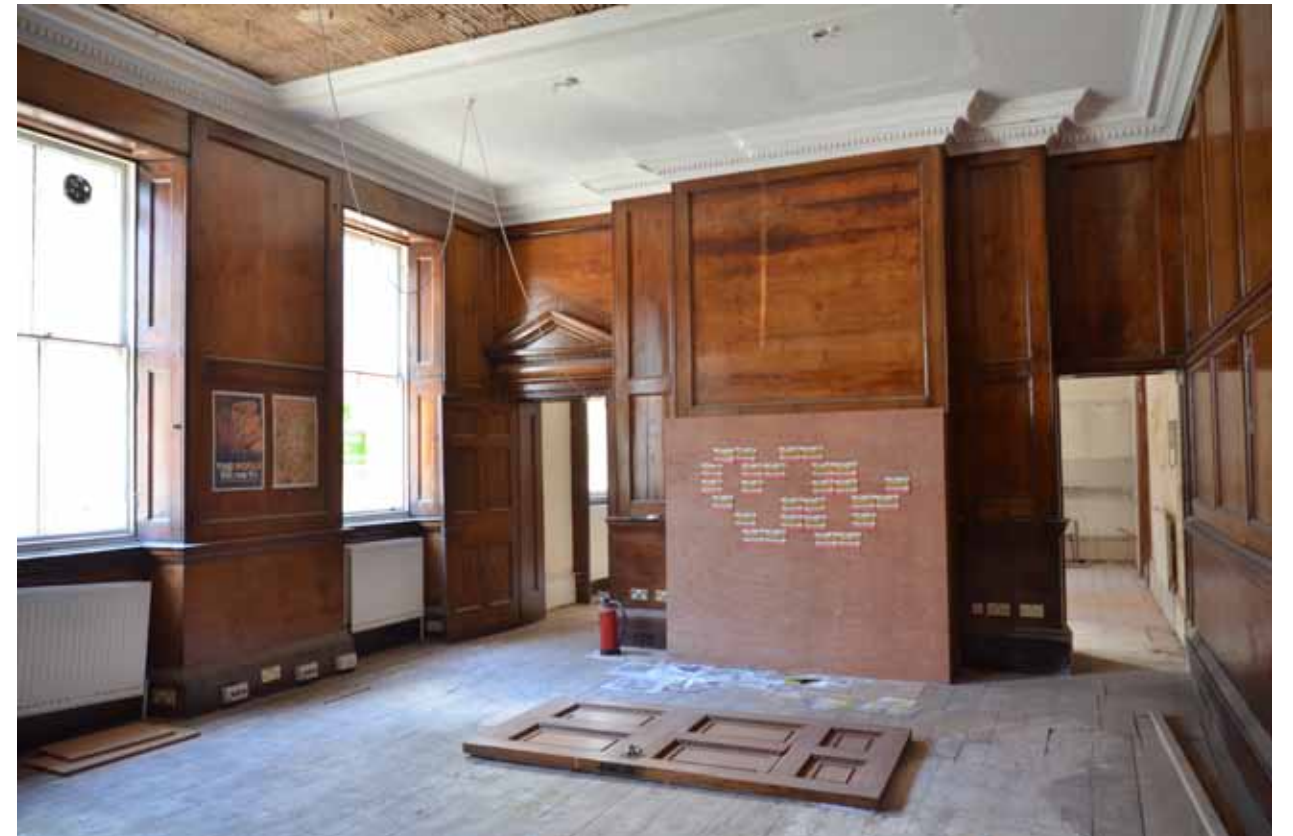
Photographs and internal elevations of historic interior in room 102

Photographs of existing room

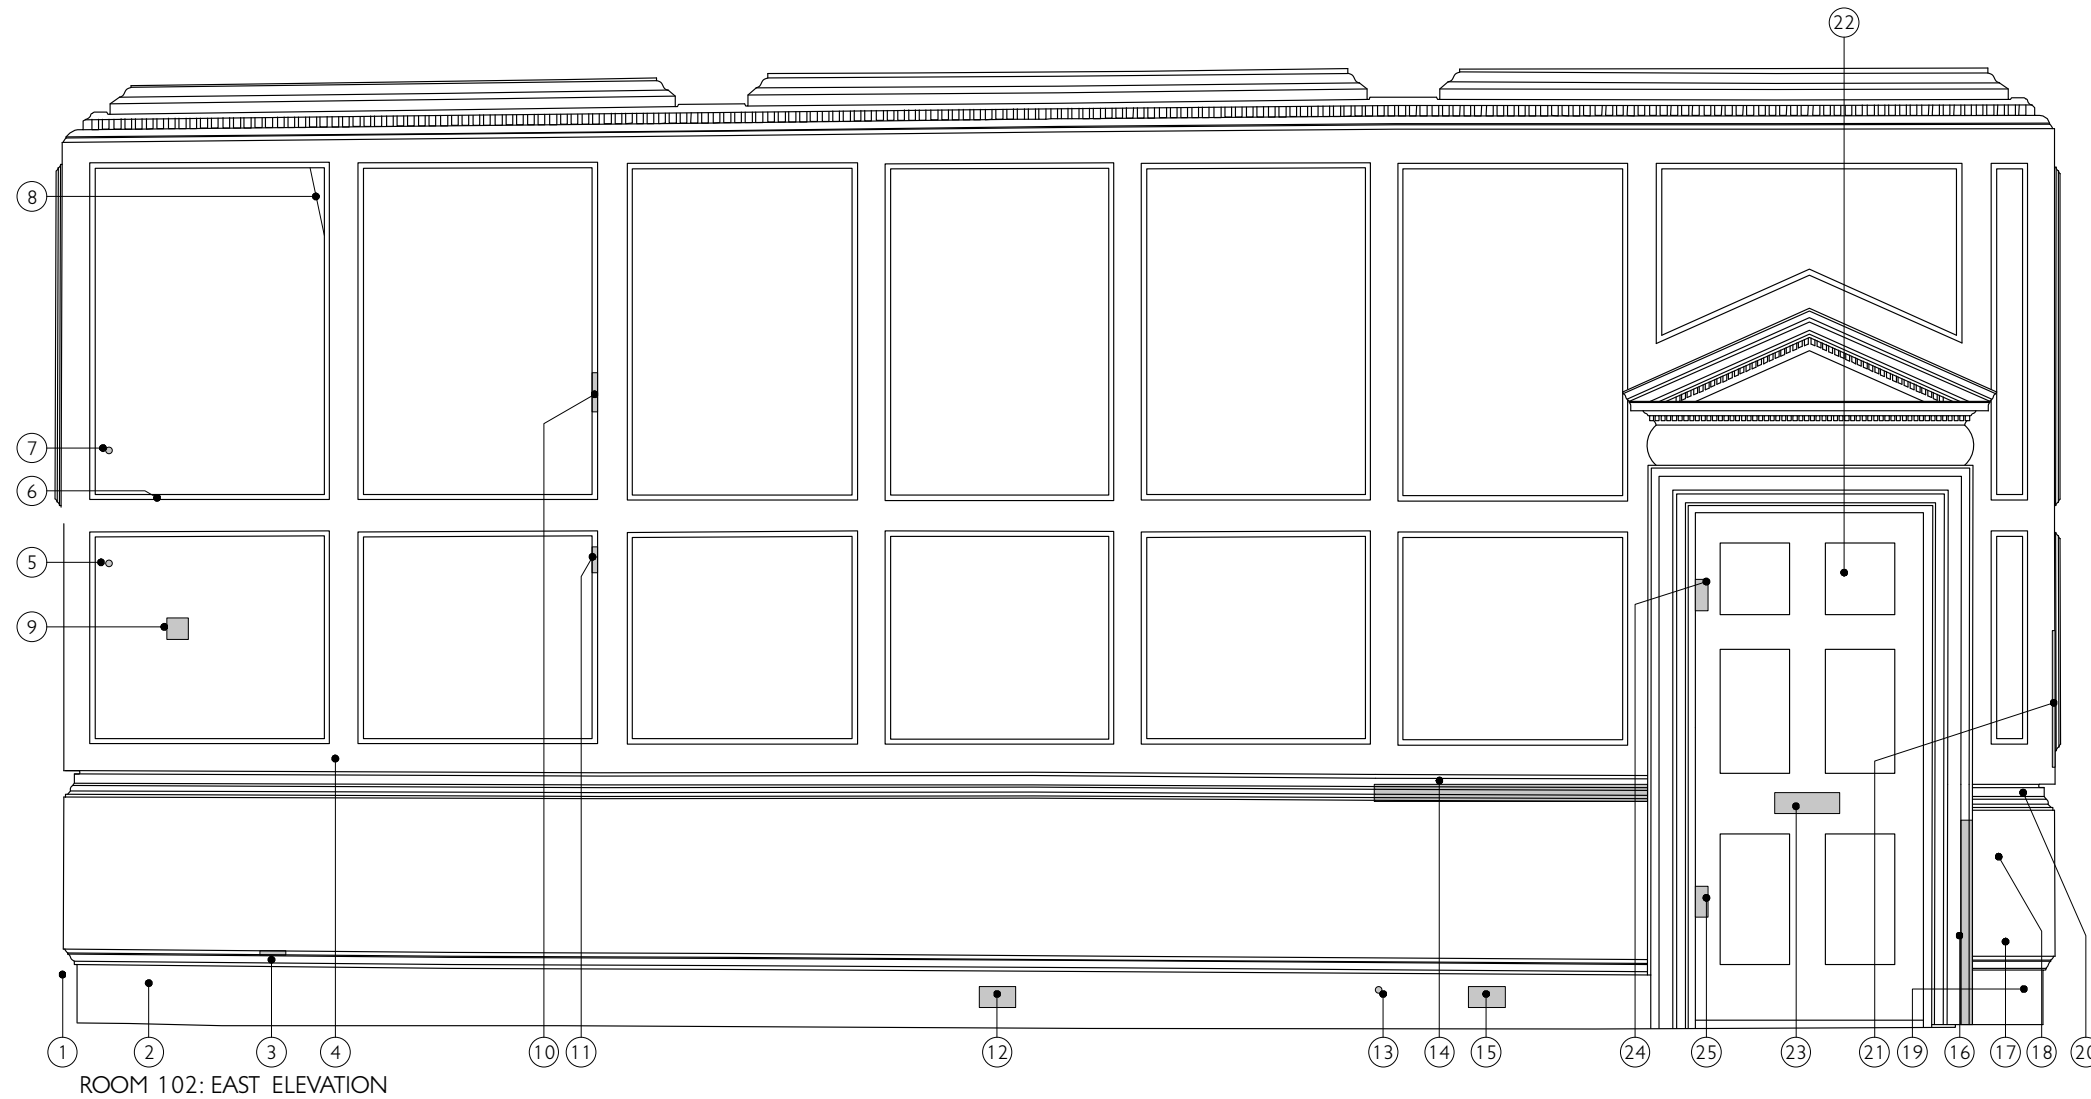
ROOM 102 DRWG 594/DD053
 EAST WALL SCALE 1:25 @ A3
 DATE SEPT. 2013

- ① Take off section of timber and clear away from site.
- ② Take off skirting board and refix in original position.
- ③ Reinstall top moulding to skirting, 100x10x10mm.

- ④ Take off quadrant moulding from top of dado rail and piece-in the joint between dado rail and panelling, say full lengthx25x25mm, scribed to suit.
- ⑤ Piece in s/w timber panelling 25x25x25mm.

- ⑥ Remove 'picture rail' moulding, full length and clear away from site. Allow for filling screw holes.
- ⑦ Ditto note 5, but 25x50x25mm.
- ⑧ Supply and install s/w timber spline repair to panelling, say 5x10x500mm, plane down repair smooth with panel surface.

- ⑨ Sand down existing repair, so it is smooth with existing panelled surface.
- ⑩ Cut out and reinstall h/w timber fillet to panel moulding, approx 5x5x150mm.

- ⑪ Ditto note 10, but 100mm.
- ⑫ Piece in s/w timber skirting, 140x80x25mm.
- ⑬ Piece in s/w timber skirting, 25mm dia.
- ⑭ Repair s/w timber timber dado moulding to match existing re-using fragments of surviving top moulding, 1050x100x65mm.

- ⑮ Ditto note 12.
- ⑯ Reinstall architrave moulding in h/w timber, 45x925x26mm to match existing.
- ⑰ Remove existing services cupboard and clear away from site.

- ⑱ Take off existing panelling and allow for piecing in and repairing to be assessed when electrics removed.

- ⑲ Allow for supplying and installing new section of s/w timber skirting to match profile of existing 320x275x50mm.
 - ⑳ Supply and install new section of h/w timber dado to match profile of existing 320x100x60mm.
 - ㉑ Supply and install s/w timber spline, 5x400x25 to fit between panelling, scribed to suit.
 - ㉒ Rehang door on this inner surface.
- Door: Piece in the following in s/w timber:
- ㉓ Letter box: 250x80x58mm
 - ㉔ Top Banham lock: 70x190x58mm
 - ㉕ Bottom Banham lock: 70x190x58mm
 - ㉖ Yale lock: 50x120x58mm
 - ㉗ Knob: 25mm dia.

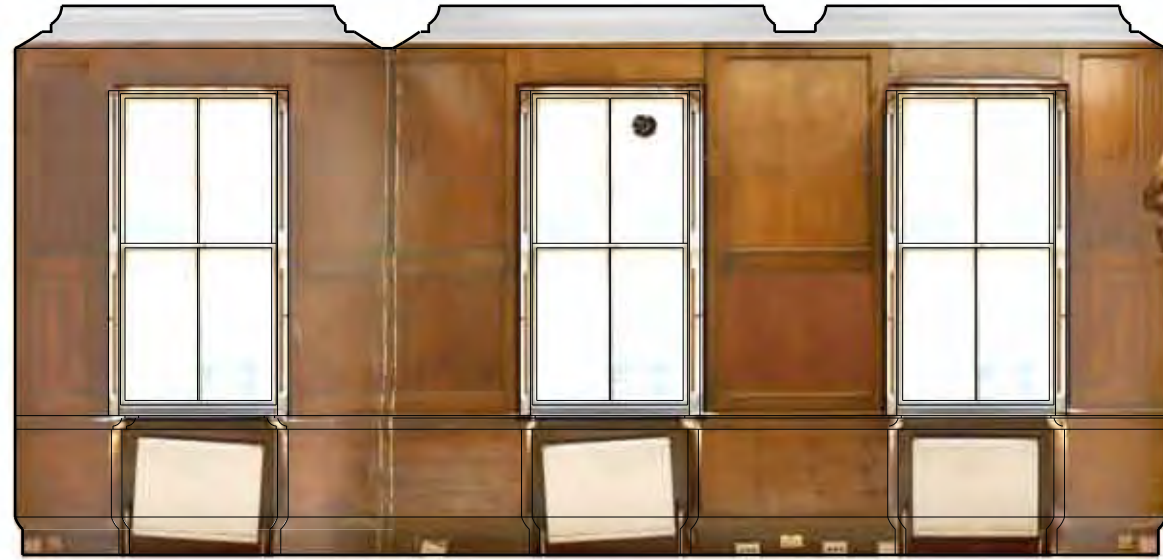
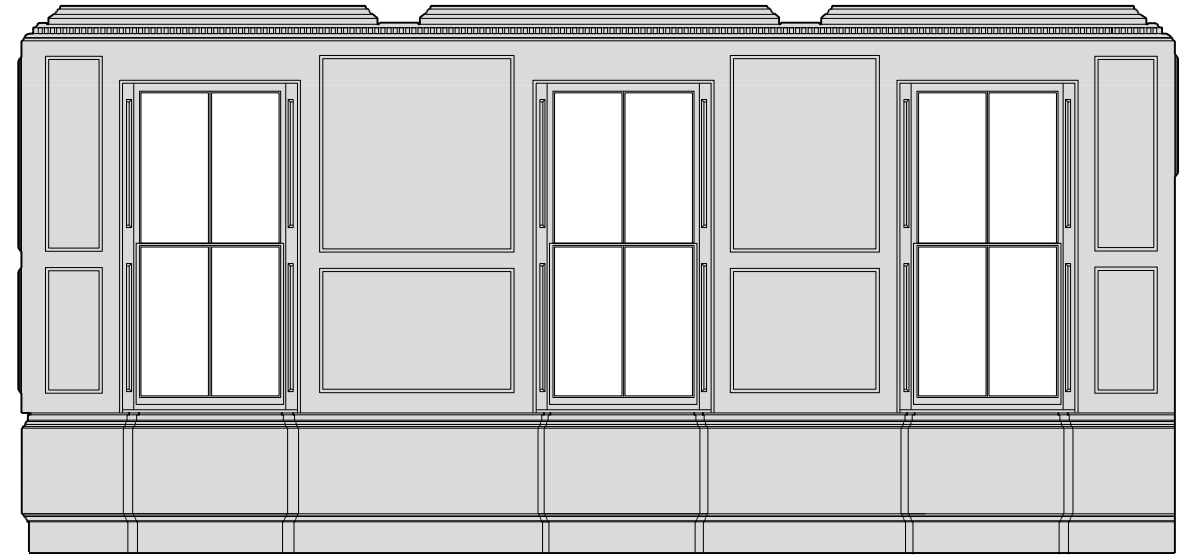
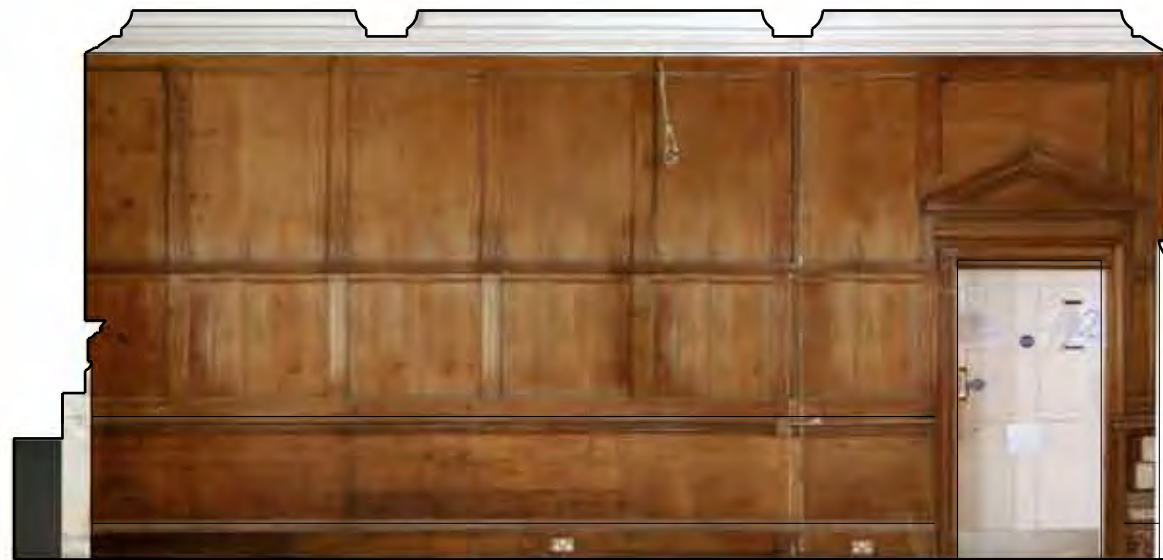
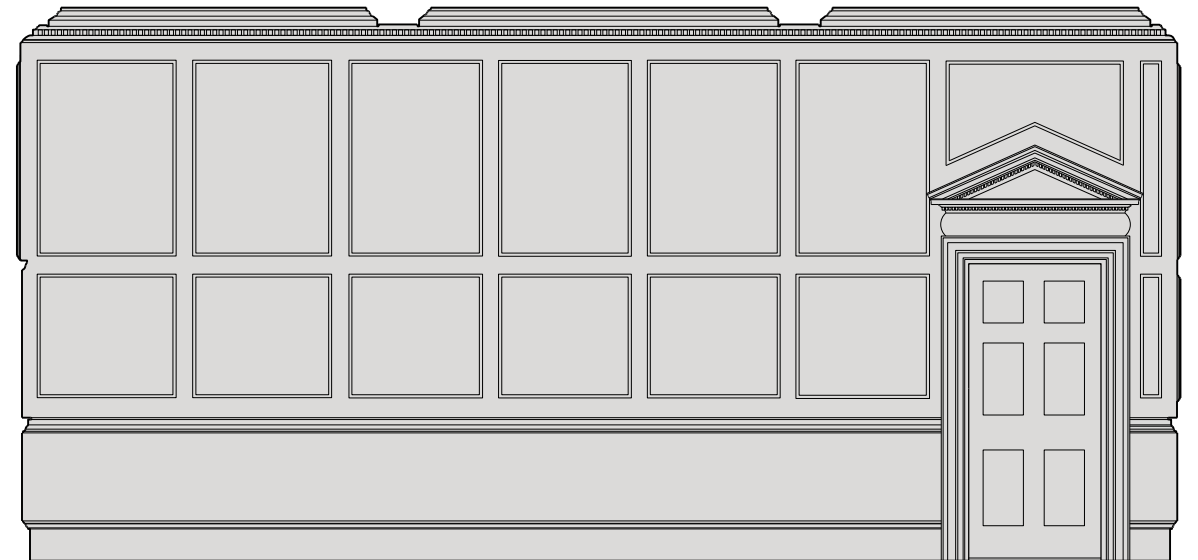
Existing and proposed internal elevations of room 102, scale 1:50

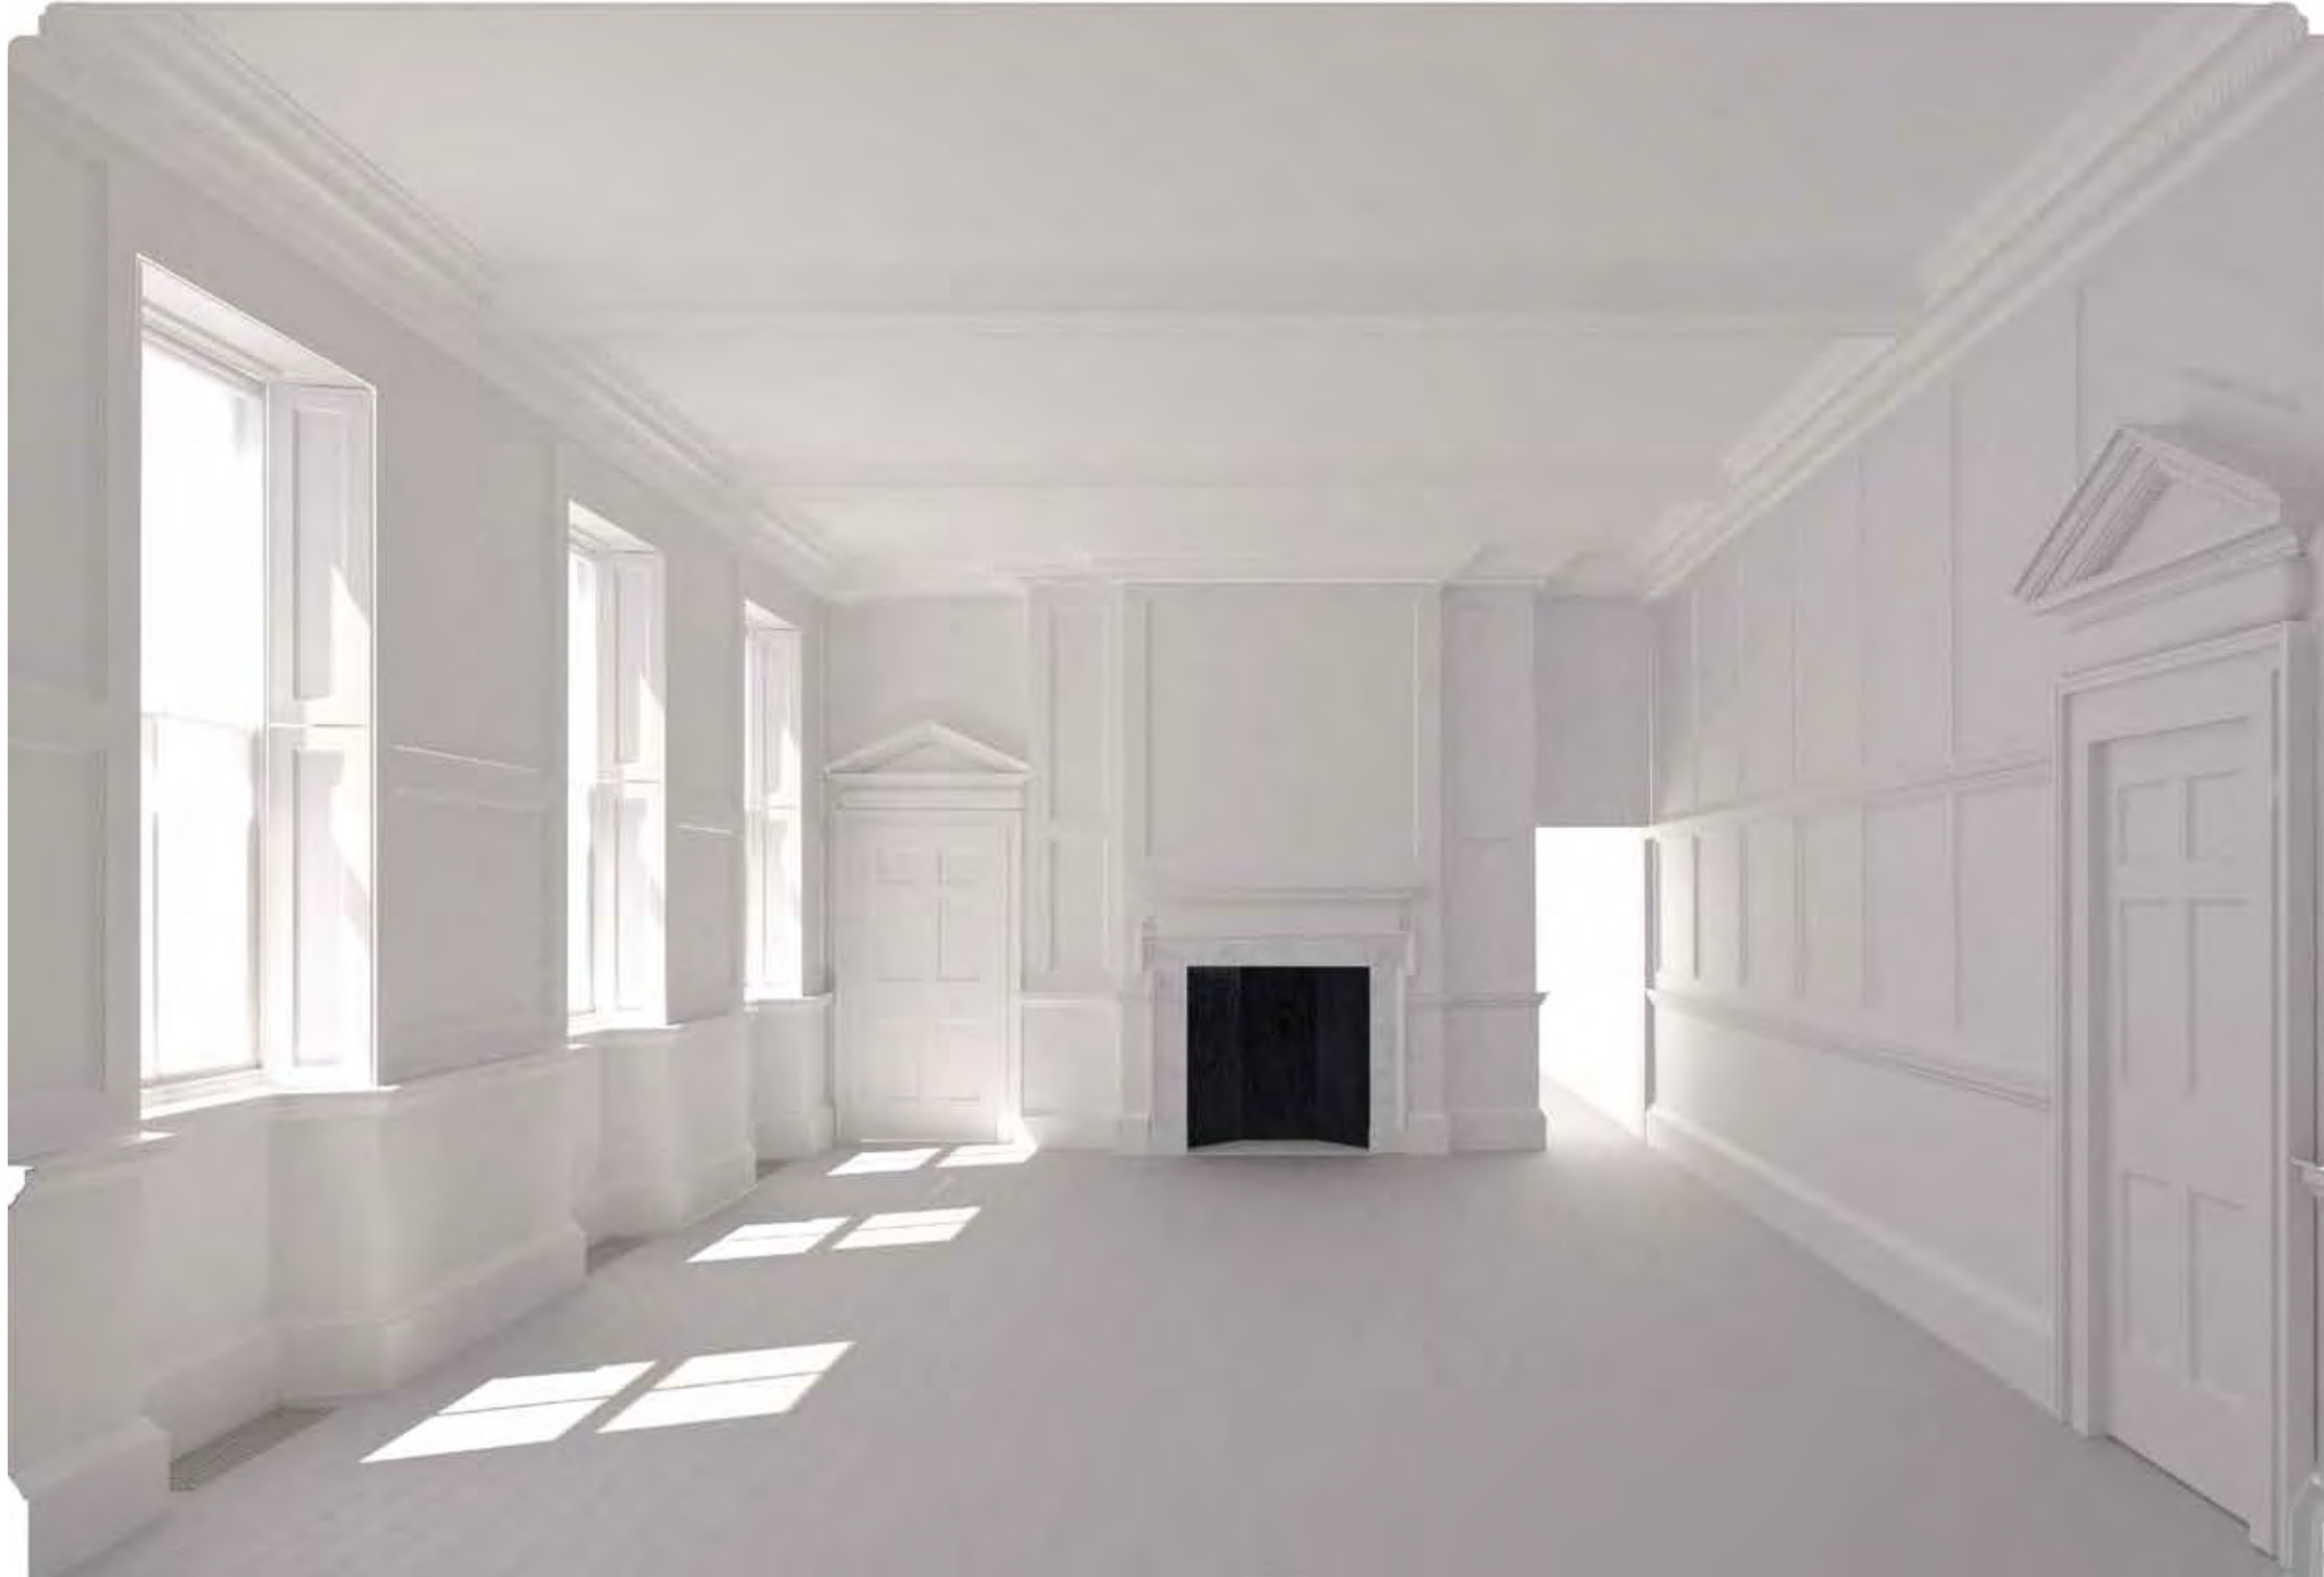
Visualisation of restored room 102

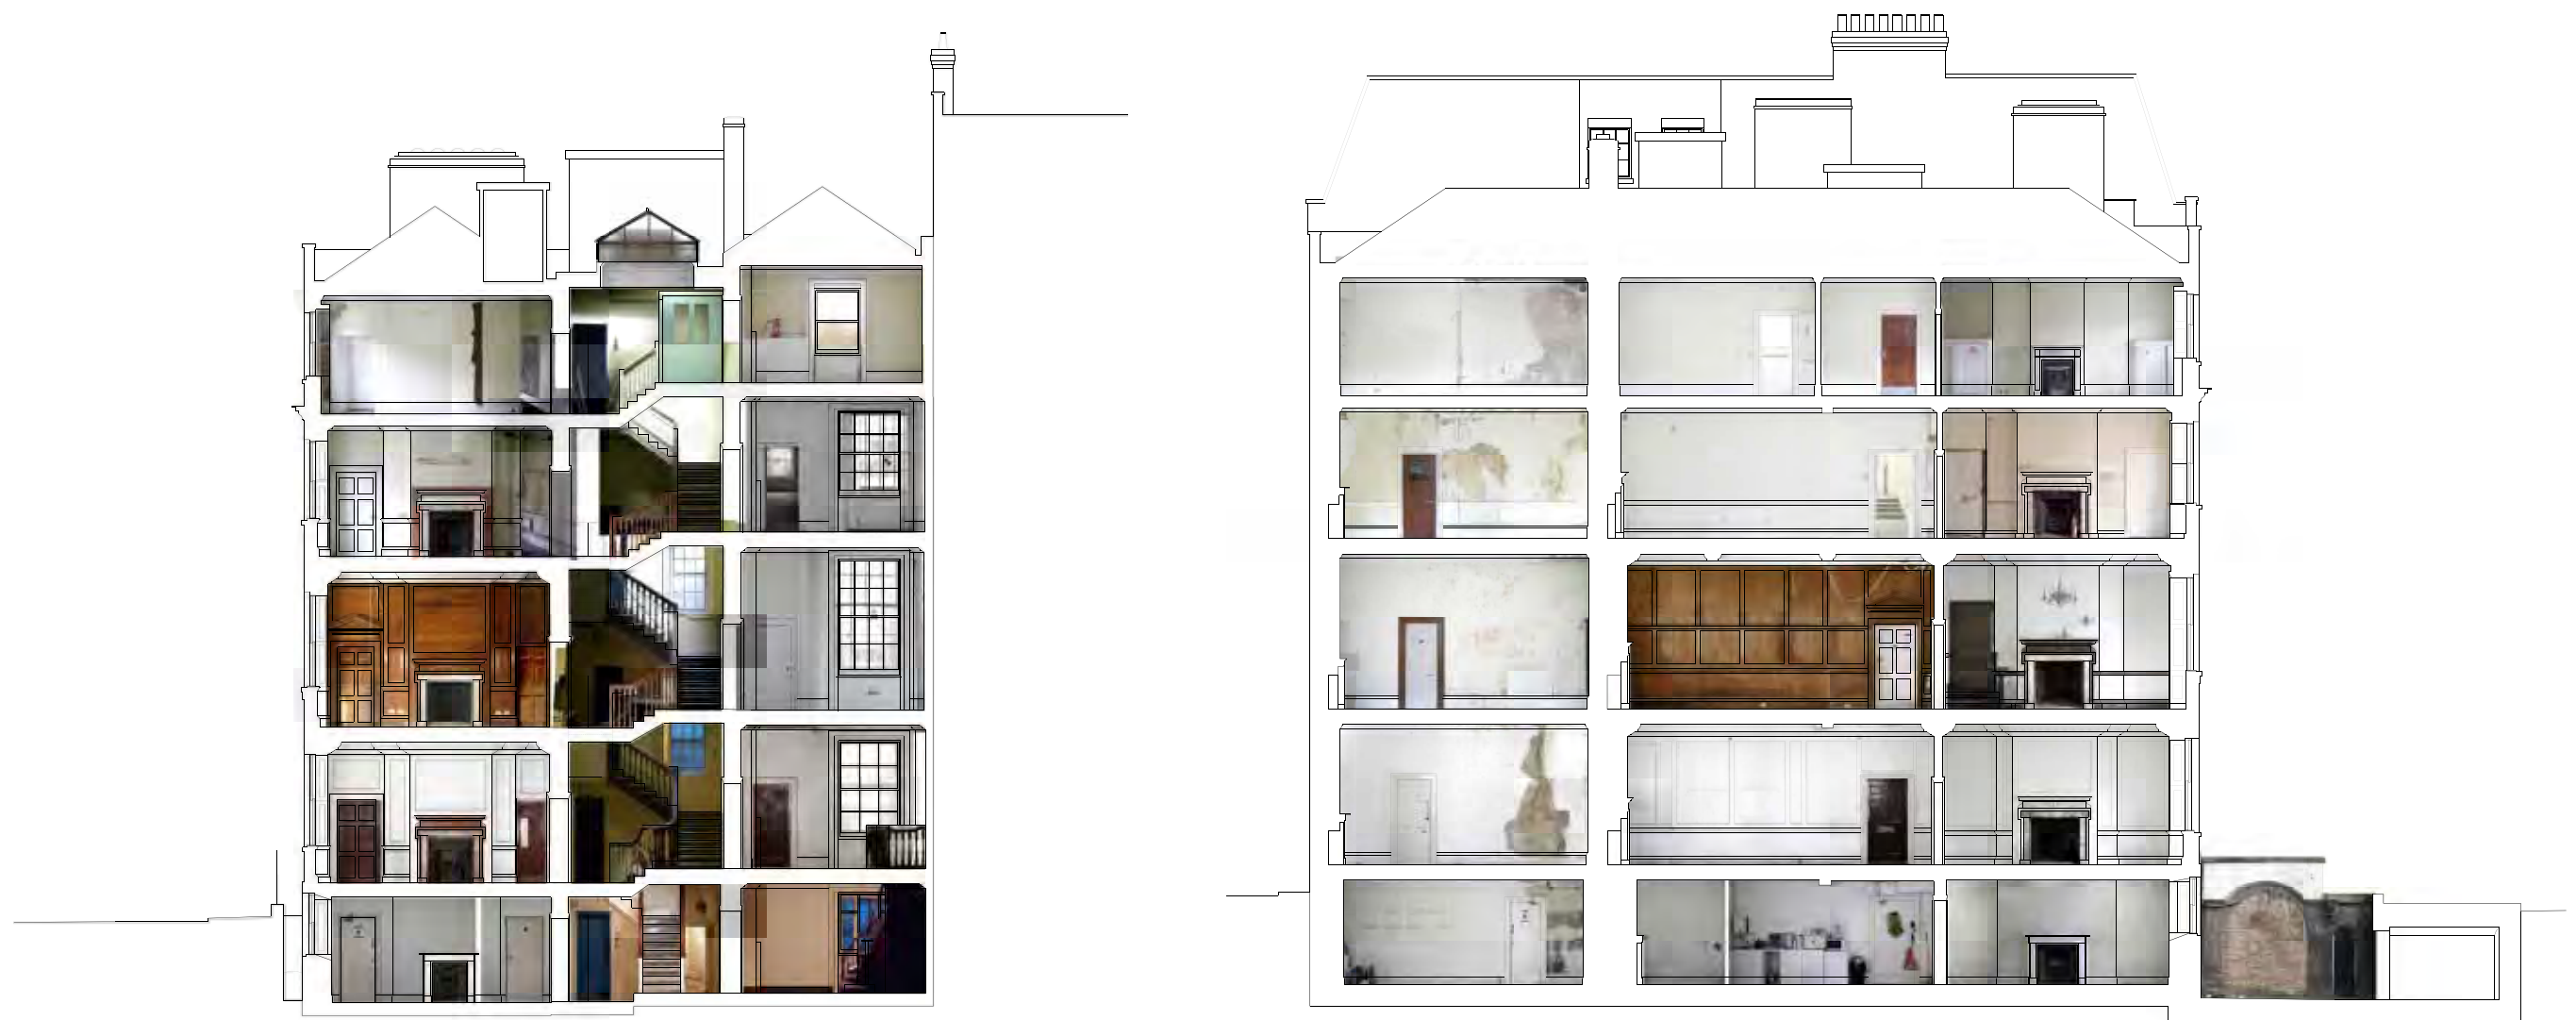
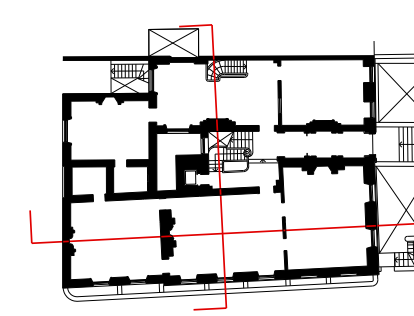
Proposed sections BB and DD showing existing historic interiors, scale 1:200

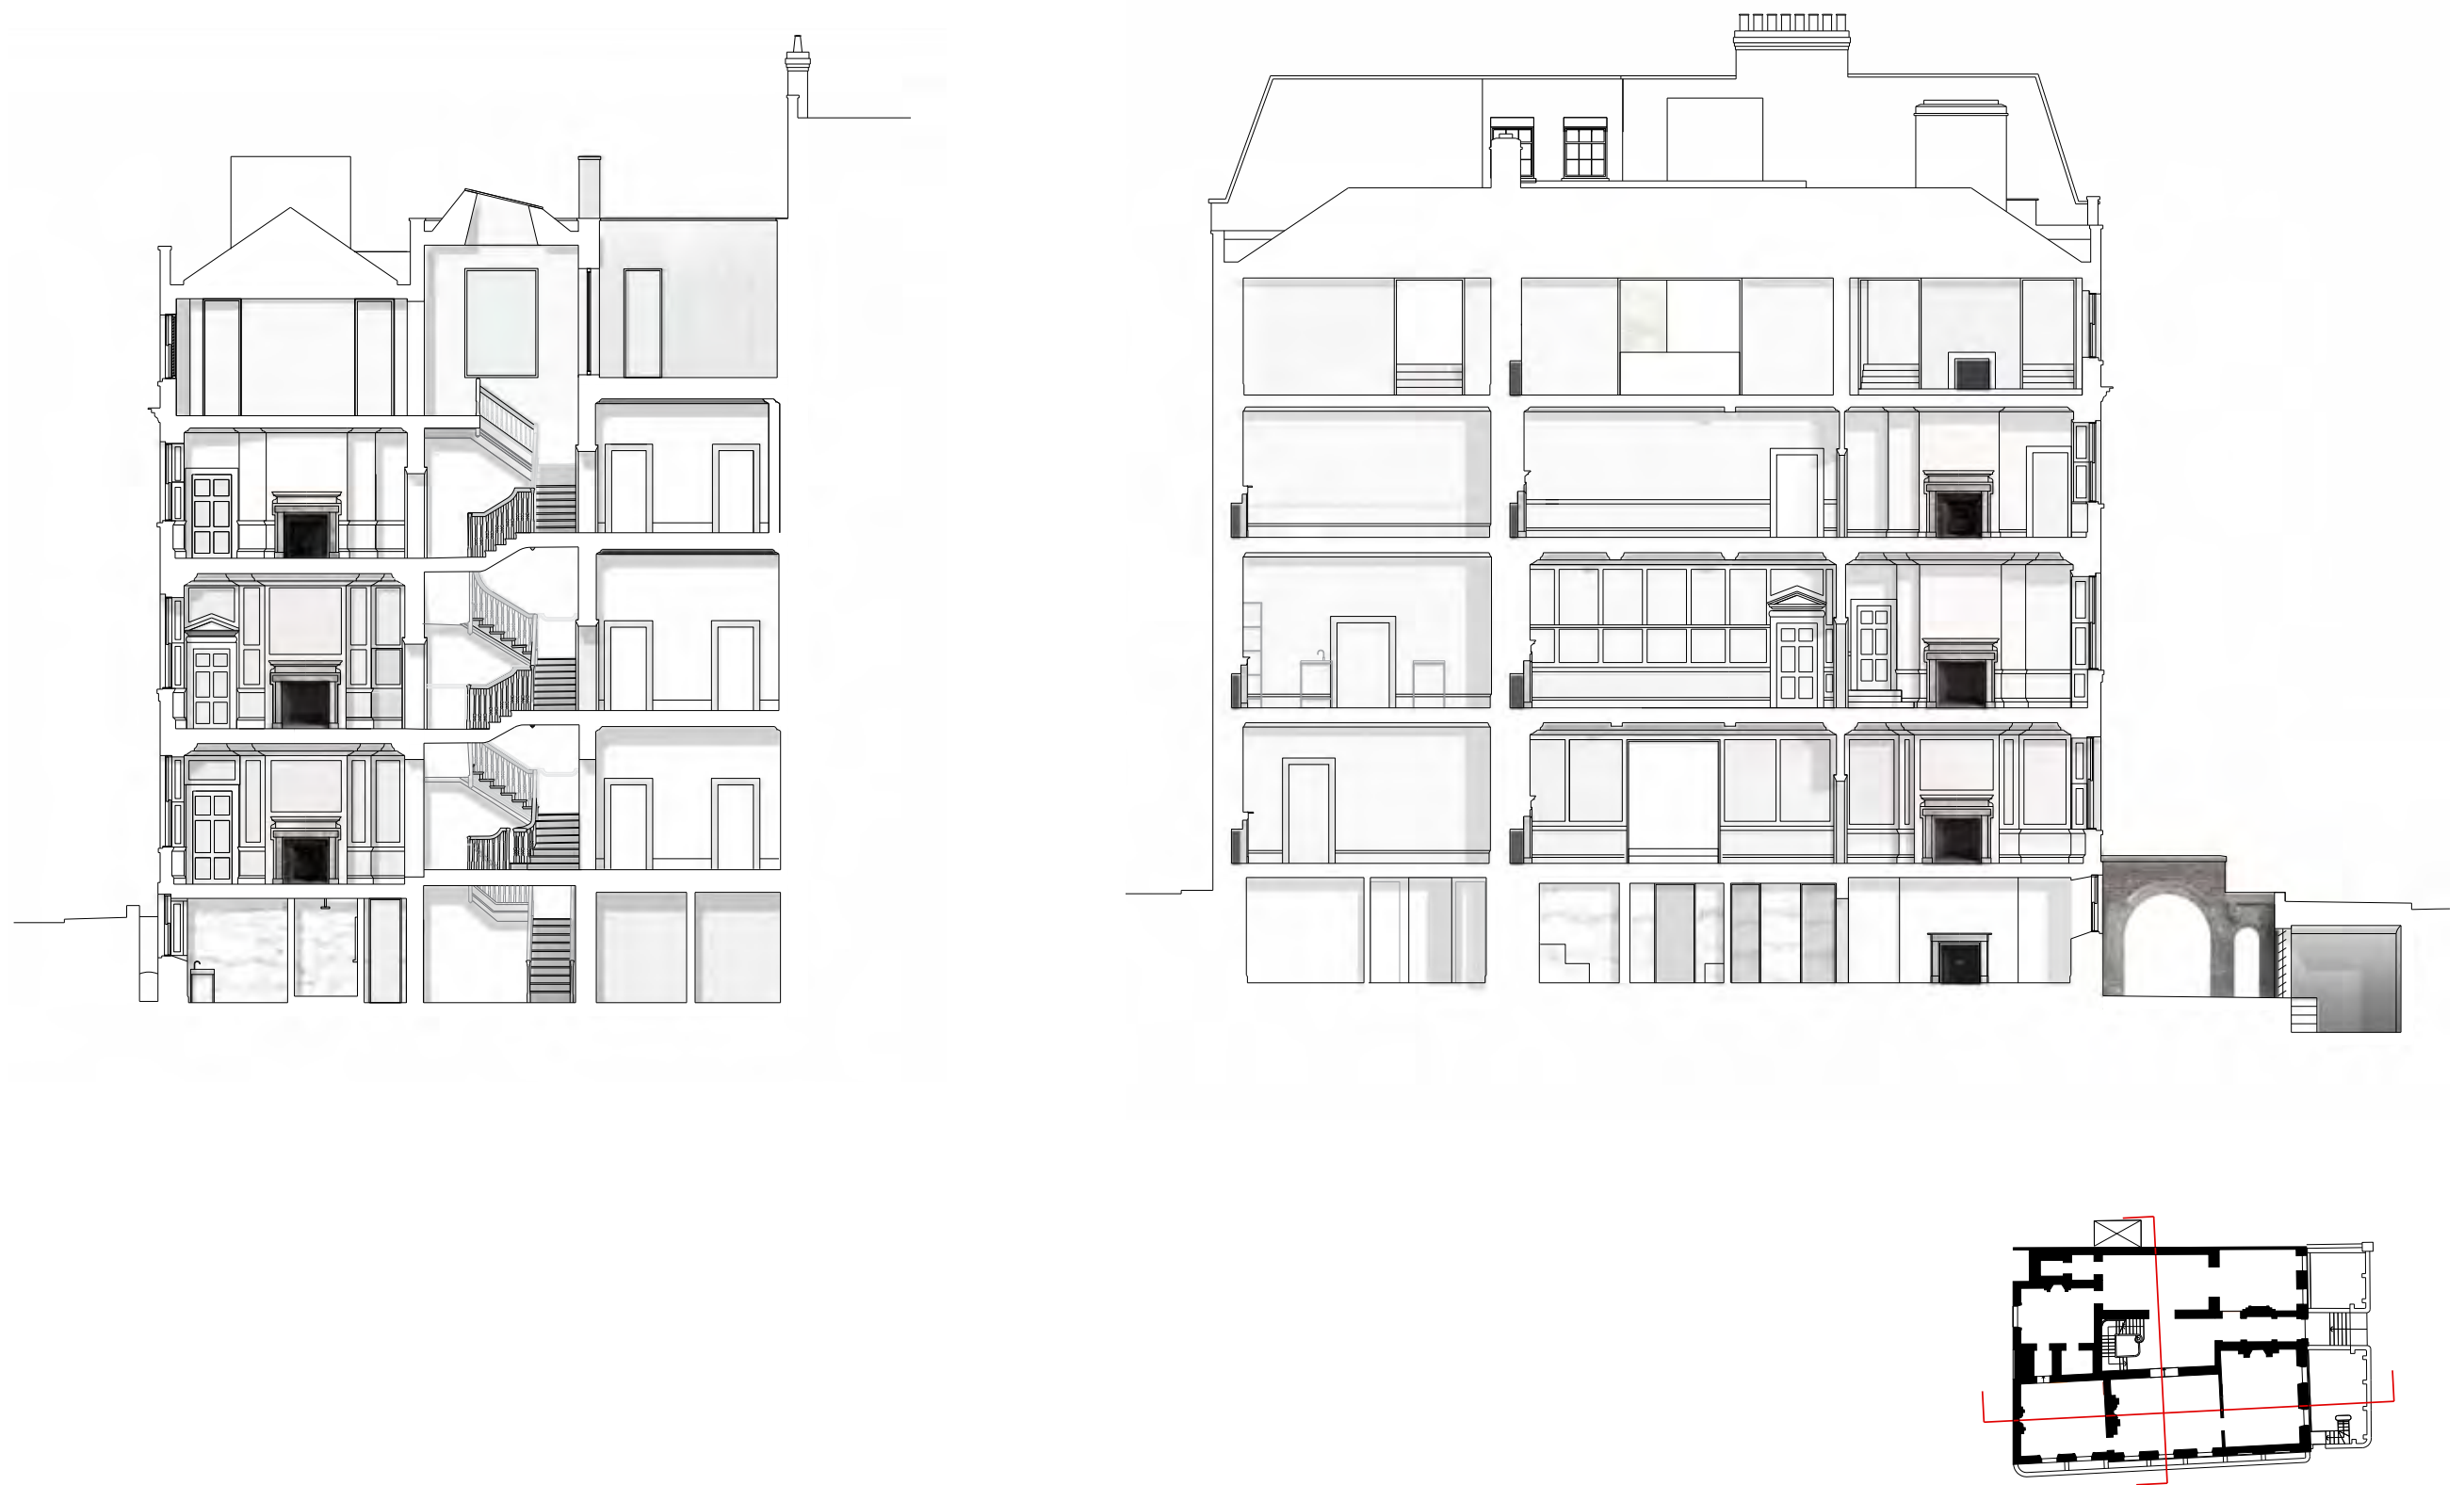
Proposed sections BB and DD showing restored historic interiors,
scale 1:200
