Interior restoration

1-2 LINCOLN'S INN FIELDS

JULIAN HARRAP
 ARCHITECTS LLP

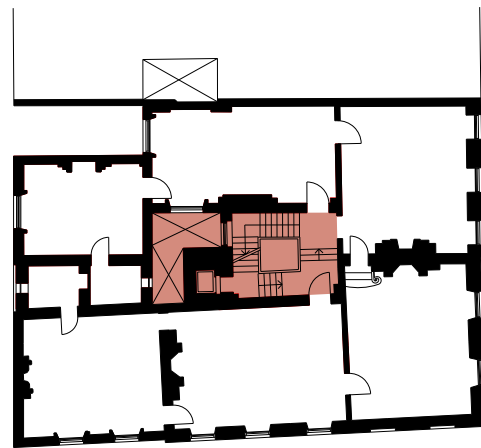
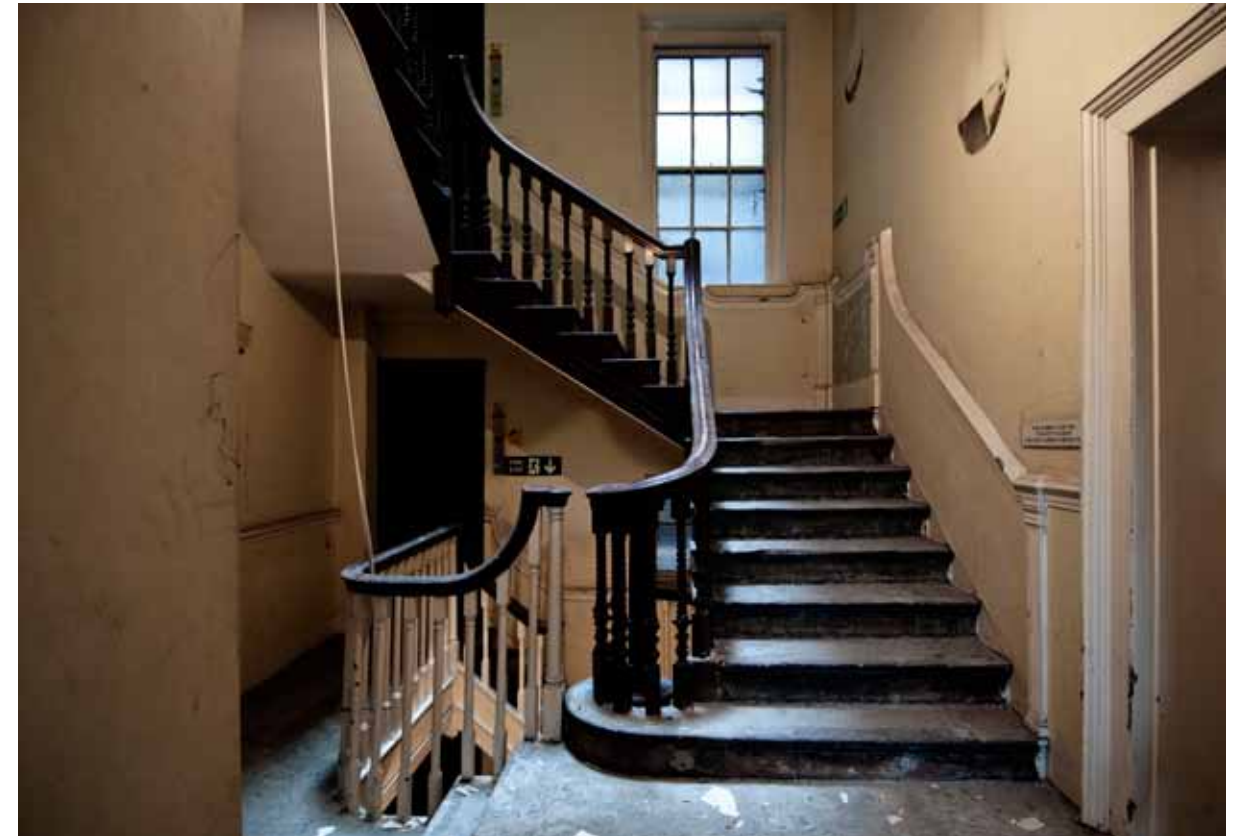
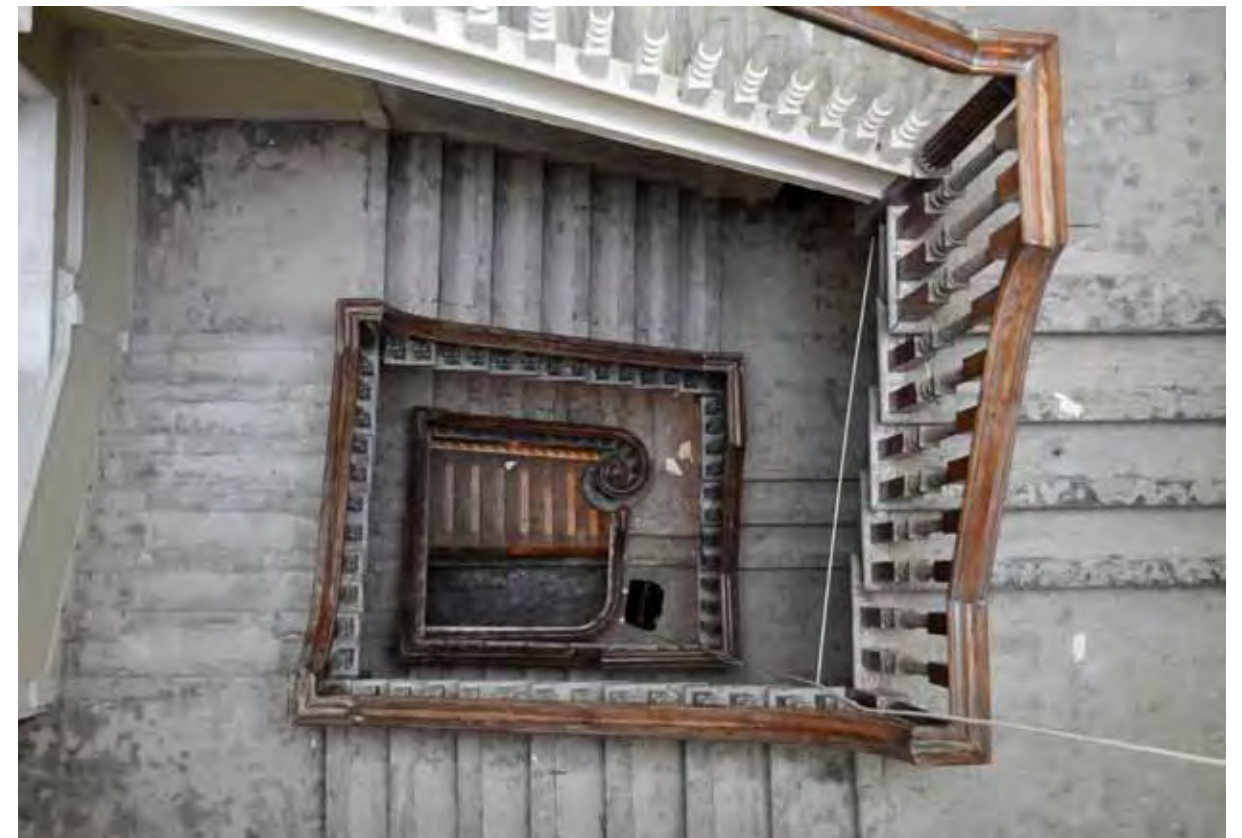
Photographs of the existing staircase

The existing staircase hall is a consequence of the 1840s remodelling of the houses into one property. While it contains elements from the early eighteenth century, it has been moved from an earlier location and incorporates elements from the 1840's and the Edwardian period. In its existing state the stair hall's compact layout allows very little daylight to pass through the well to the floors below. It is also requires careful repair and restoration work.

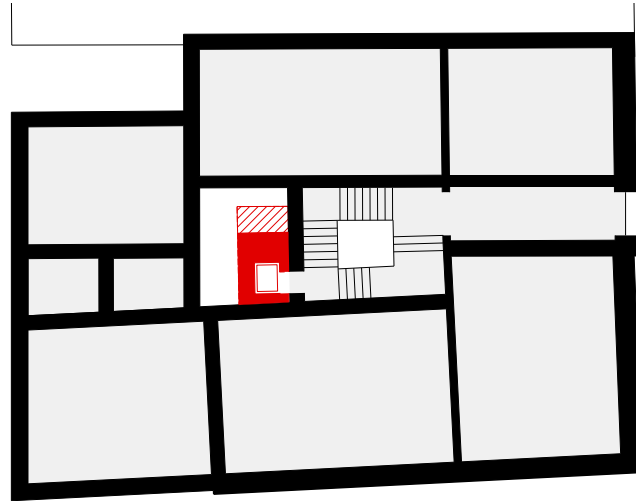
1. Lift removed from light well

Diagrams illustrating proposals to improve daylight spread and openness within existing stairhall

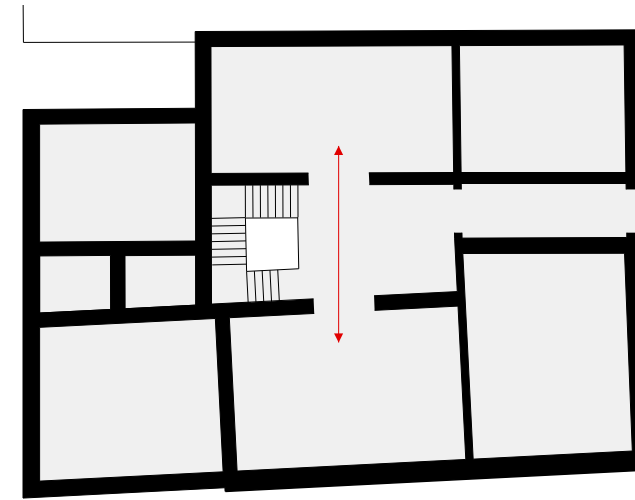
3. Groundfloor staircase repositioned in enlarged stair hall

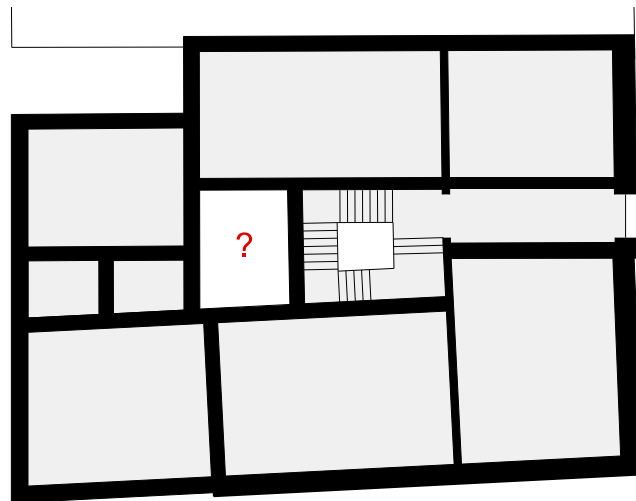
2. Light well remaining

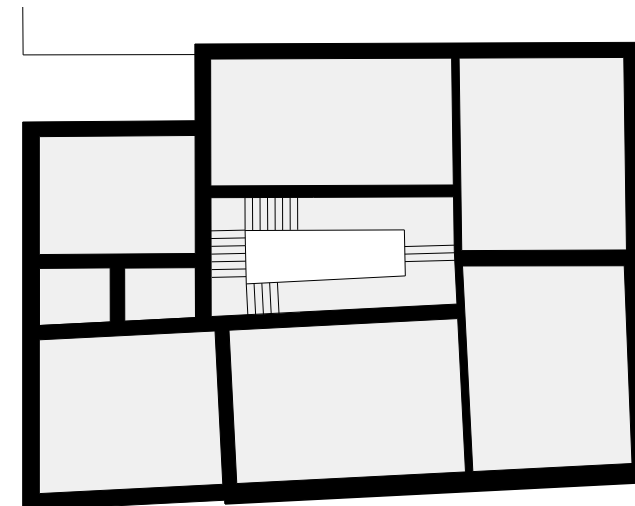
4. Staircase extended on all floors

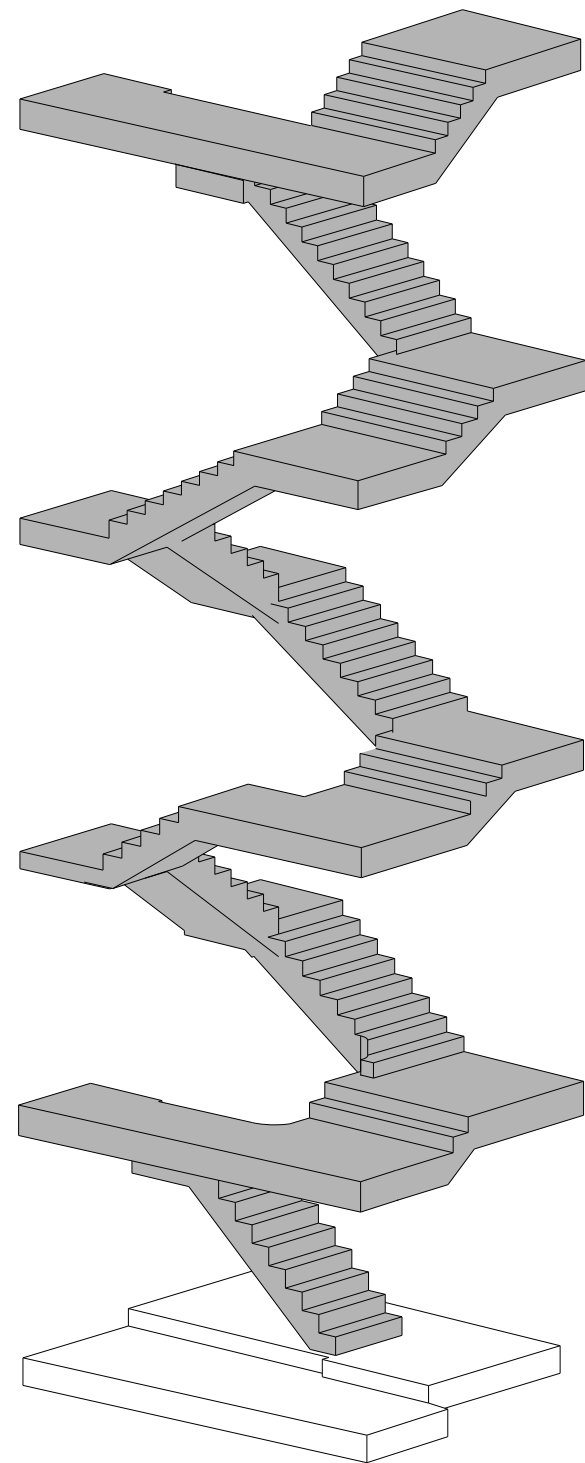
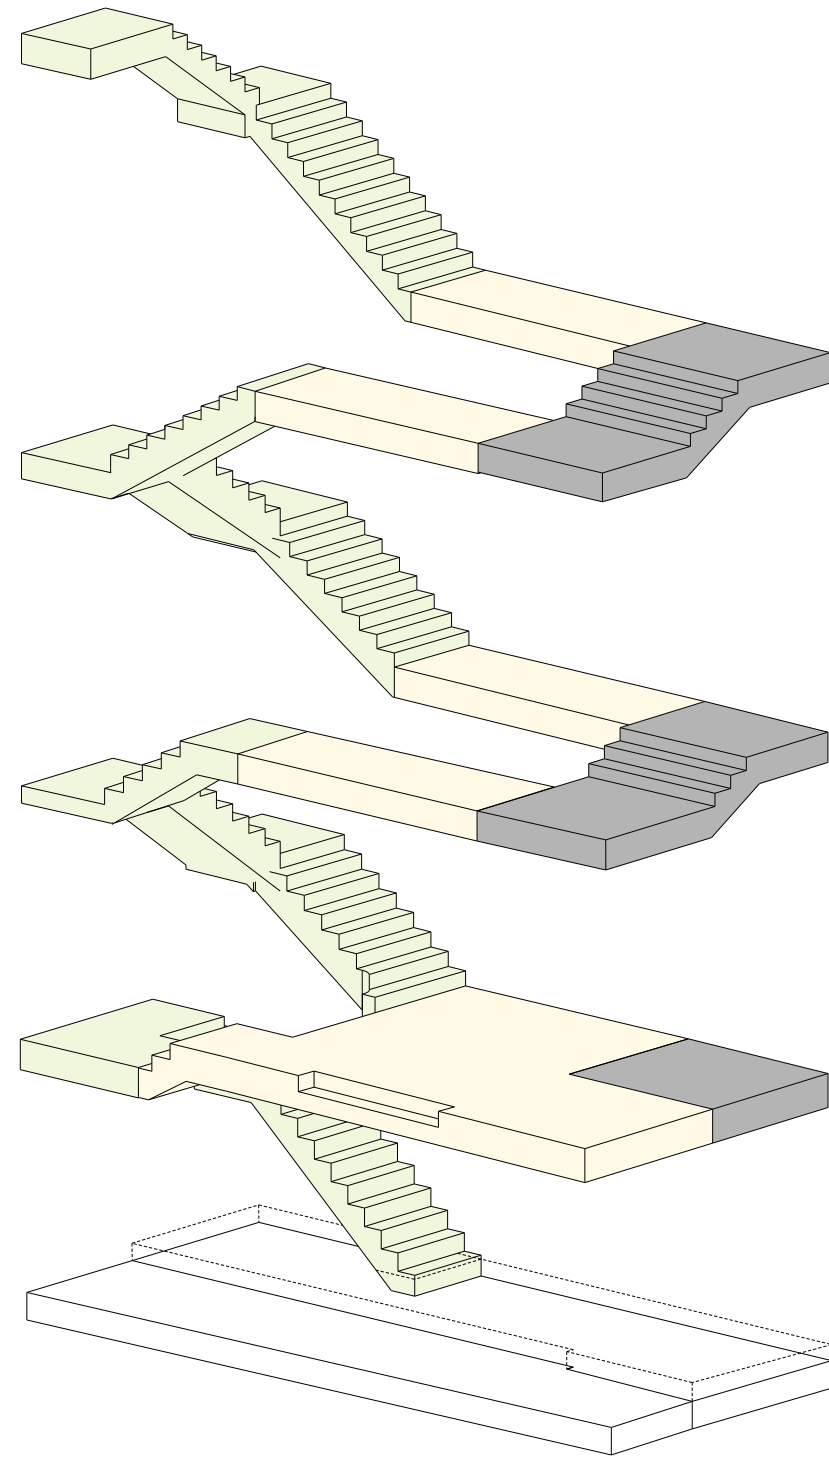
- retained
- dismantled and reconstructed
- new

Axonometric diagrams showing existing and reconfigured stairs

This application proposes the removal of the north wall of the existing staircase hall, including the lift shaft the formation of a more generous hall from the lightwell and existing staircase enclosure. The existing staircase, including the balustrade, handrail and dado-height panelling on the adjacent walls will be reused in the proposed scheme. The staircase will form an open well staircase which will provide the house with a top-lit, bright, pivotal space that will complement the scale of the re-worked house. The existing staircase would be carefully dismantled into its components, repaired and re-assembled into a similar configuration on the new north wall. New landing sections will be required to extend the staircase around the perimeter walls; it is proposed that these sections of balustrade follow the Edwardian precedent of modifications and match the pattern of the turned standards and handrail.

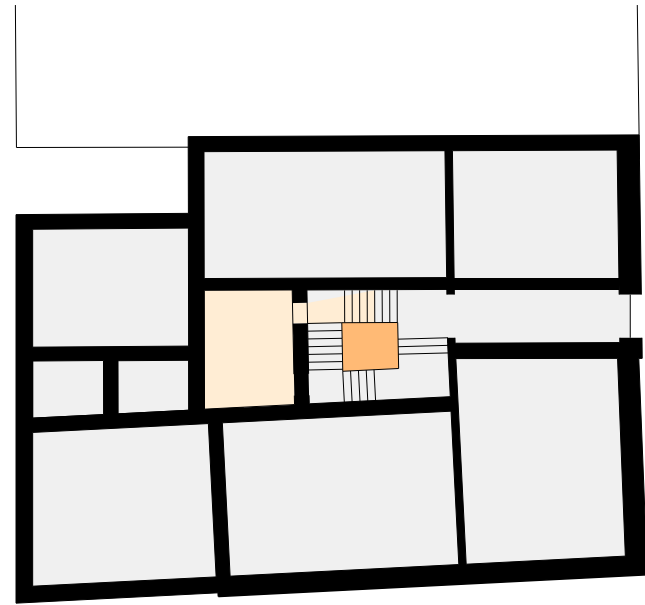
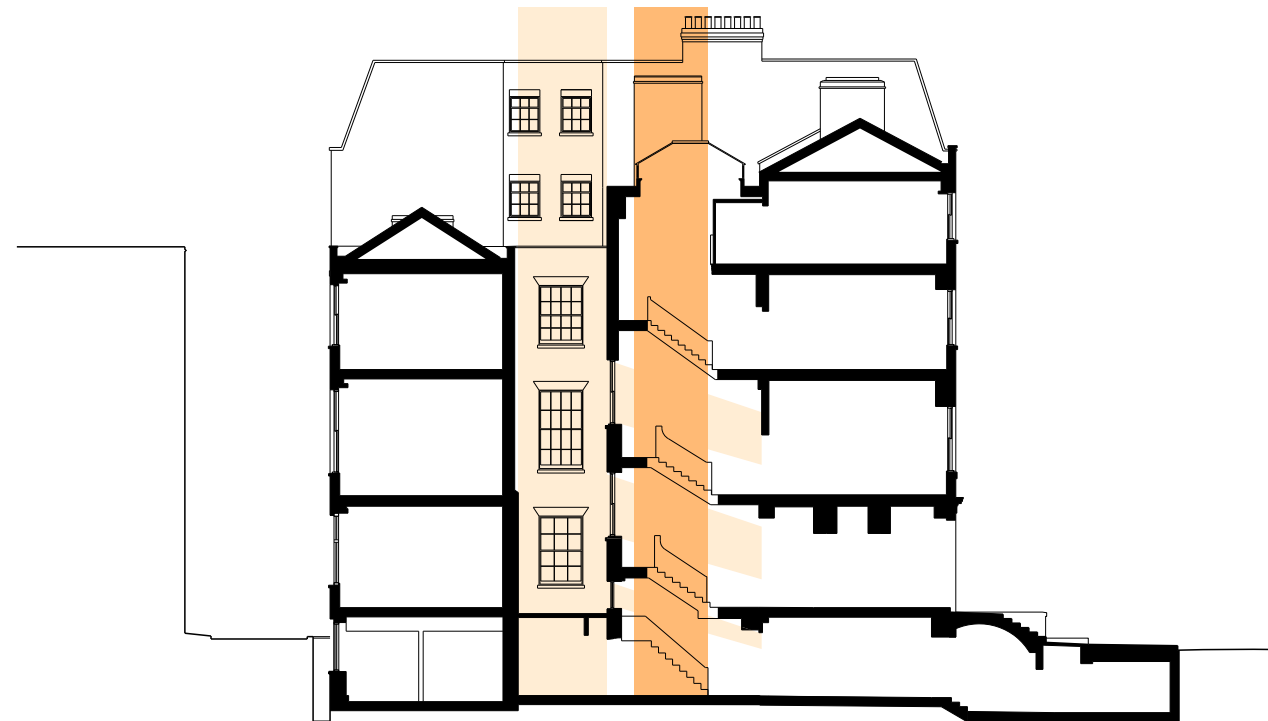
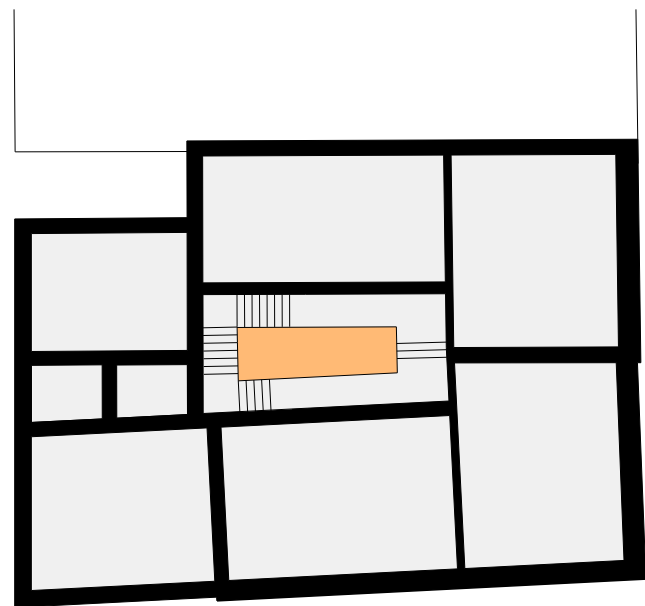
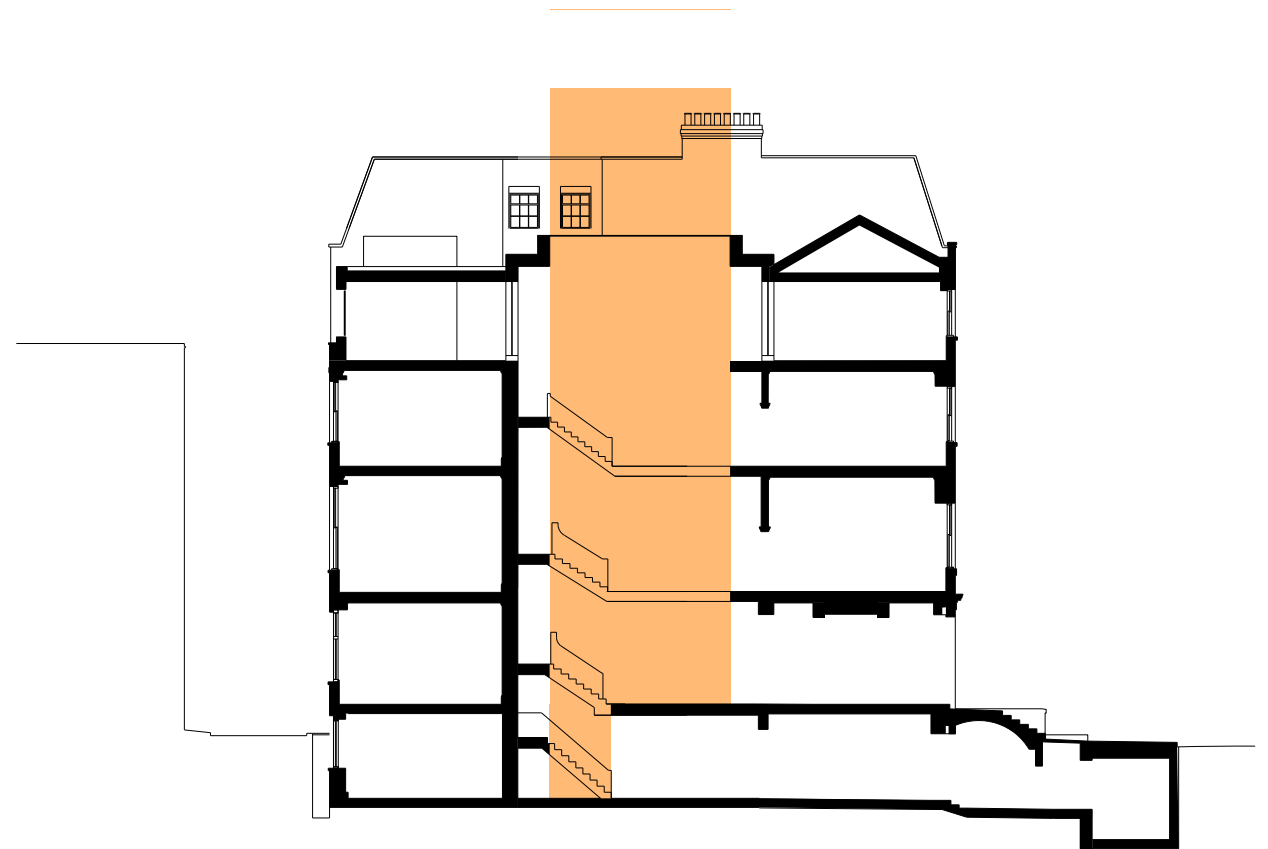
indirect light
 direct light

Diagrams showing existing stair hall daylighting and improved condition in proposal

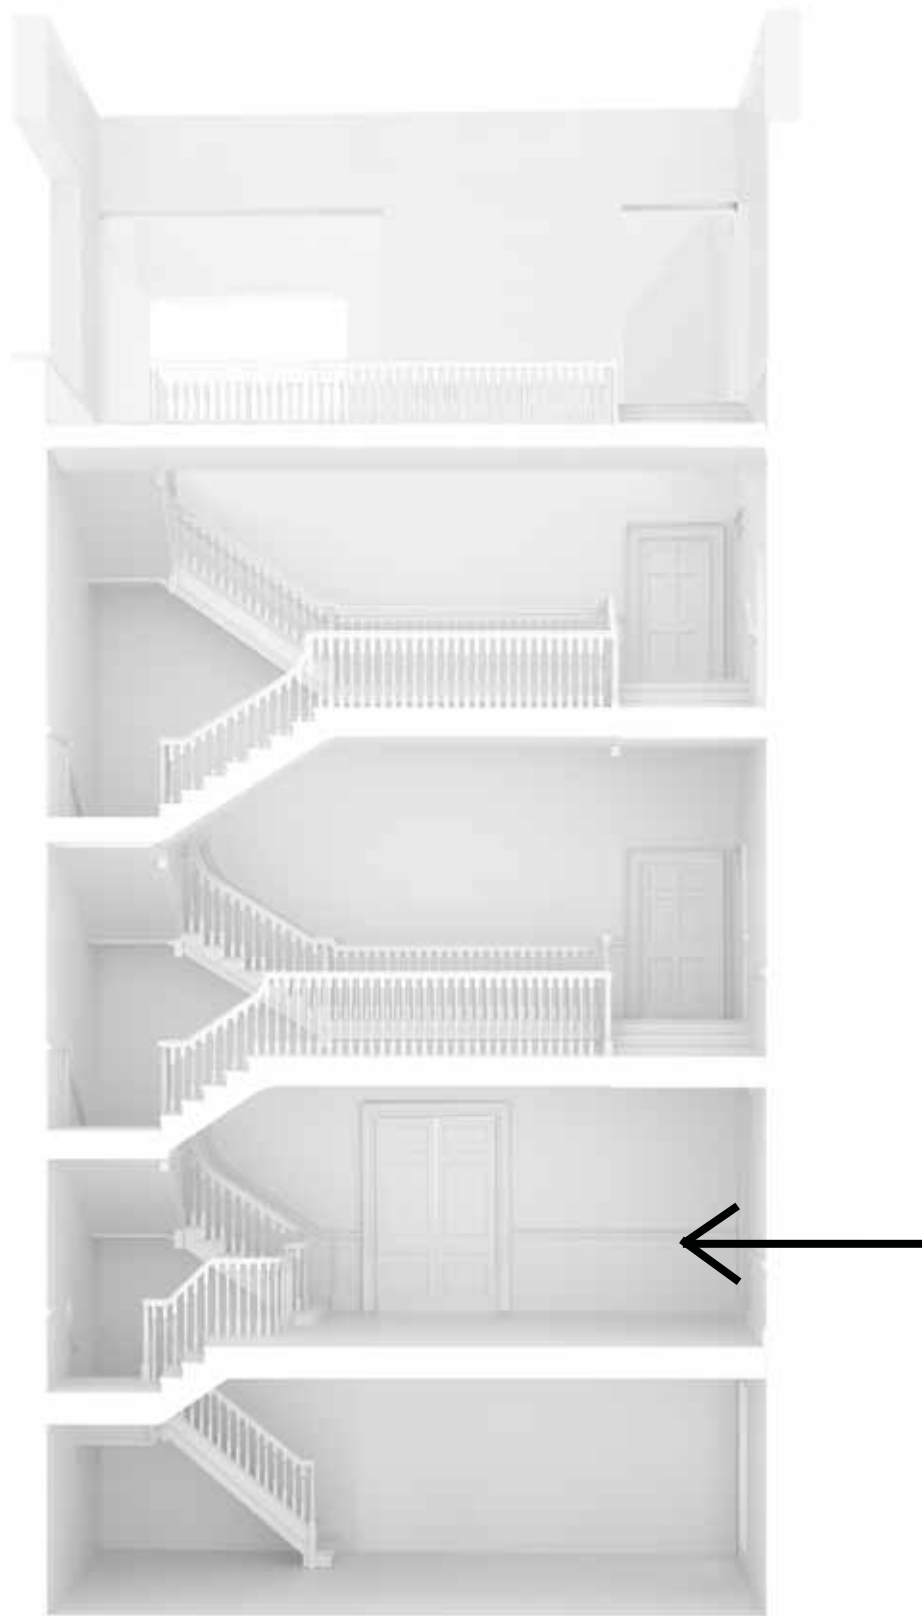
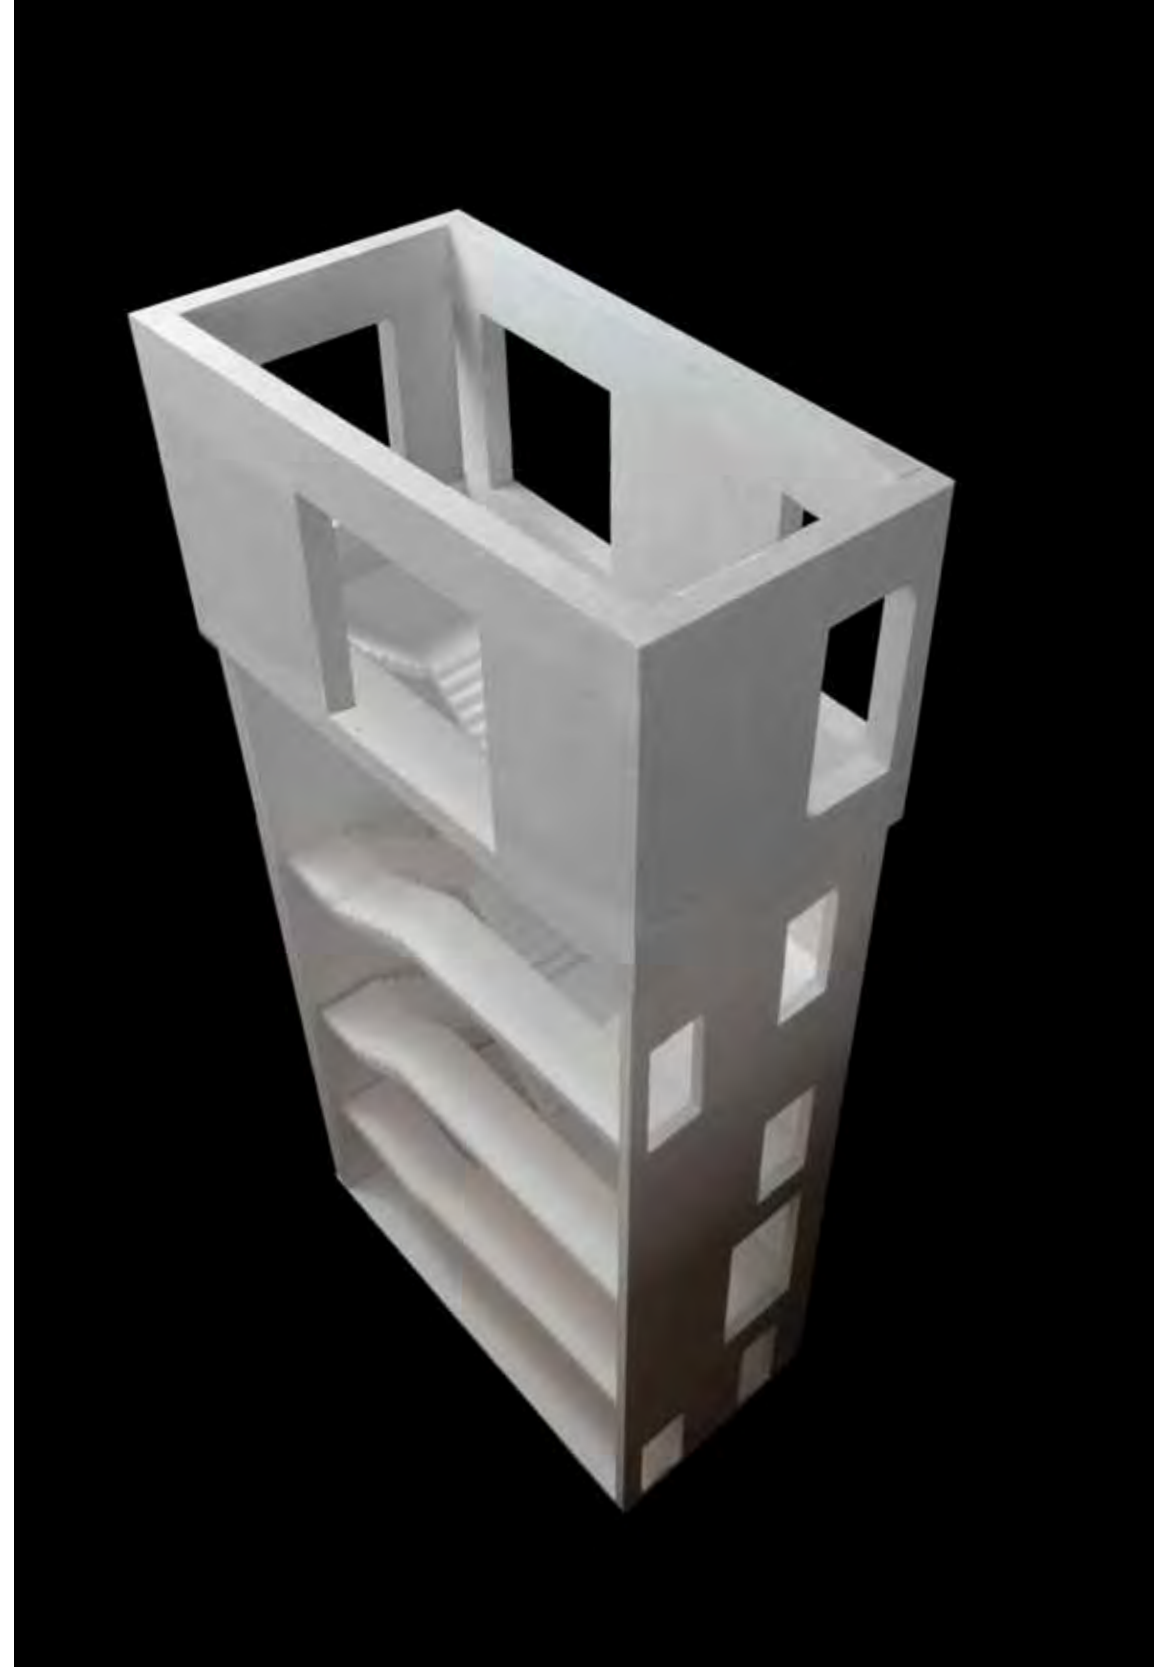
Sectional perspective and model photograph of enlarged stairhall

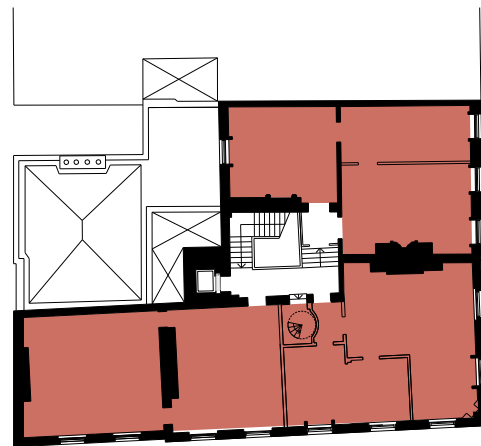
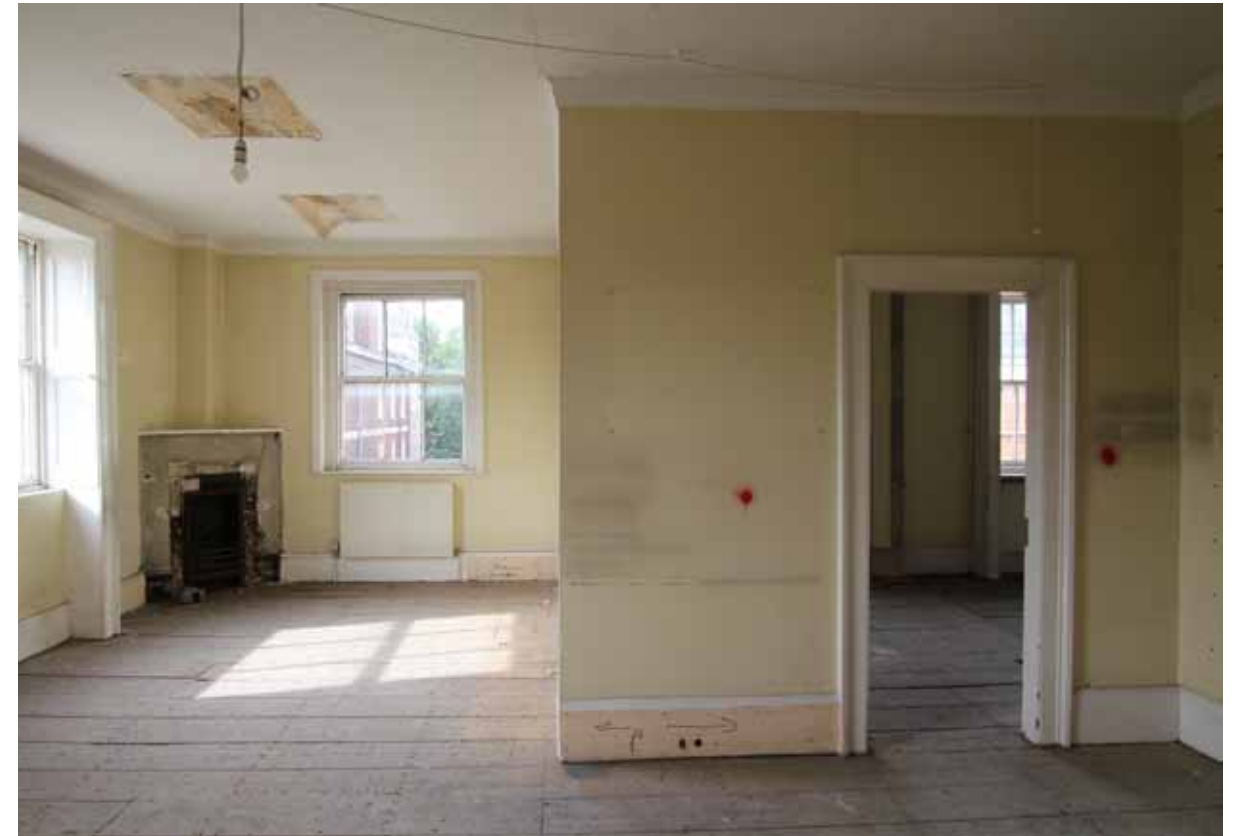
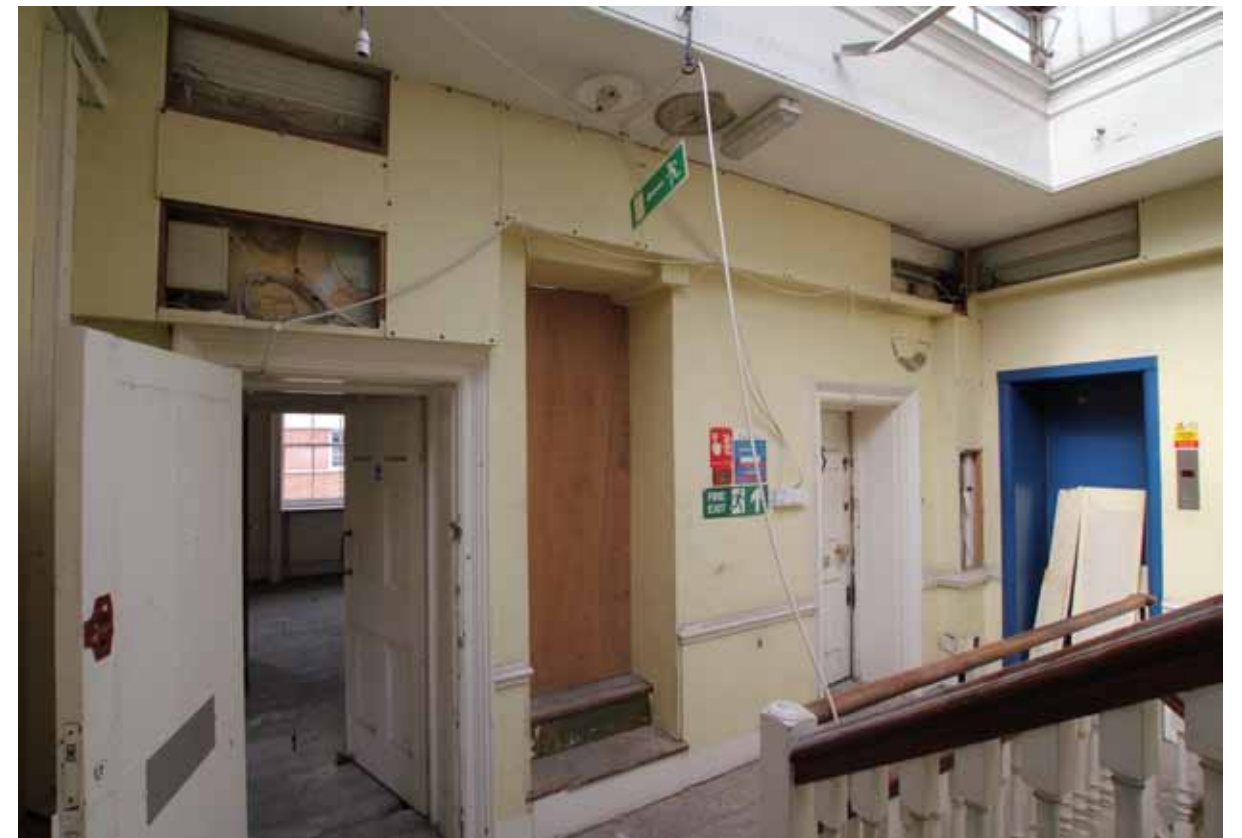
Photographs of the existing third floor

The rooms on the third floor of 1-2 Lincoln's Inn Fields survive as a series of small spaces with various alterations and interventions to adapt them to their use as legal offices during the 19th and 20th centuries.

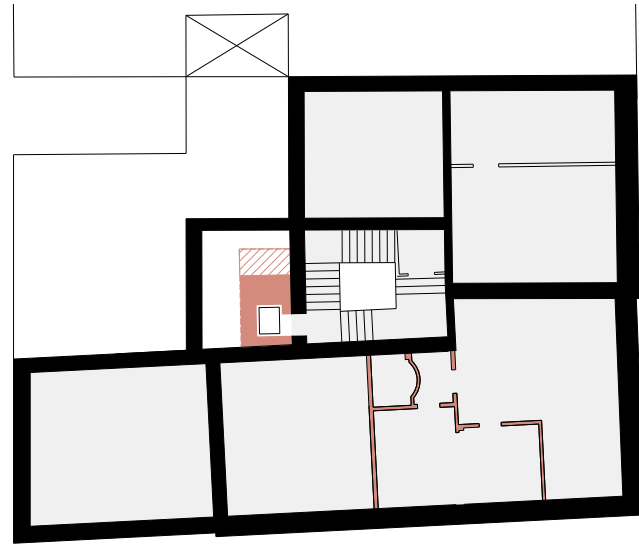
1. Existing third floor

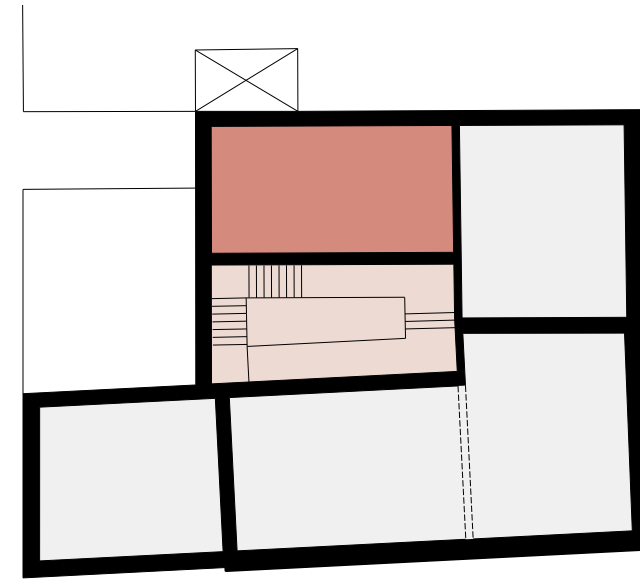
3. Plan to match lower floors

In reflection of this lower status of significance the proposals for the third floor are slightly more radical than the lower floors. In the spirit of the proposal for general repair and resolution of compromised situations within the house the intention is to 'complete the plan' of this floor, removing secondary partitions and extending over the rear room of No.2.

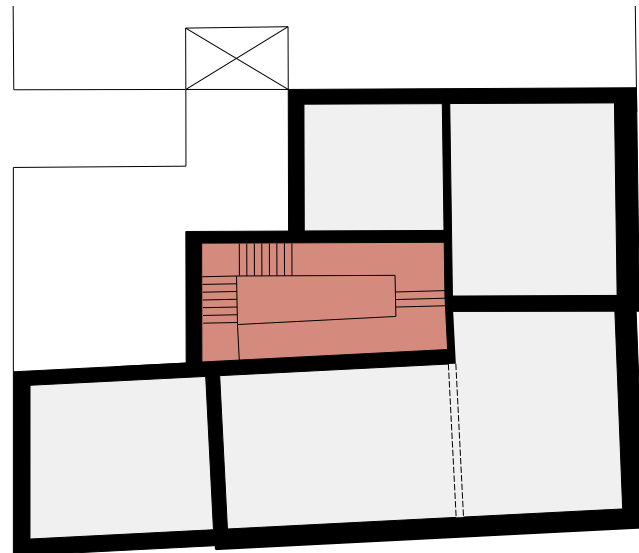
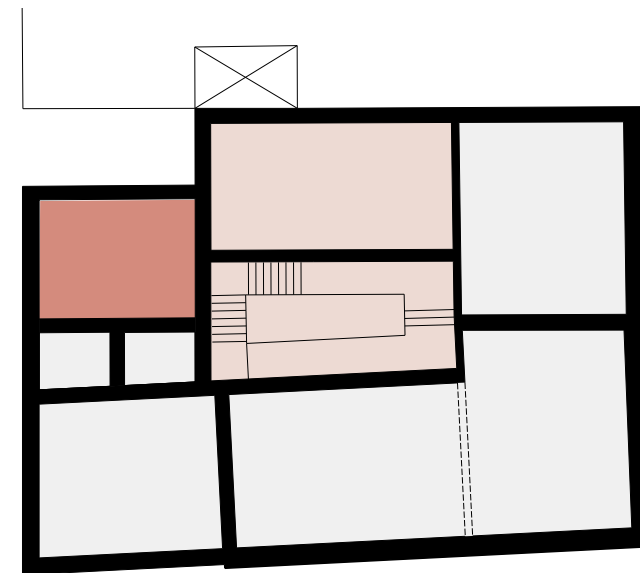
2. Staircase extended, lightweight partitions removed

4. Plan form completed

Diagrams illustrating proposals to enlarge rooms and resolve plan form of third floor by extending over the rear of No.2

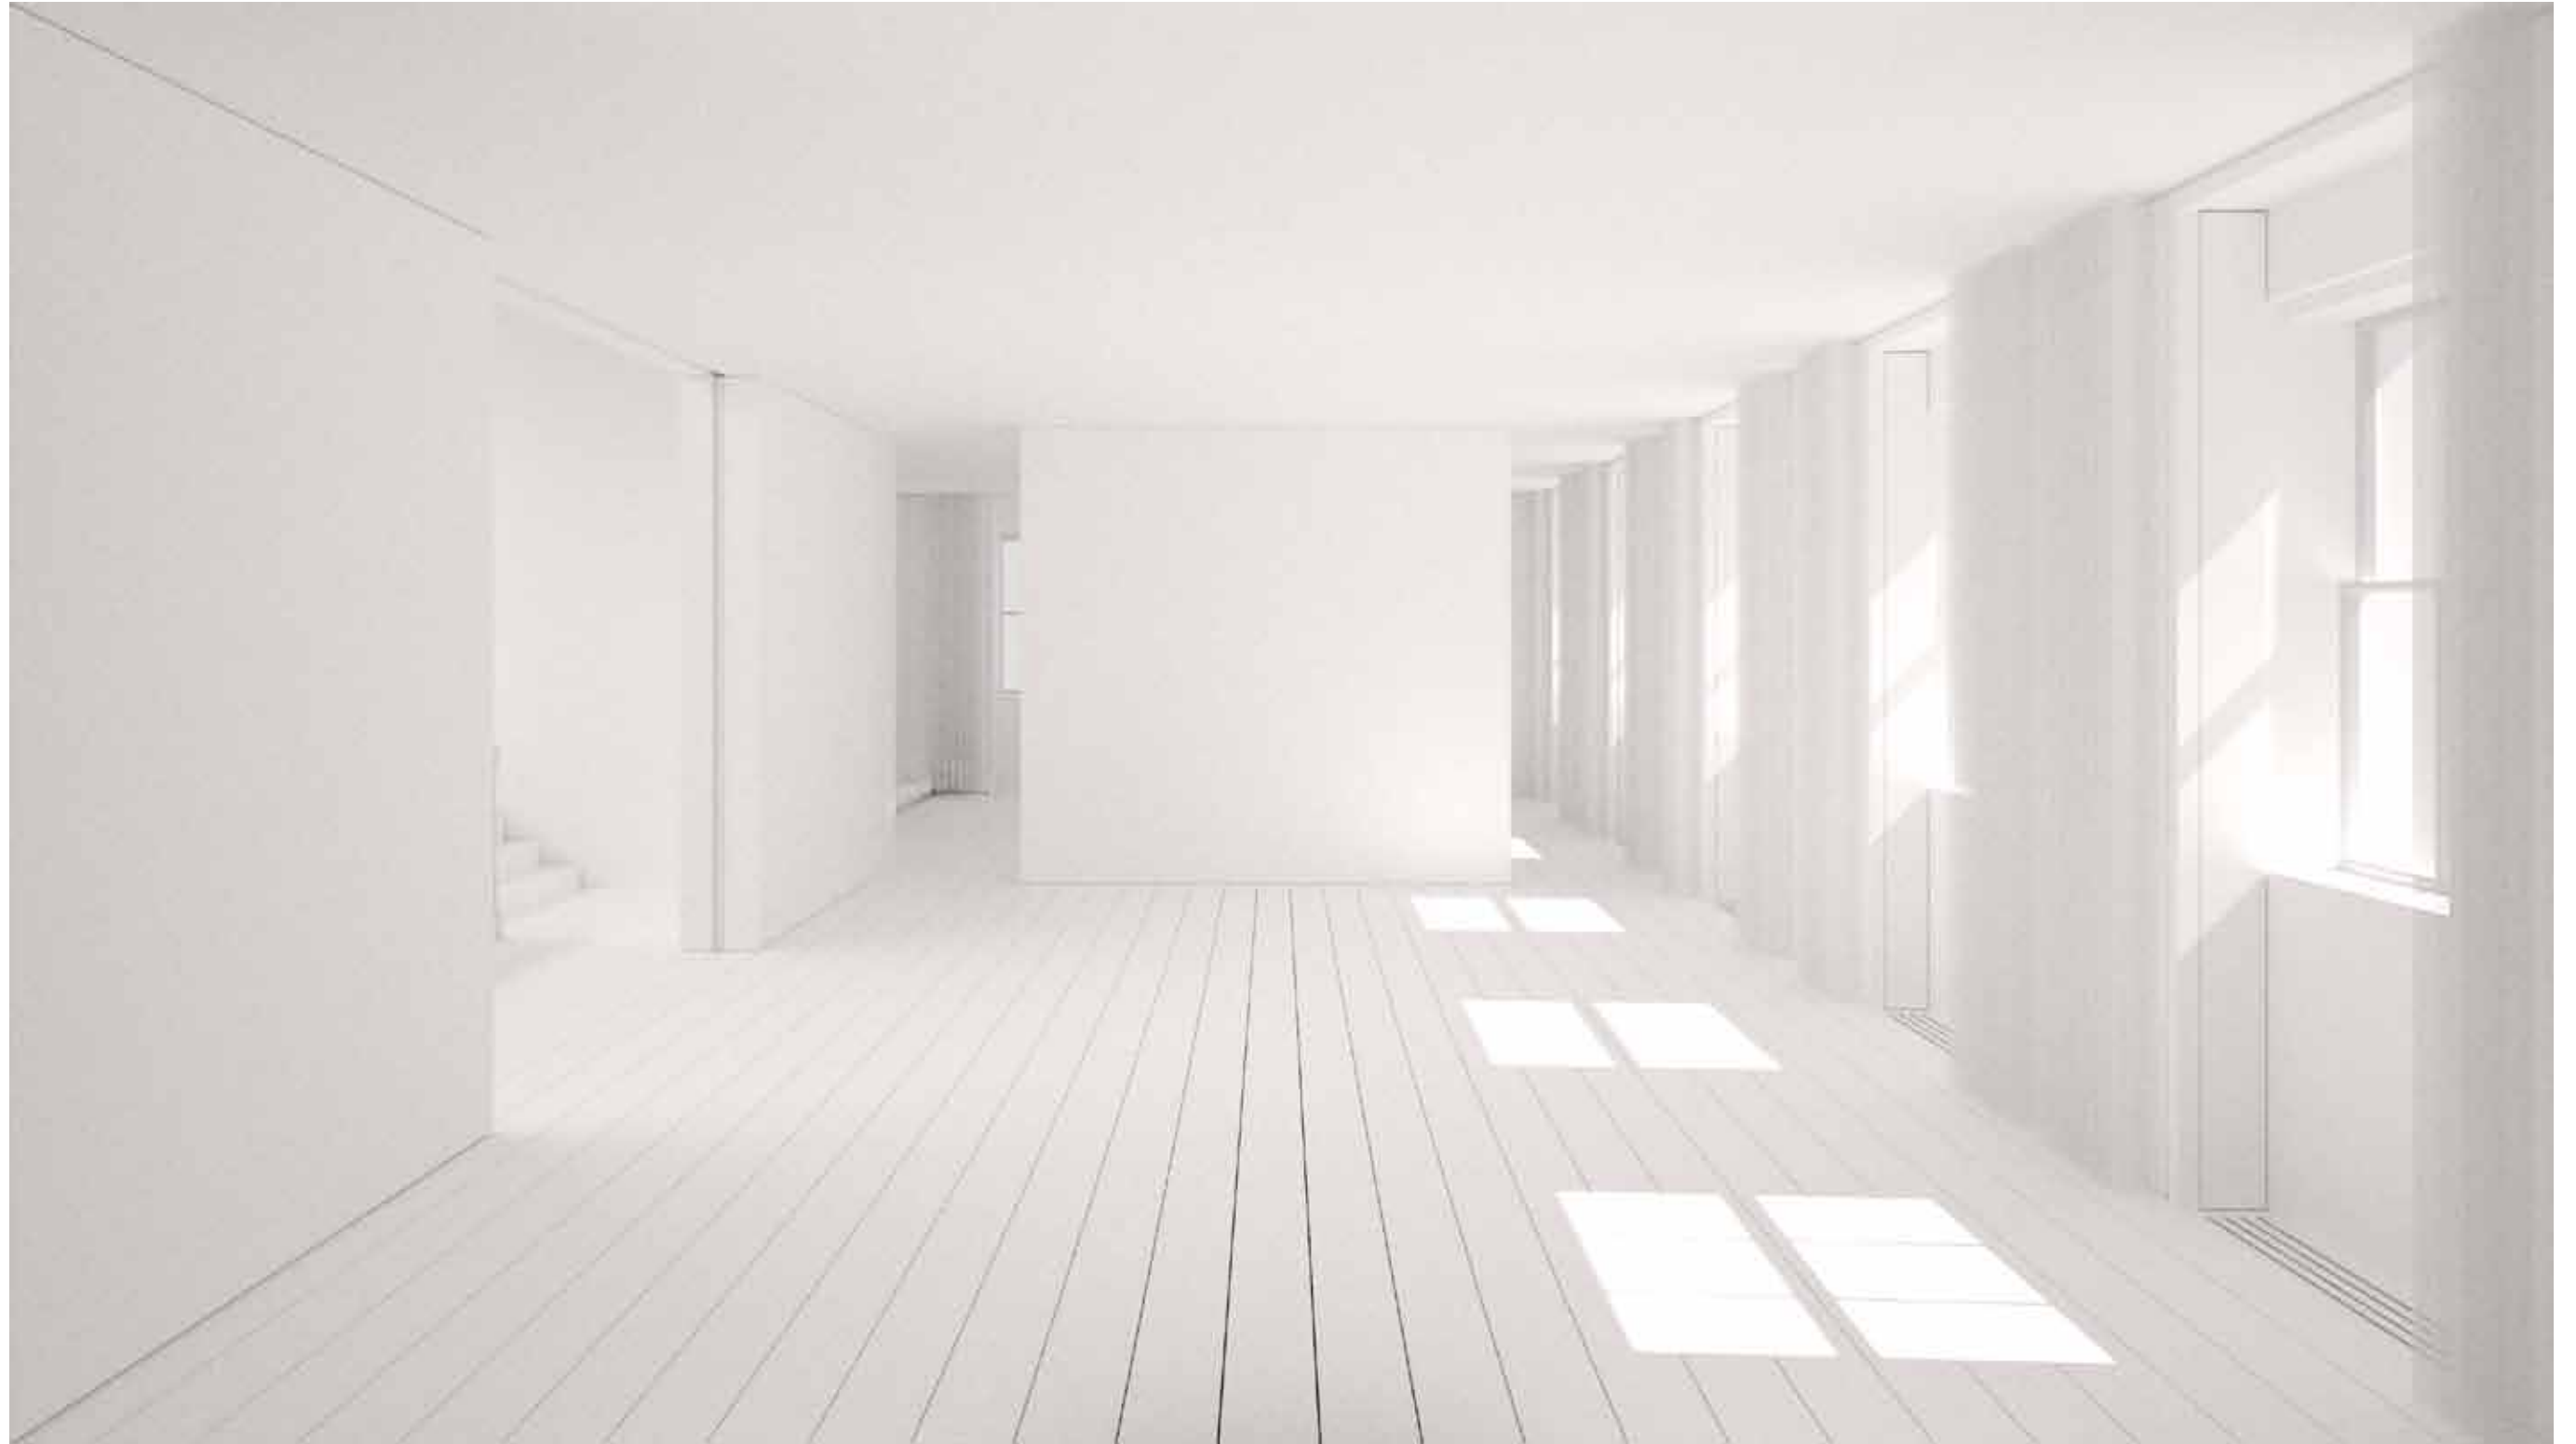
Visualisation of proposed third floor (room 302 looking south)

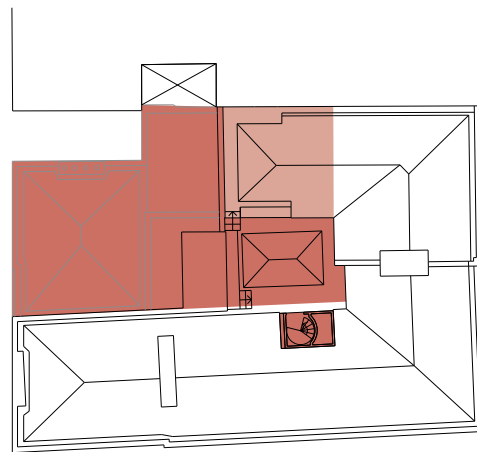
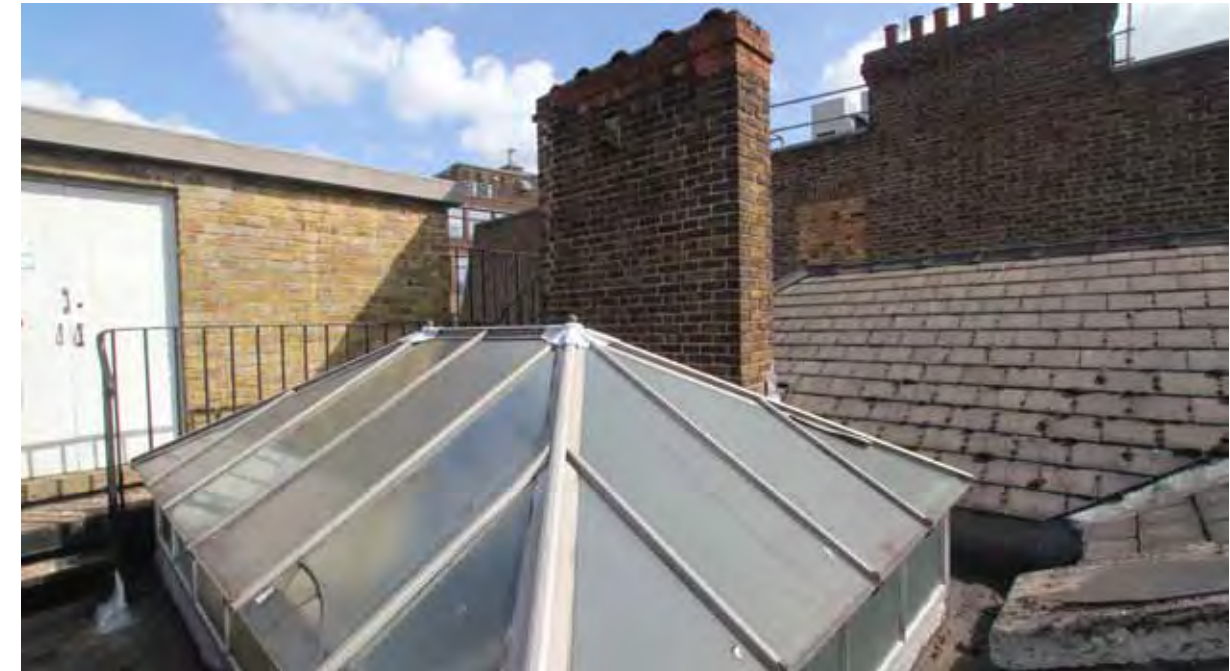
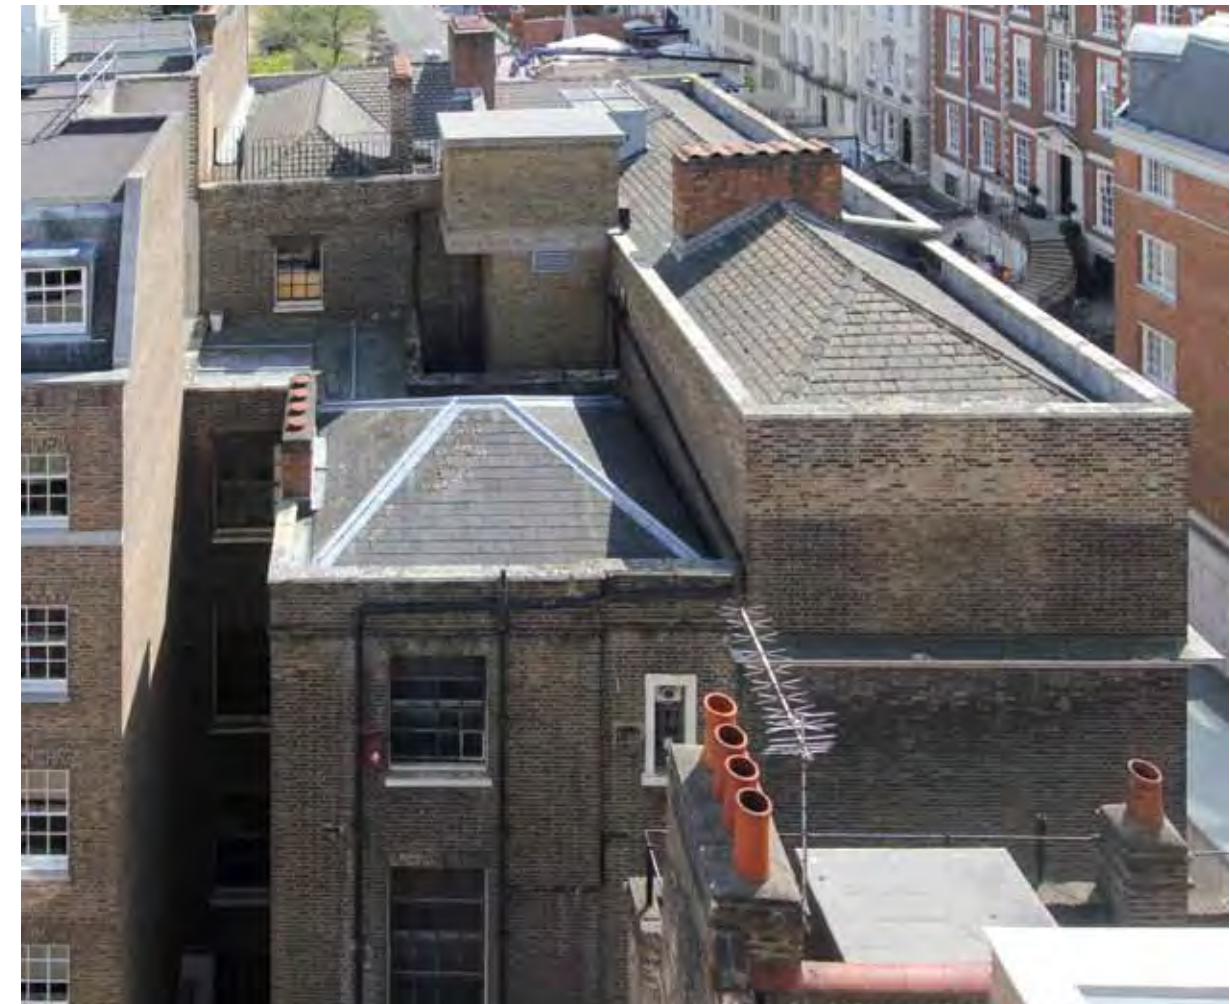
Photographs of the existing roofscape

In its current state the existing roofscape is formed of a collection of slate covered pitched roof elements which were reconstructed in the late 19th century with newer 20th century additions of the lift motor room and roof access box. None of the finishes on the roof are original and currently the drainage/gutter system functions poorly leaking into the house on a regular basis.
