Interior restoration

1-2 LINCOLN'S INN FIELDS

JULIAN HARRAP
 ARCHITECTS LLP

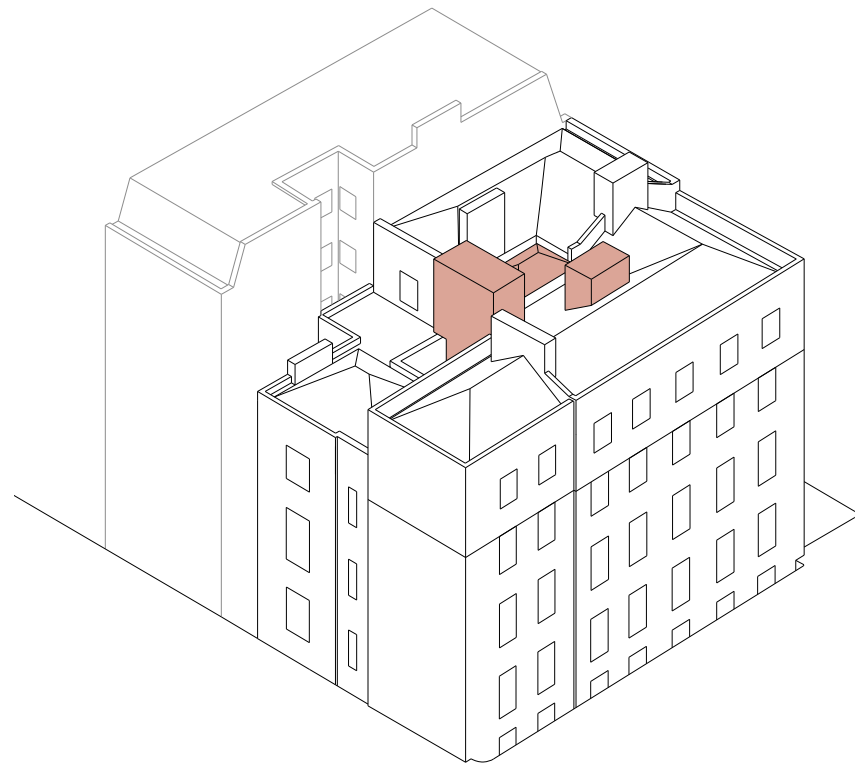
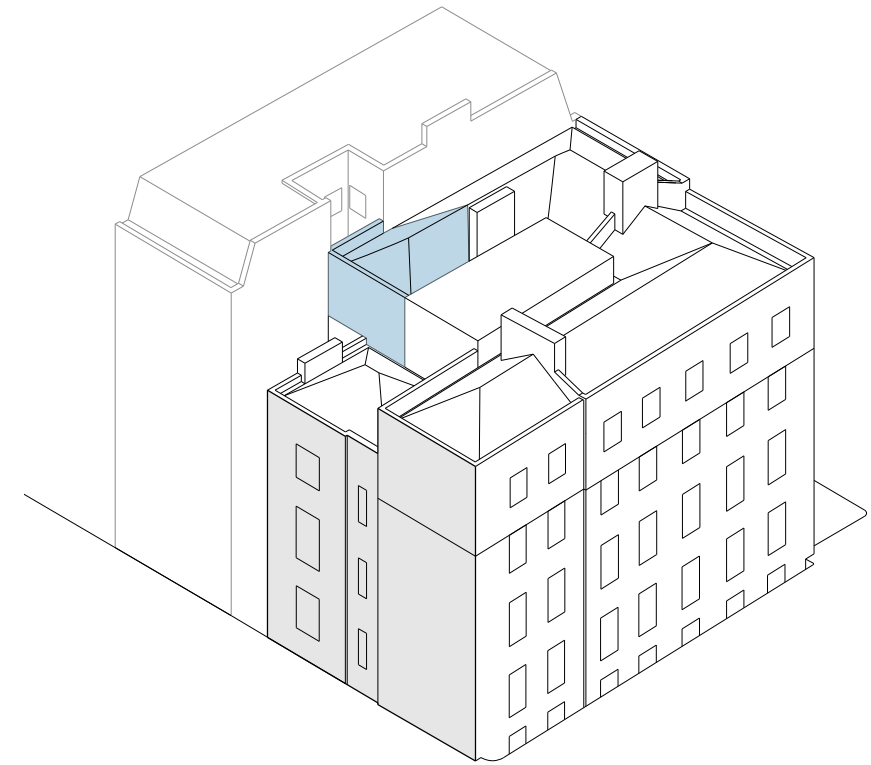
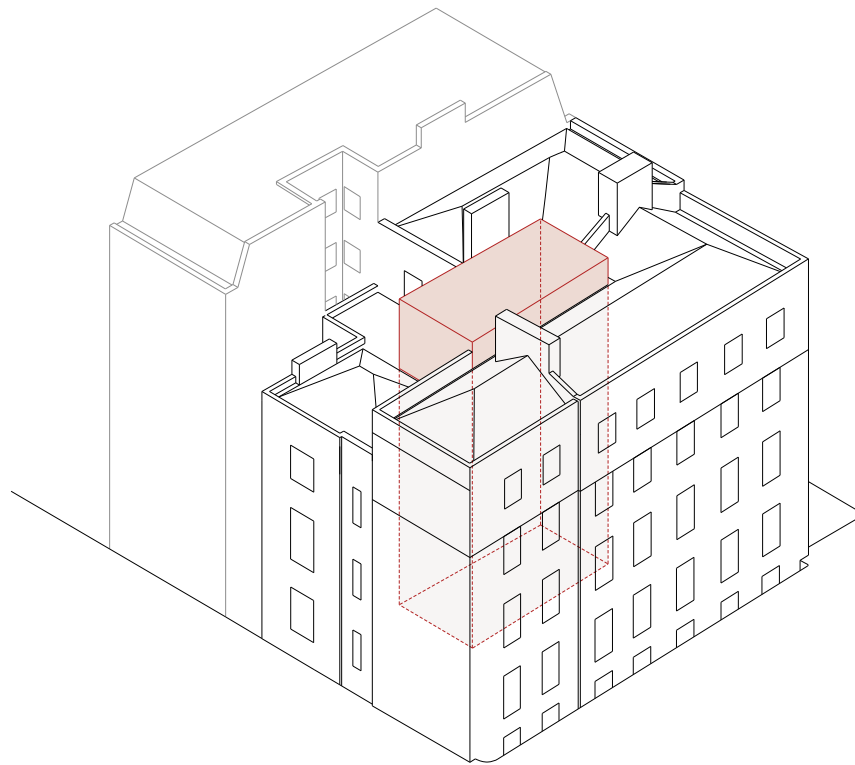
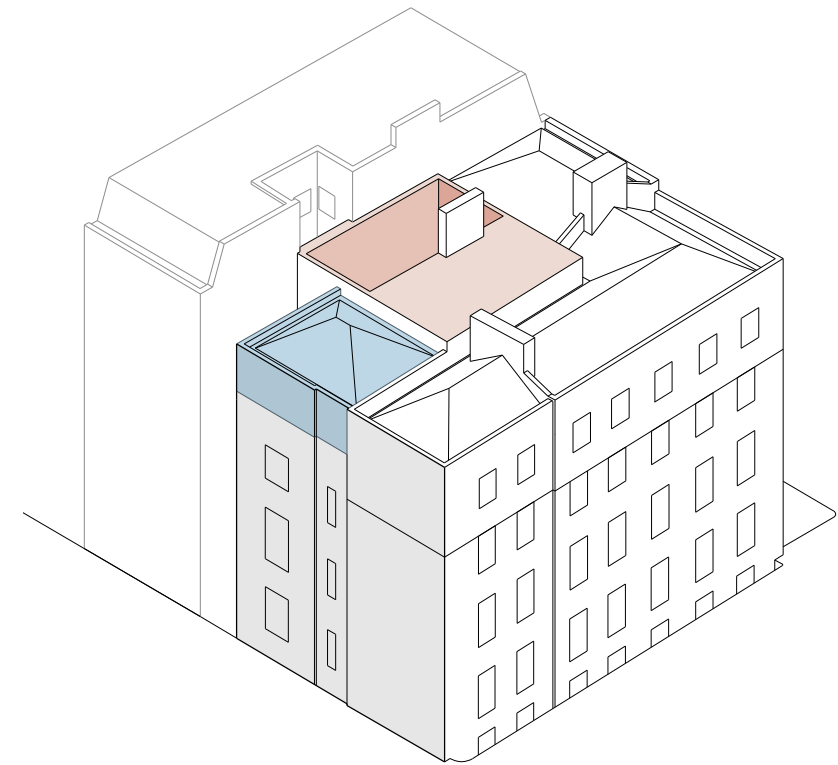
Diagrams illustrating proposals to remove detrimental elements at roof level and extend over rear rooms of No.2

The proposals for the roof that form part of this application are a consequence of the proposed alterations to the third floor but also stem from the desire to 'tidy up' the ad-hoc and fragmented nature of the existing roof.

The interventions described opposite therefore illustrate the proposals as a series of moves that firstly remove detrimental elements, then align volumes resulting from the extended staircase and finally infill the 'missing tooth' at the rear of No.2.

In its revised form the new roof scape (which will leave in tact over 70% of the 1840s pitched roof structure) will provide a continuity and completeness to the roofscape of this building that has been hitherto lacking.

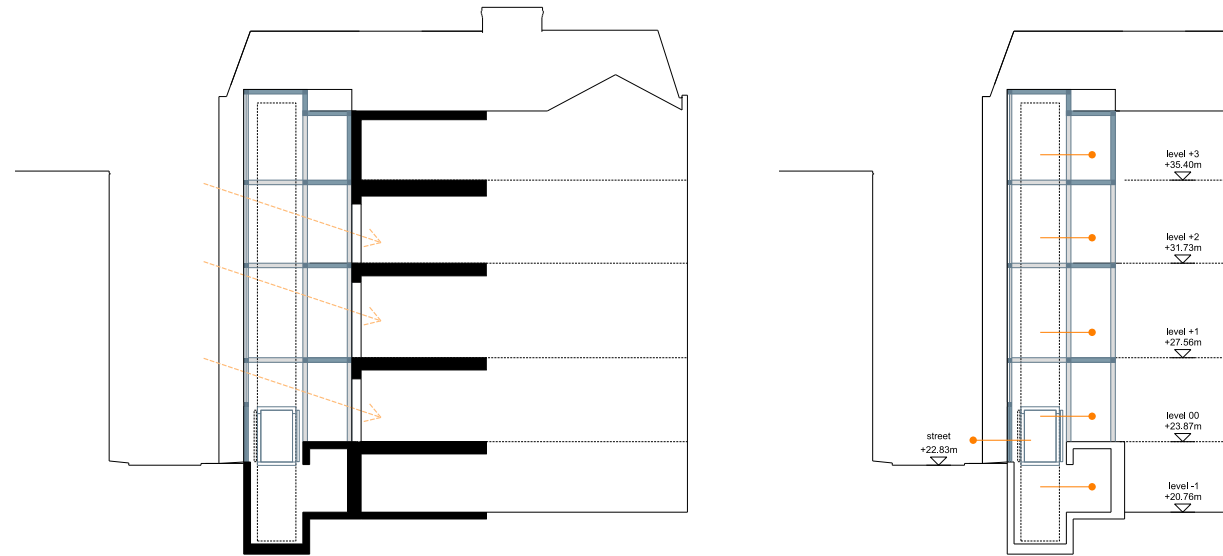
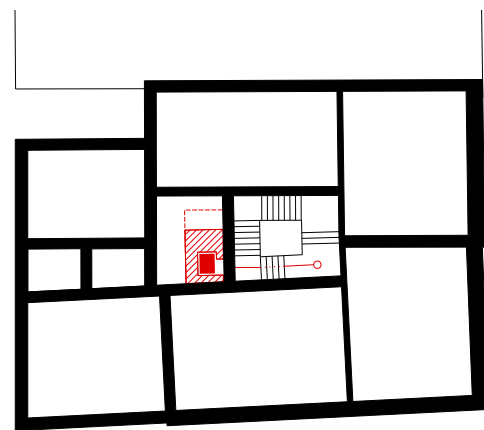
Existing lift location

The existing lift, added in the 1970s, is poorly located, arriving at the half landing between every floor. The lift shaft and oversized motor room also block out most of the daylight from the central lightwell. This renders the windows to the stair hall and the middle rooms of No.2 largely ineffective.

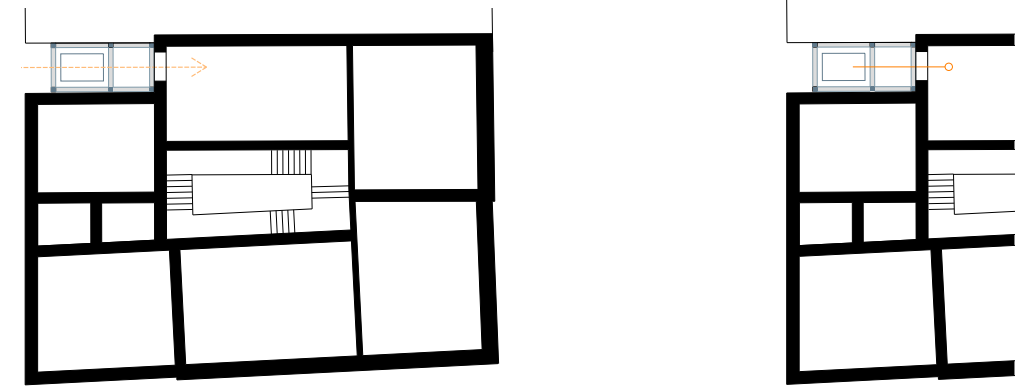
Proposed lift location showing natural light and access

The proposal seeks to improve accessibility by introducing a new lift shaft that would fill the indent of the North facade. This will provide step free access to over half of the house.

A translucent facade allows natural light to filter through the lift structure and feed into the adjacent room via the original window.

In addition to providing accessible circulation within the building, the proposed lift will have opposite door openings enabling level access from street level from Whetstone Park. It will also act as a fire-fighting lift providing a direct route of egress from the second and third floors in the event of a fire.

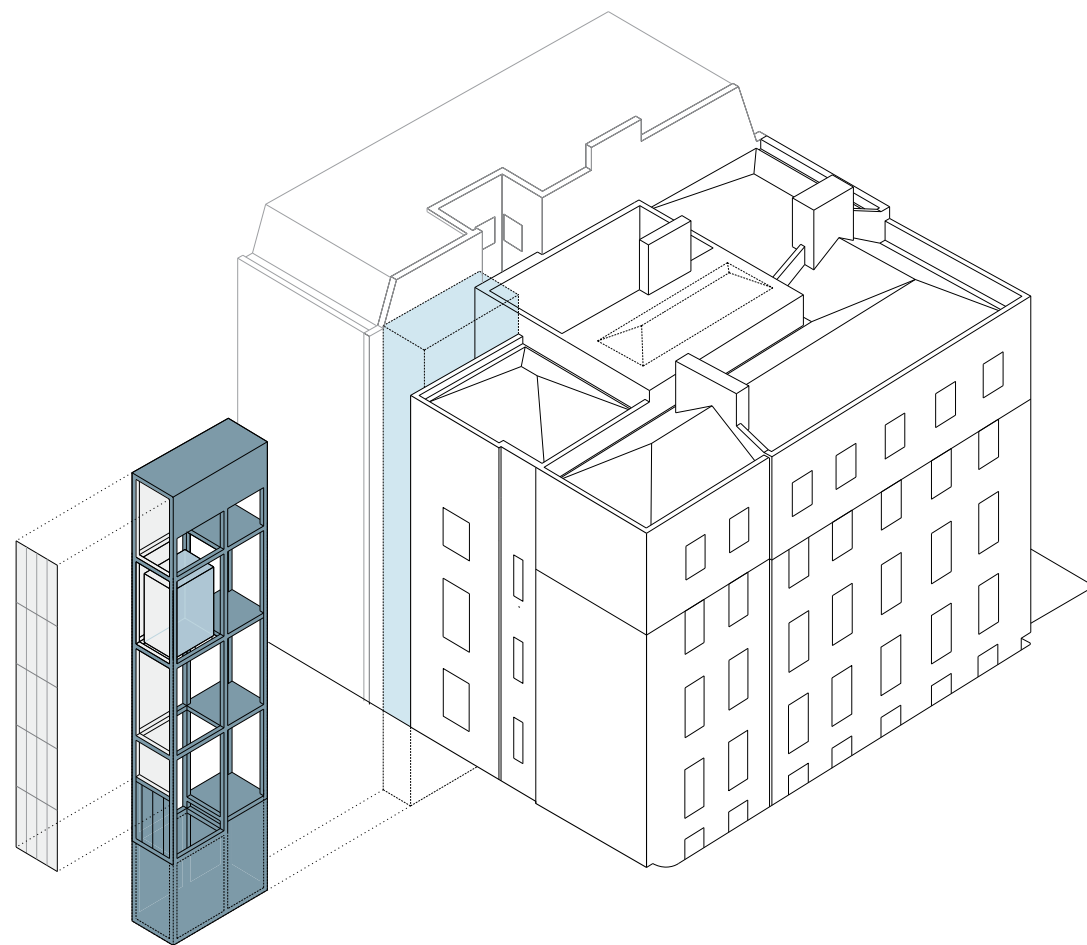
Diagram illustrating proposed lift as a lightweight 'infill' element with low impact on historic fabric

The lift infill, lobby and core, is a lightweight steel structure. Its contrasting material and structural autonomy preserve the readability of the house's historic plan form.

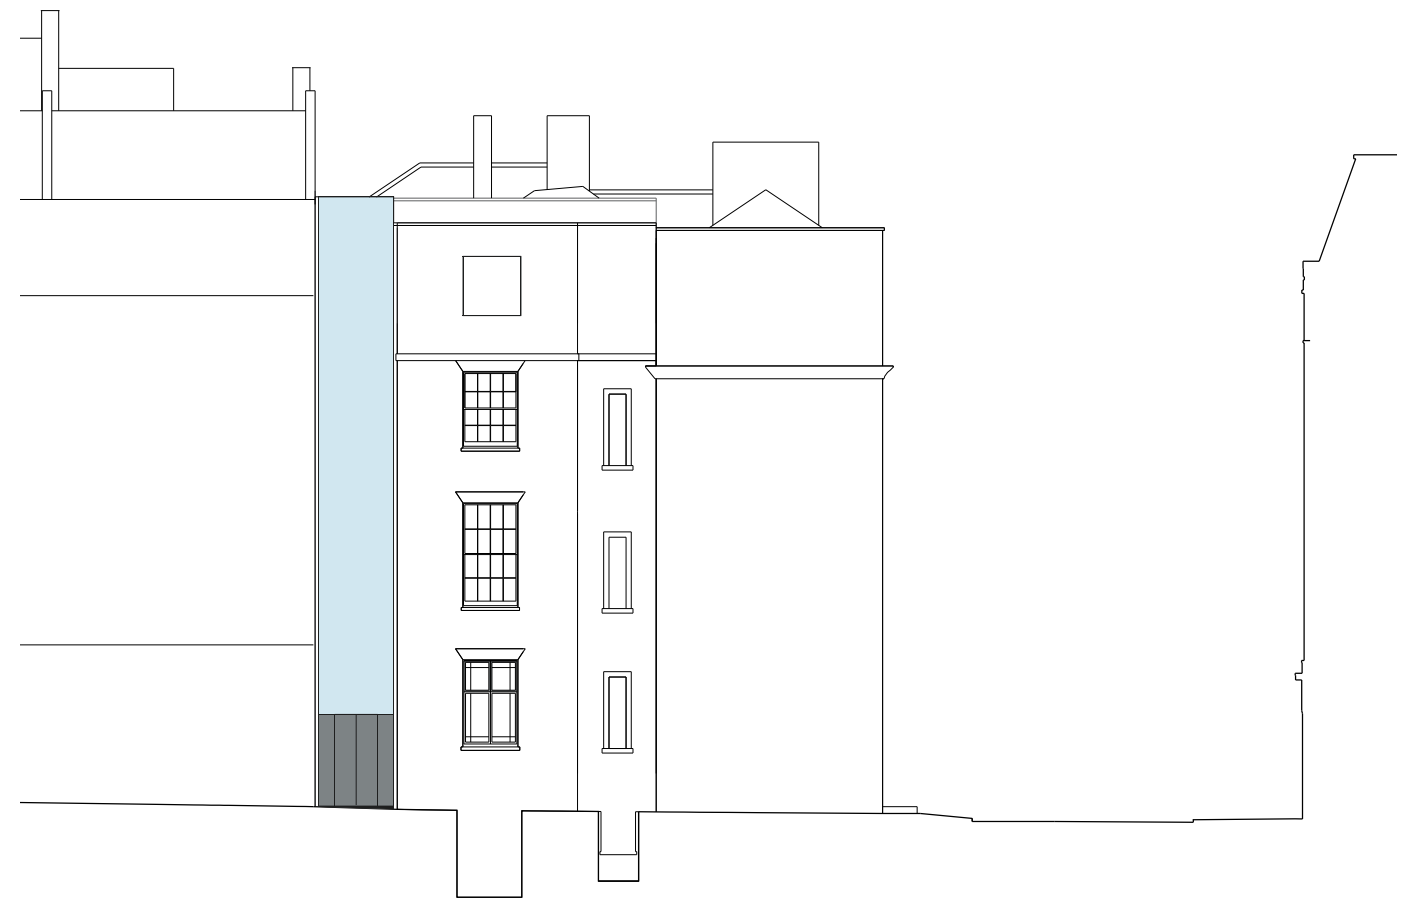
Lift infill element mediating between Nos. 1 & 2 and adjacent taller facade of No.3

The height of the lift shaft is taken 1m above the height of the extension to emphasise the articulation of the new elements and to graduate the change in height between the building and its neighbour at No.3.

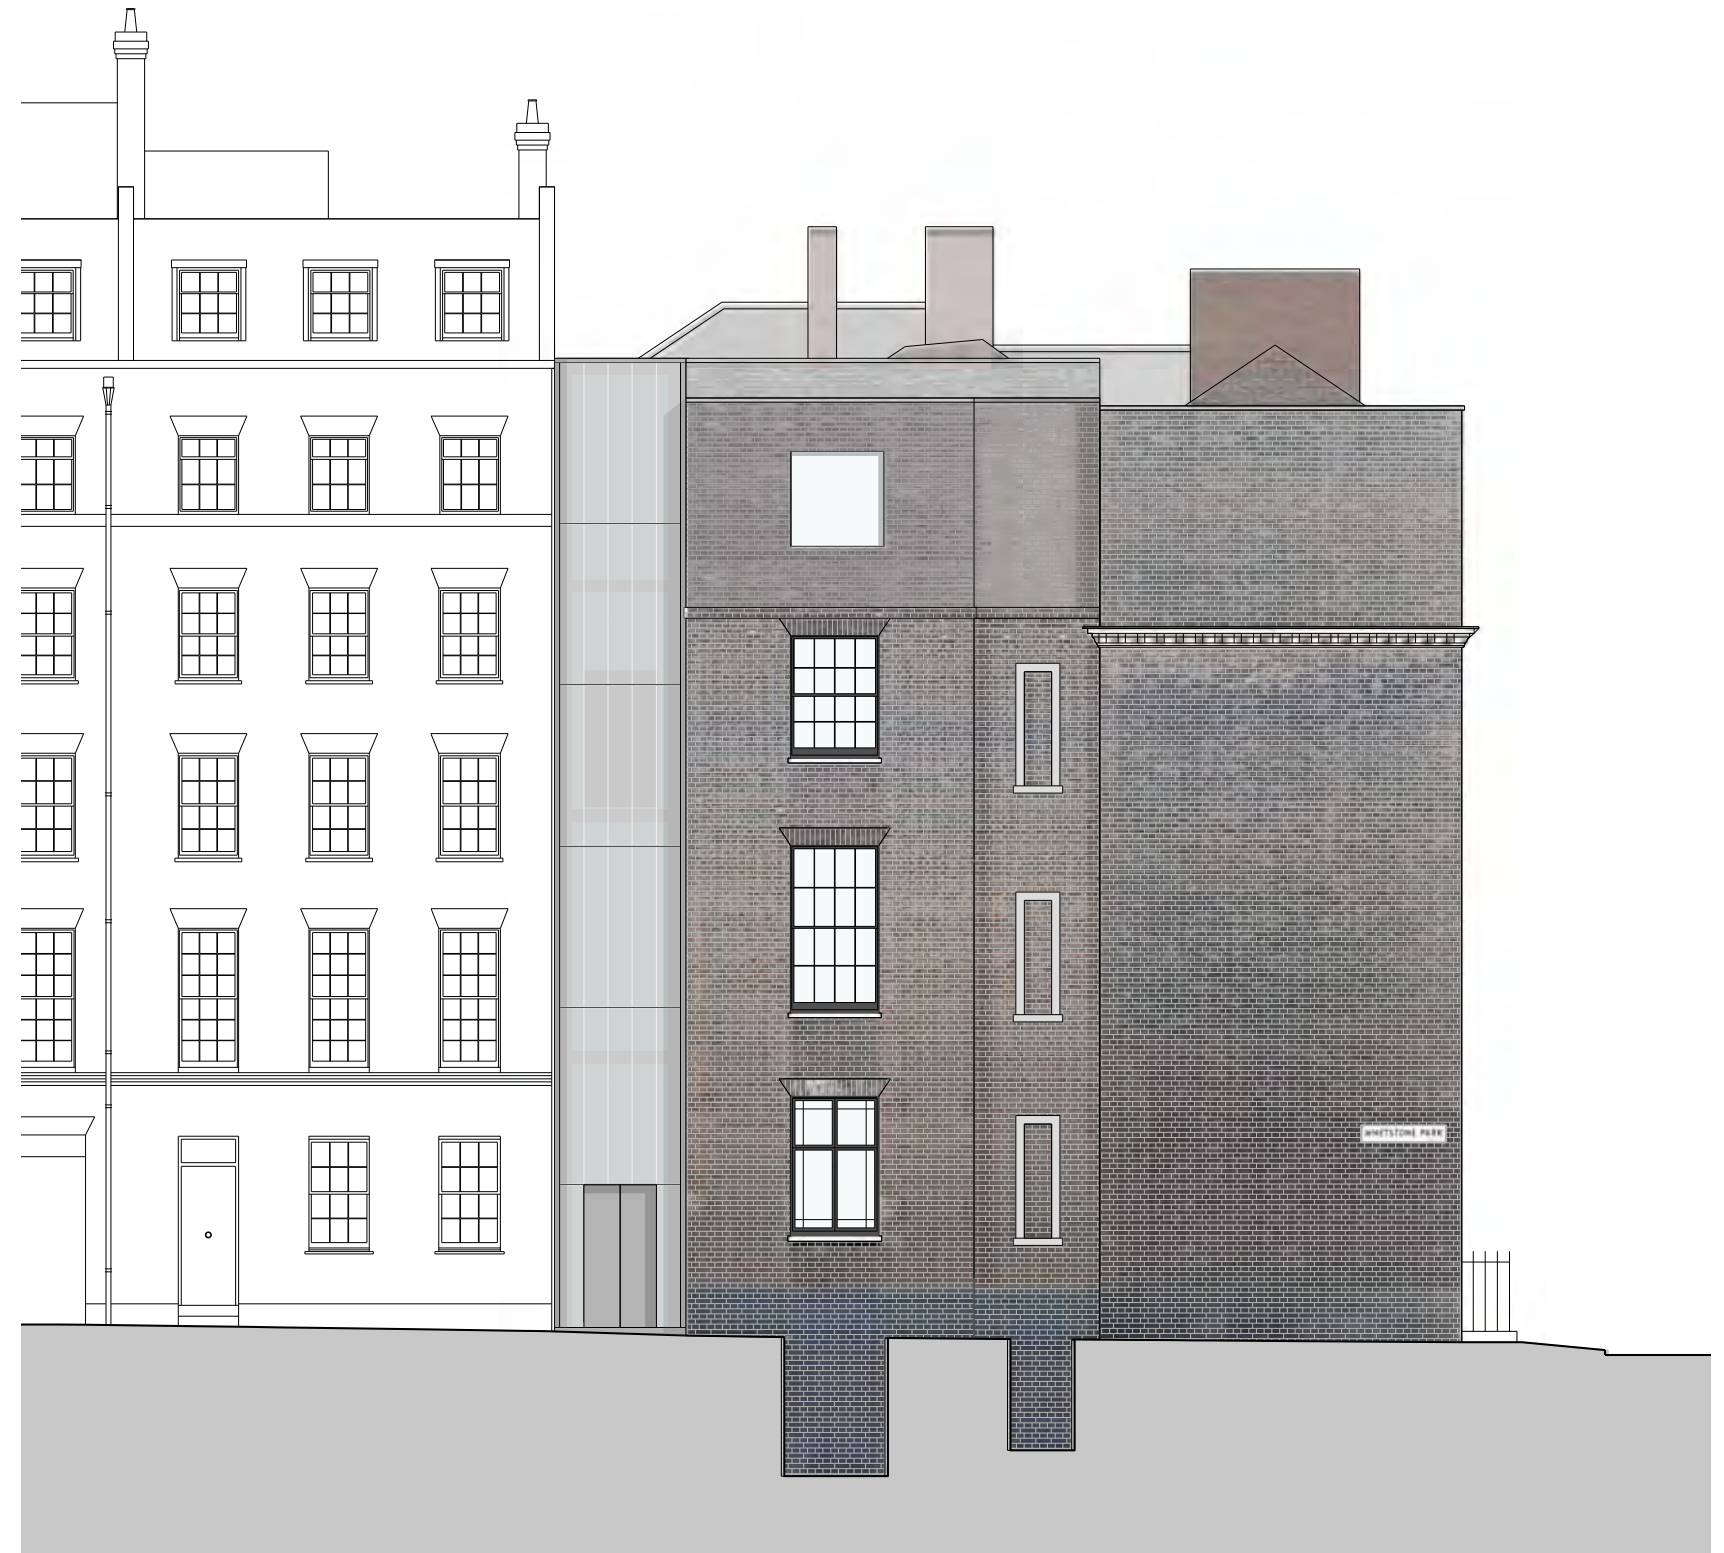
Proposed north elevation (1:125)

The determination of the footprint of the infill/extension is based on the plan-form of the structural walls below. The north elevation of the extension is profiled to mimic the stepped form of the rear elevation of Nos. 1 and 2 which itself has developed through previous infill for the strong rooms carried out during the 1890s conversion of the house into solicitors' offices. The lift shaft is stepped in 1.2m from the north facade to create a further articulation of this rear elevation.

The roof infill/extension is designed as a simple brick ensemble with an articulated opening at high level for the large window above the rear rooms of No.2.

The lift core is designed as a light steel structure with a translucent facade that contrasts with the adjacent historic fabric. On the ground floor, metal doors provide access from the street directly into the lift.

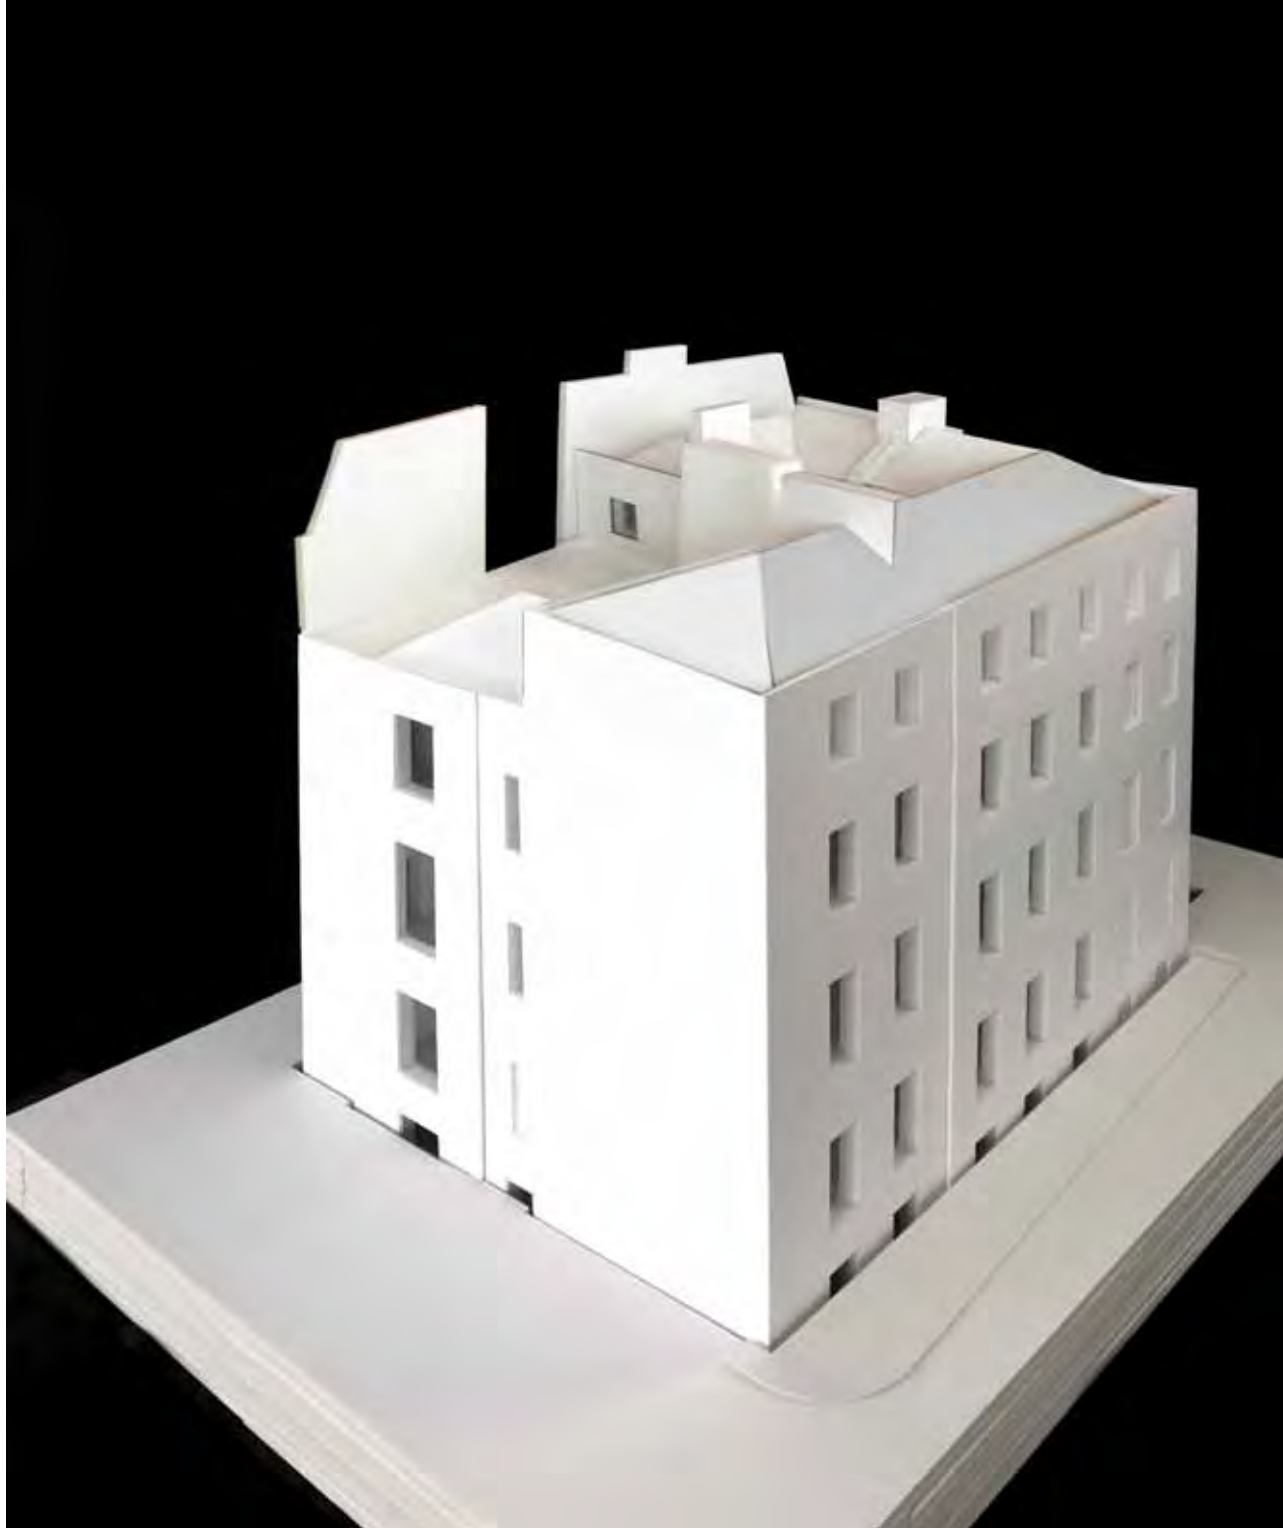
Existing roofscape

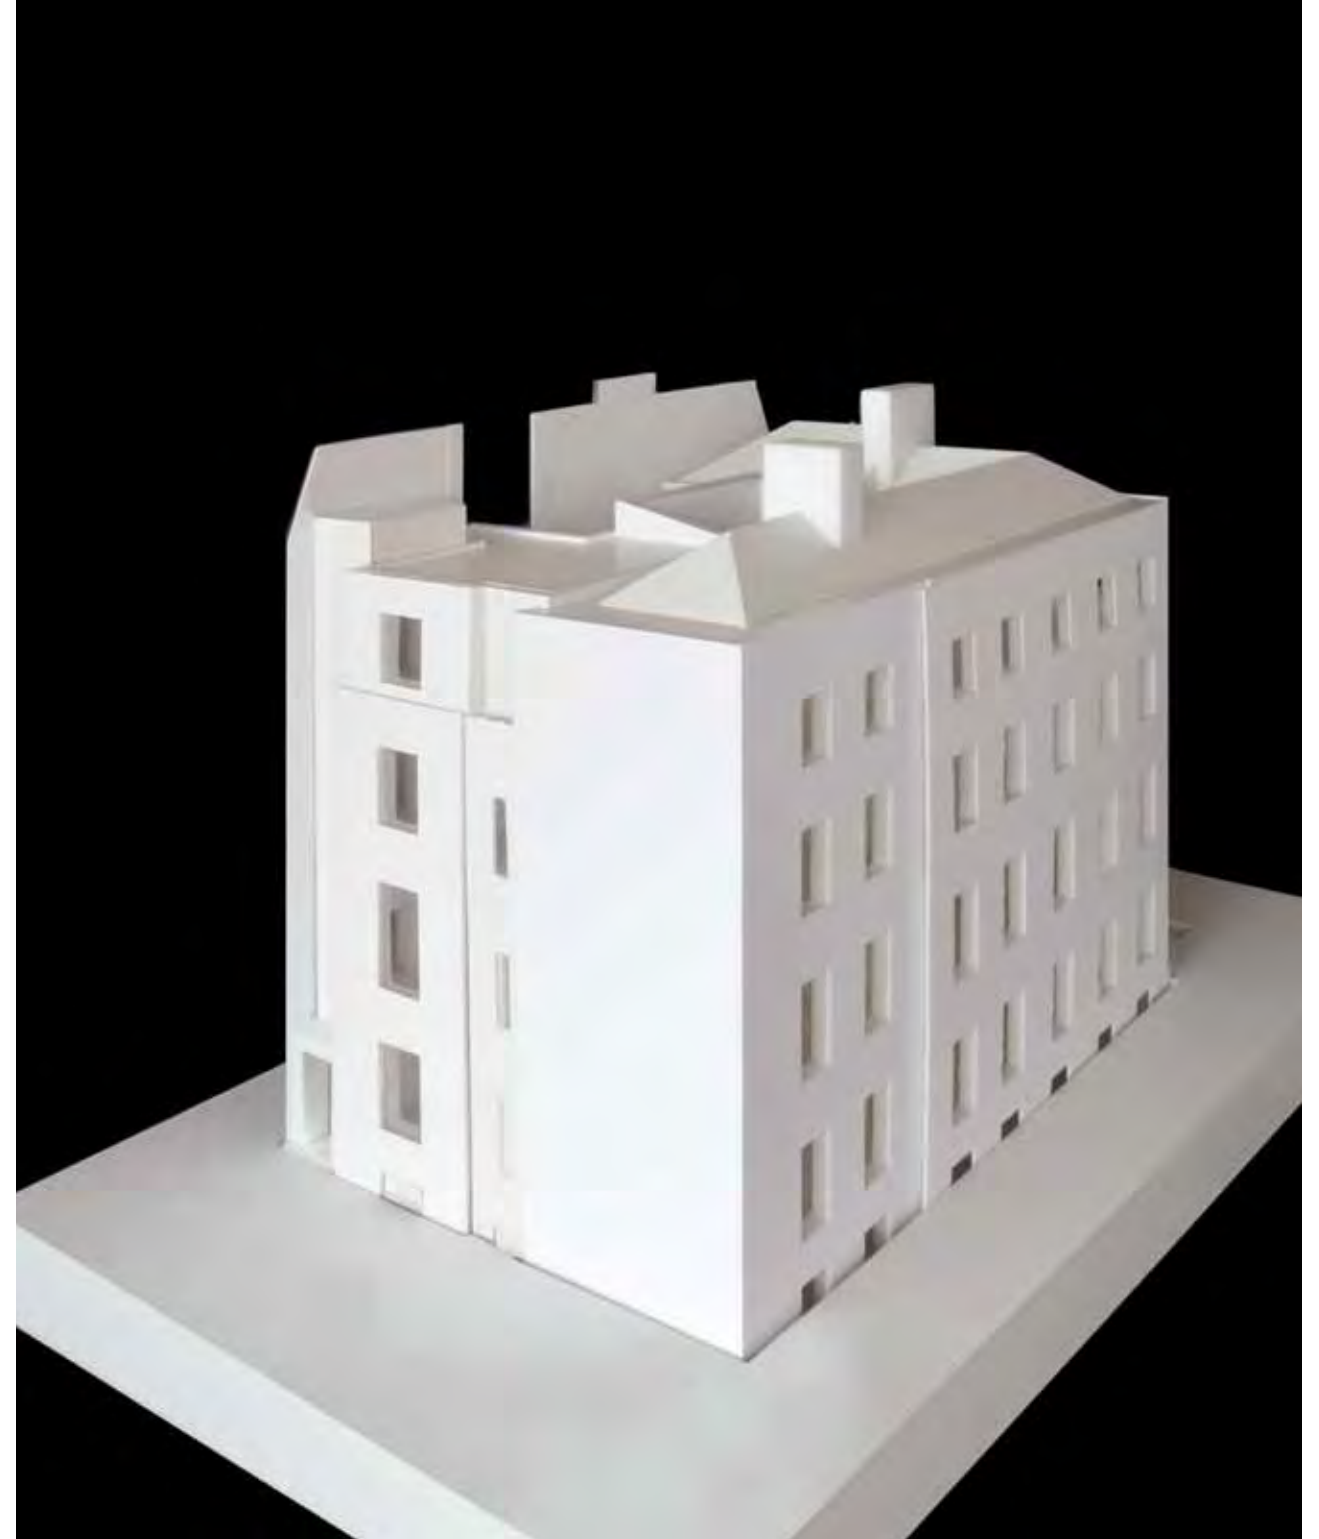
Proposed roofscape
