Queries from Campbell Reith 14/09/2016

Response to para 4.7 - Item 1

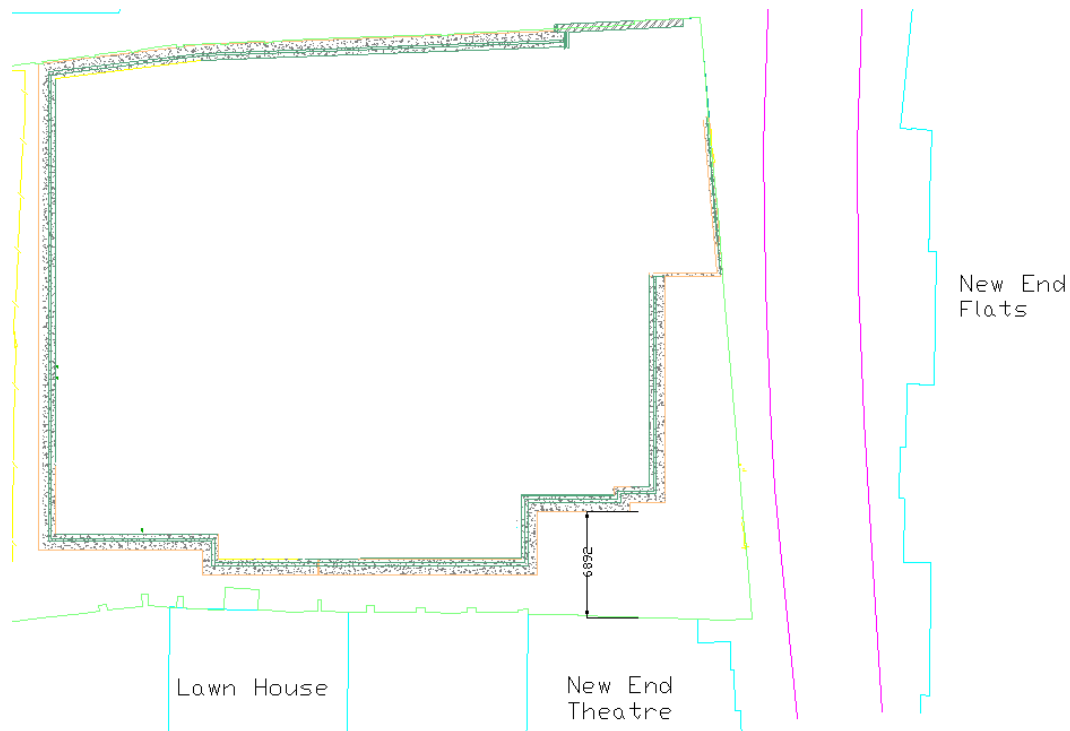
**Figure 1: Relative position of New End Theatre to proposed development. Offset approximately 6.8m.**

Referring to Figure 1 below, the relative location of New End Theatre to the proposed basement retaining wall can be seen explicitly. The basement retaining wall outline can be seen to divert away from New End Theatre. The relative setting out of the excavation and the surrounding buildings used for the Xdisp analyses is based on the available survey information as presented. It is our belief that building damage assessment captures this geometry accurately.

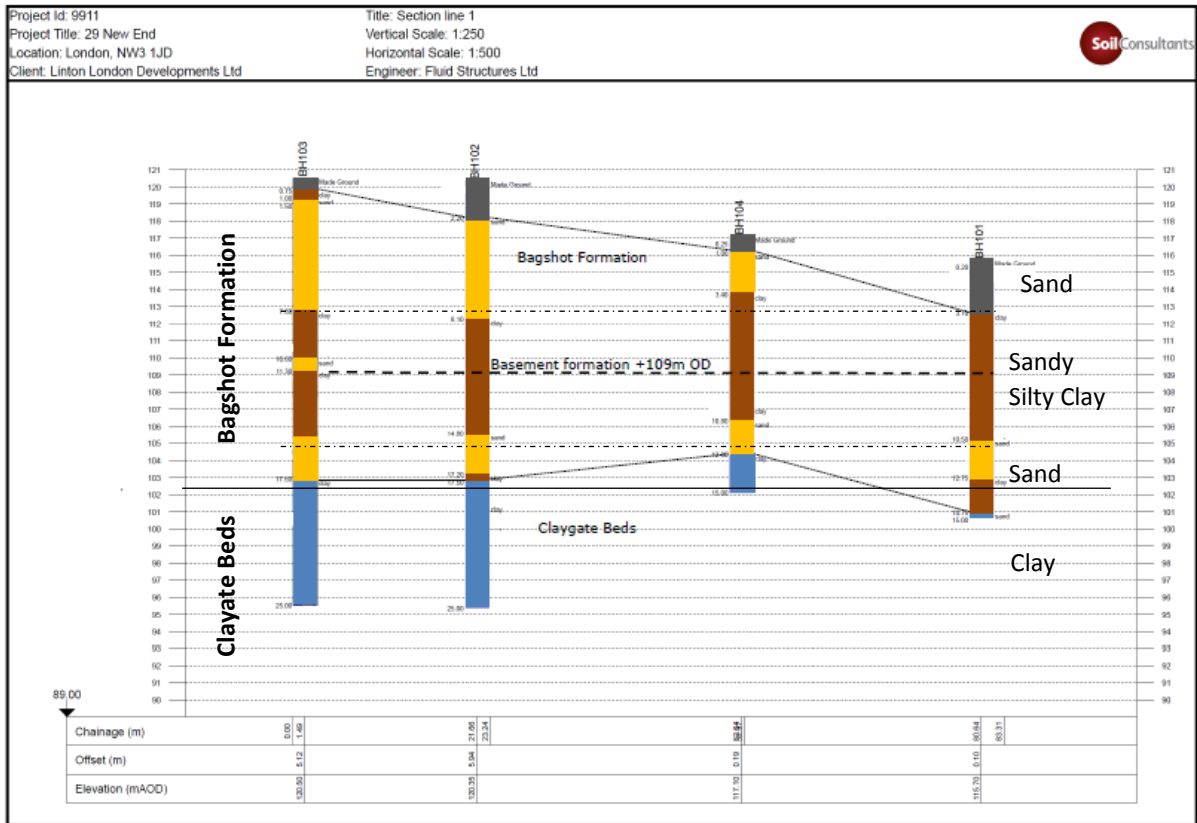
Figure 2: Delineation of Sand and sandy silty Clay of Bagshot Formation (modified from GIR report in BIA).

The clay layer referred to is a part of the Bagshot Formation, which was typically described as a sandy/silty Clays and identified between approximately +113m AOD to +105m AOD in the site investigation report. Figure 2 reproduced from the recent GIR illustrates the assumed stratigraphic profile through the site.

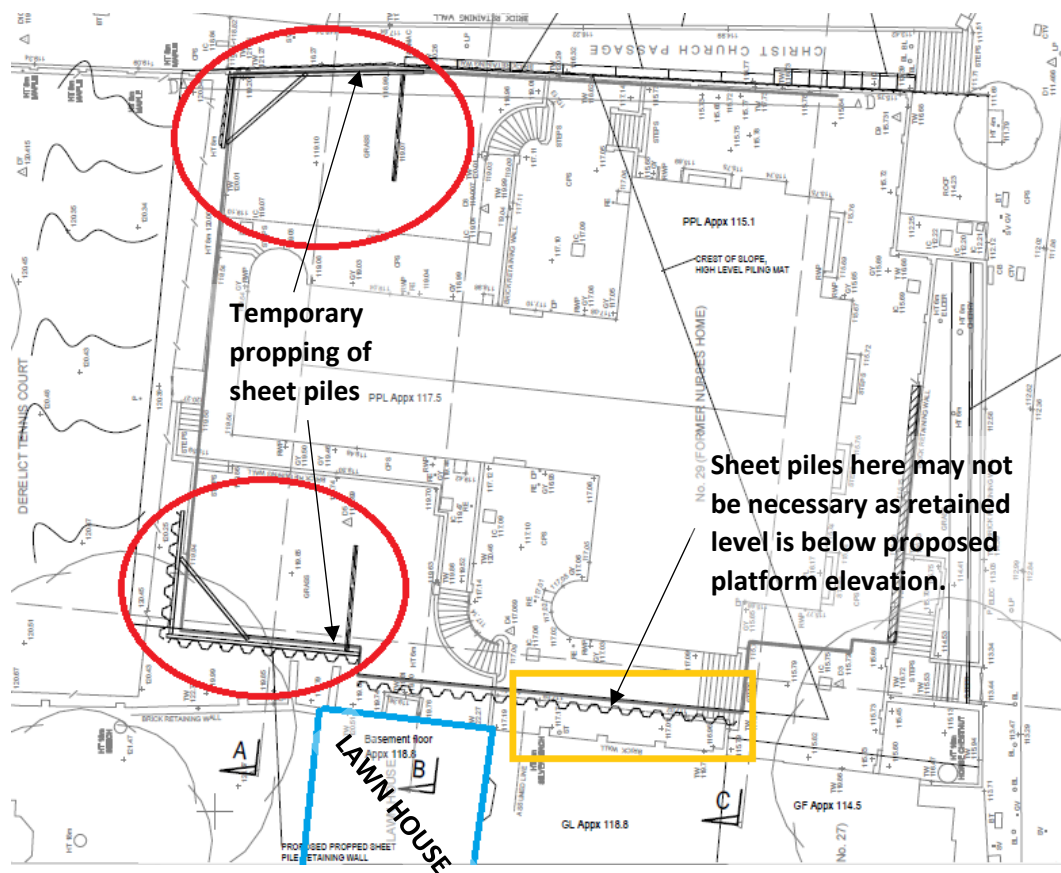
Figure 4: Preliminary arrangement of temporary sheet pile and propping to enable secant pile wall construction.

- During construction, the temporary sheet pile walls required to enable secant pile wall installation are shown as having some temporary propping provided. Refer highlights in Figure 4.
- During construction, the secant pile walls are propped from a high level with large diameter CHS Sections. Refer highlights in Figure 5.
- In the permanent case, the walls are partially propped by the permanent basement/floor slabs with the top portion of the wall cantilevering in some locations. Drawing sections BIA/006-1 to BIA/006-5 (Appendix E of BIA) best illustrate the typical wall restraint following the end of construction.

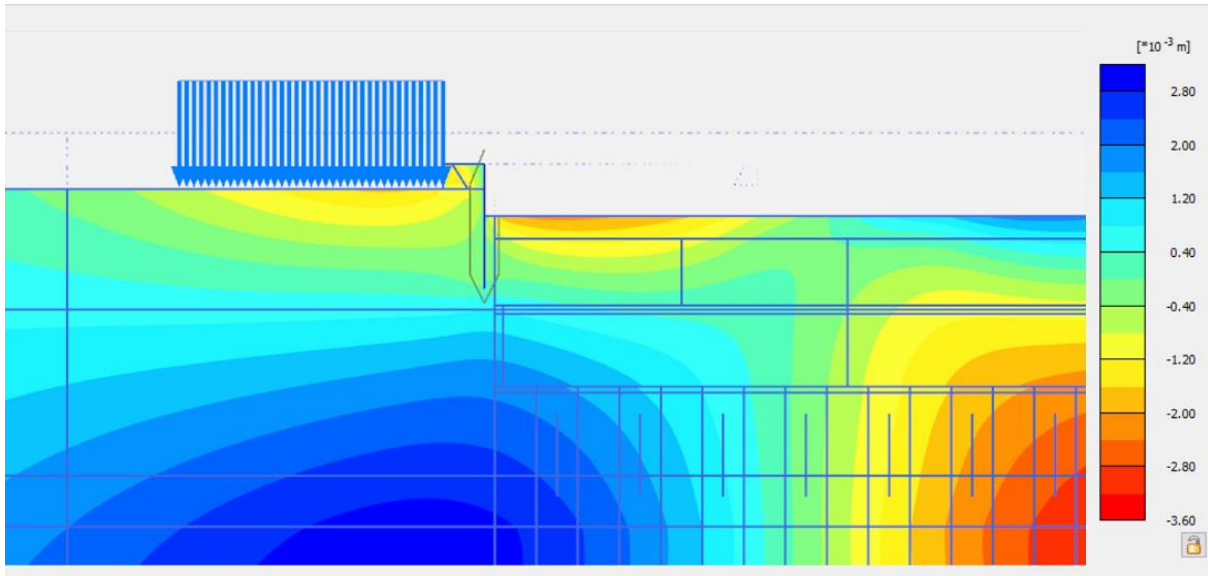
**Figure 6: Horizontal ground deformation with sheet pile wall cantilevered in temporary case.**

We have assessed two scenarios, which incorporate sheet piles without a temporary prop and sheet piles with a temporary prop. The horizontal ground movements at the sheet pile wall are estimated to be less than 5mm in both cases. Output from both cases is provided in Figure 6 and Figure 7.

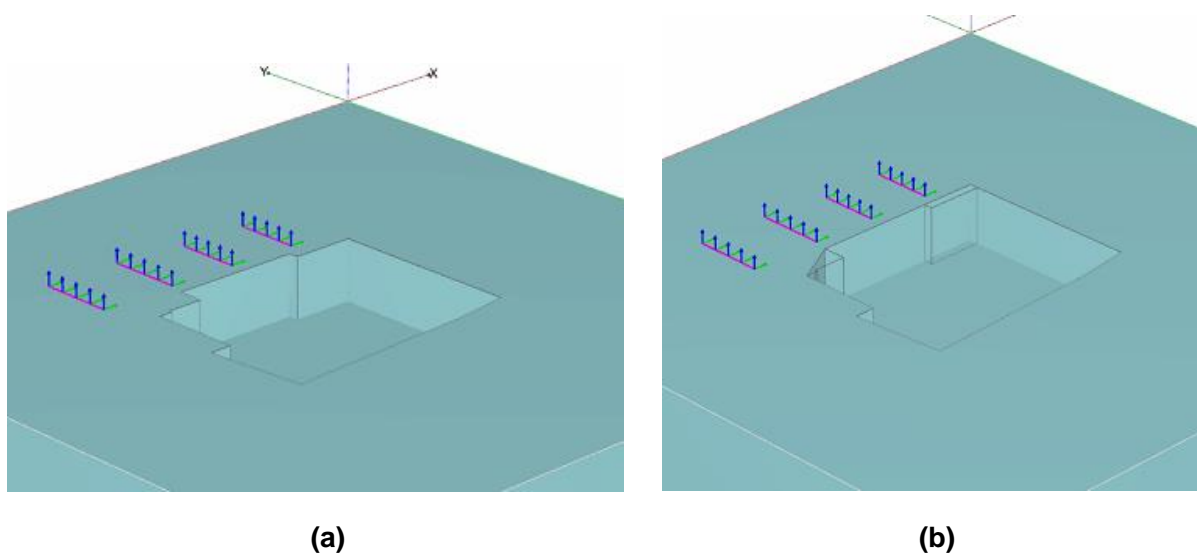
Figure 8: (a) Actual excavation geometry (b) Simplified excavation geometry

There is no consistent means by which the effect of re-entrant corners can be handled with simplified models such as Xdisp. The approach taken for the New End basement analysis was to simplify the excavation geometry and remove the re-entrant corners by offsetting the excavation perimeter as shown in Figure 8. The removal of the re-entrant corners by the adopted method, was assessed to be conservative because the process effectively decreased the distance between the nearest retaining wall and neighbouring structure.

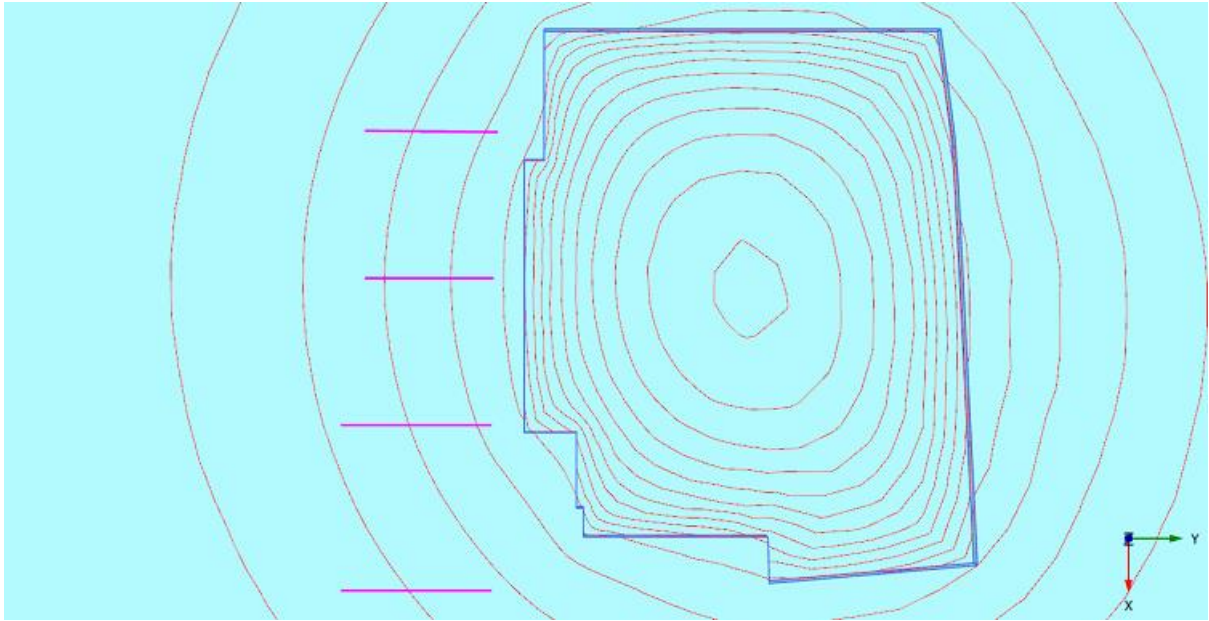
**Figure 9: Contours of total ground movement due to excavation using actual basement geometry.**

A check was carried out by modelling both (actual and simplified, i.e. without re-entrant corners) excavation geometries in a simplified 3D model, with the ground mass represented by a linear elastic material. Figure 9 and 10 illustrate the distribution in ground contours between the “realistic” and “simplified” excavation geometries. It is noted that the patterns of ground movement between both methods are very similar. Secondly, a comparison was made between the ground movements at the north and south walls of Lawn House and New End Theatre, which are shown in Figure 11. These figures show the ratio of total ground movement estimated from the simplified excavation geometry to the actual excavation geometry. It is observed that the simplified excavation geometry tends to predict larger ground movements than if the actual geometry was adopted (typically about 102% – 105% at the north and south walls of Lawn House and New End Theatre), due to the relative increased proximity of the excavation to the wall elements. On this basis it was assessed that the simplified excavation geometry adopted for the building damage assessment was satisfactory.

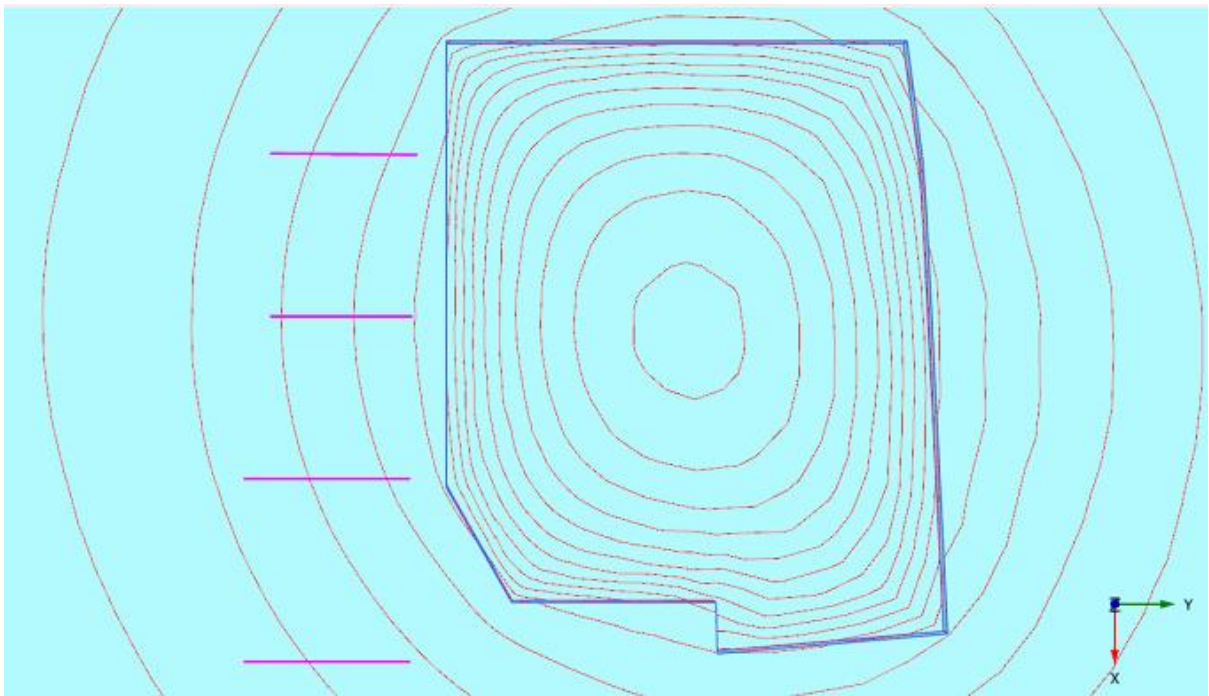
**Figure 10: Contours of total ground surface movement from simplified model with re-entrant corners removed.**

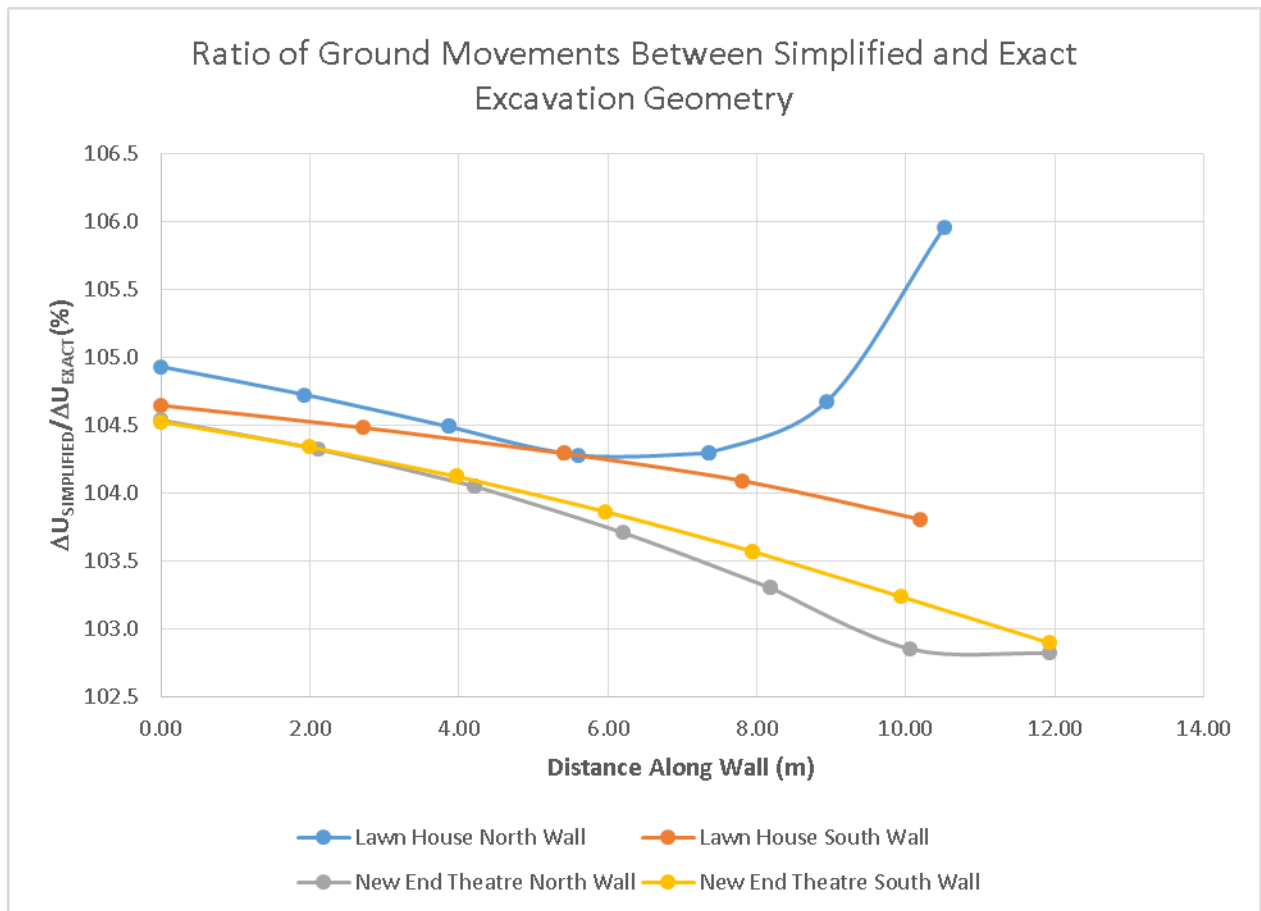
**Figure 11: Ratio of ground movements at building walls evaluated from simplified excavation geometry and exact excavation geometry.**
