General Scope of Works Main Facade Elevations:

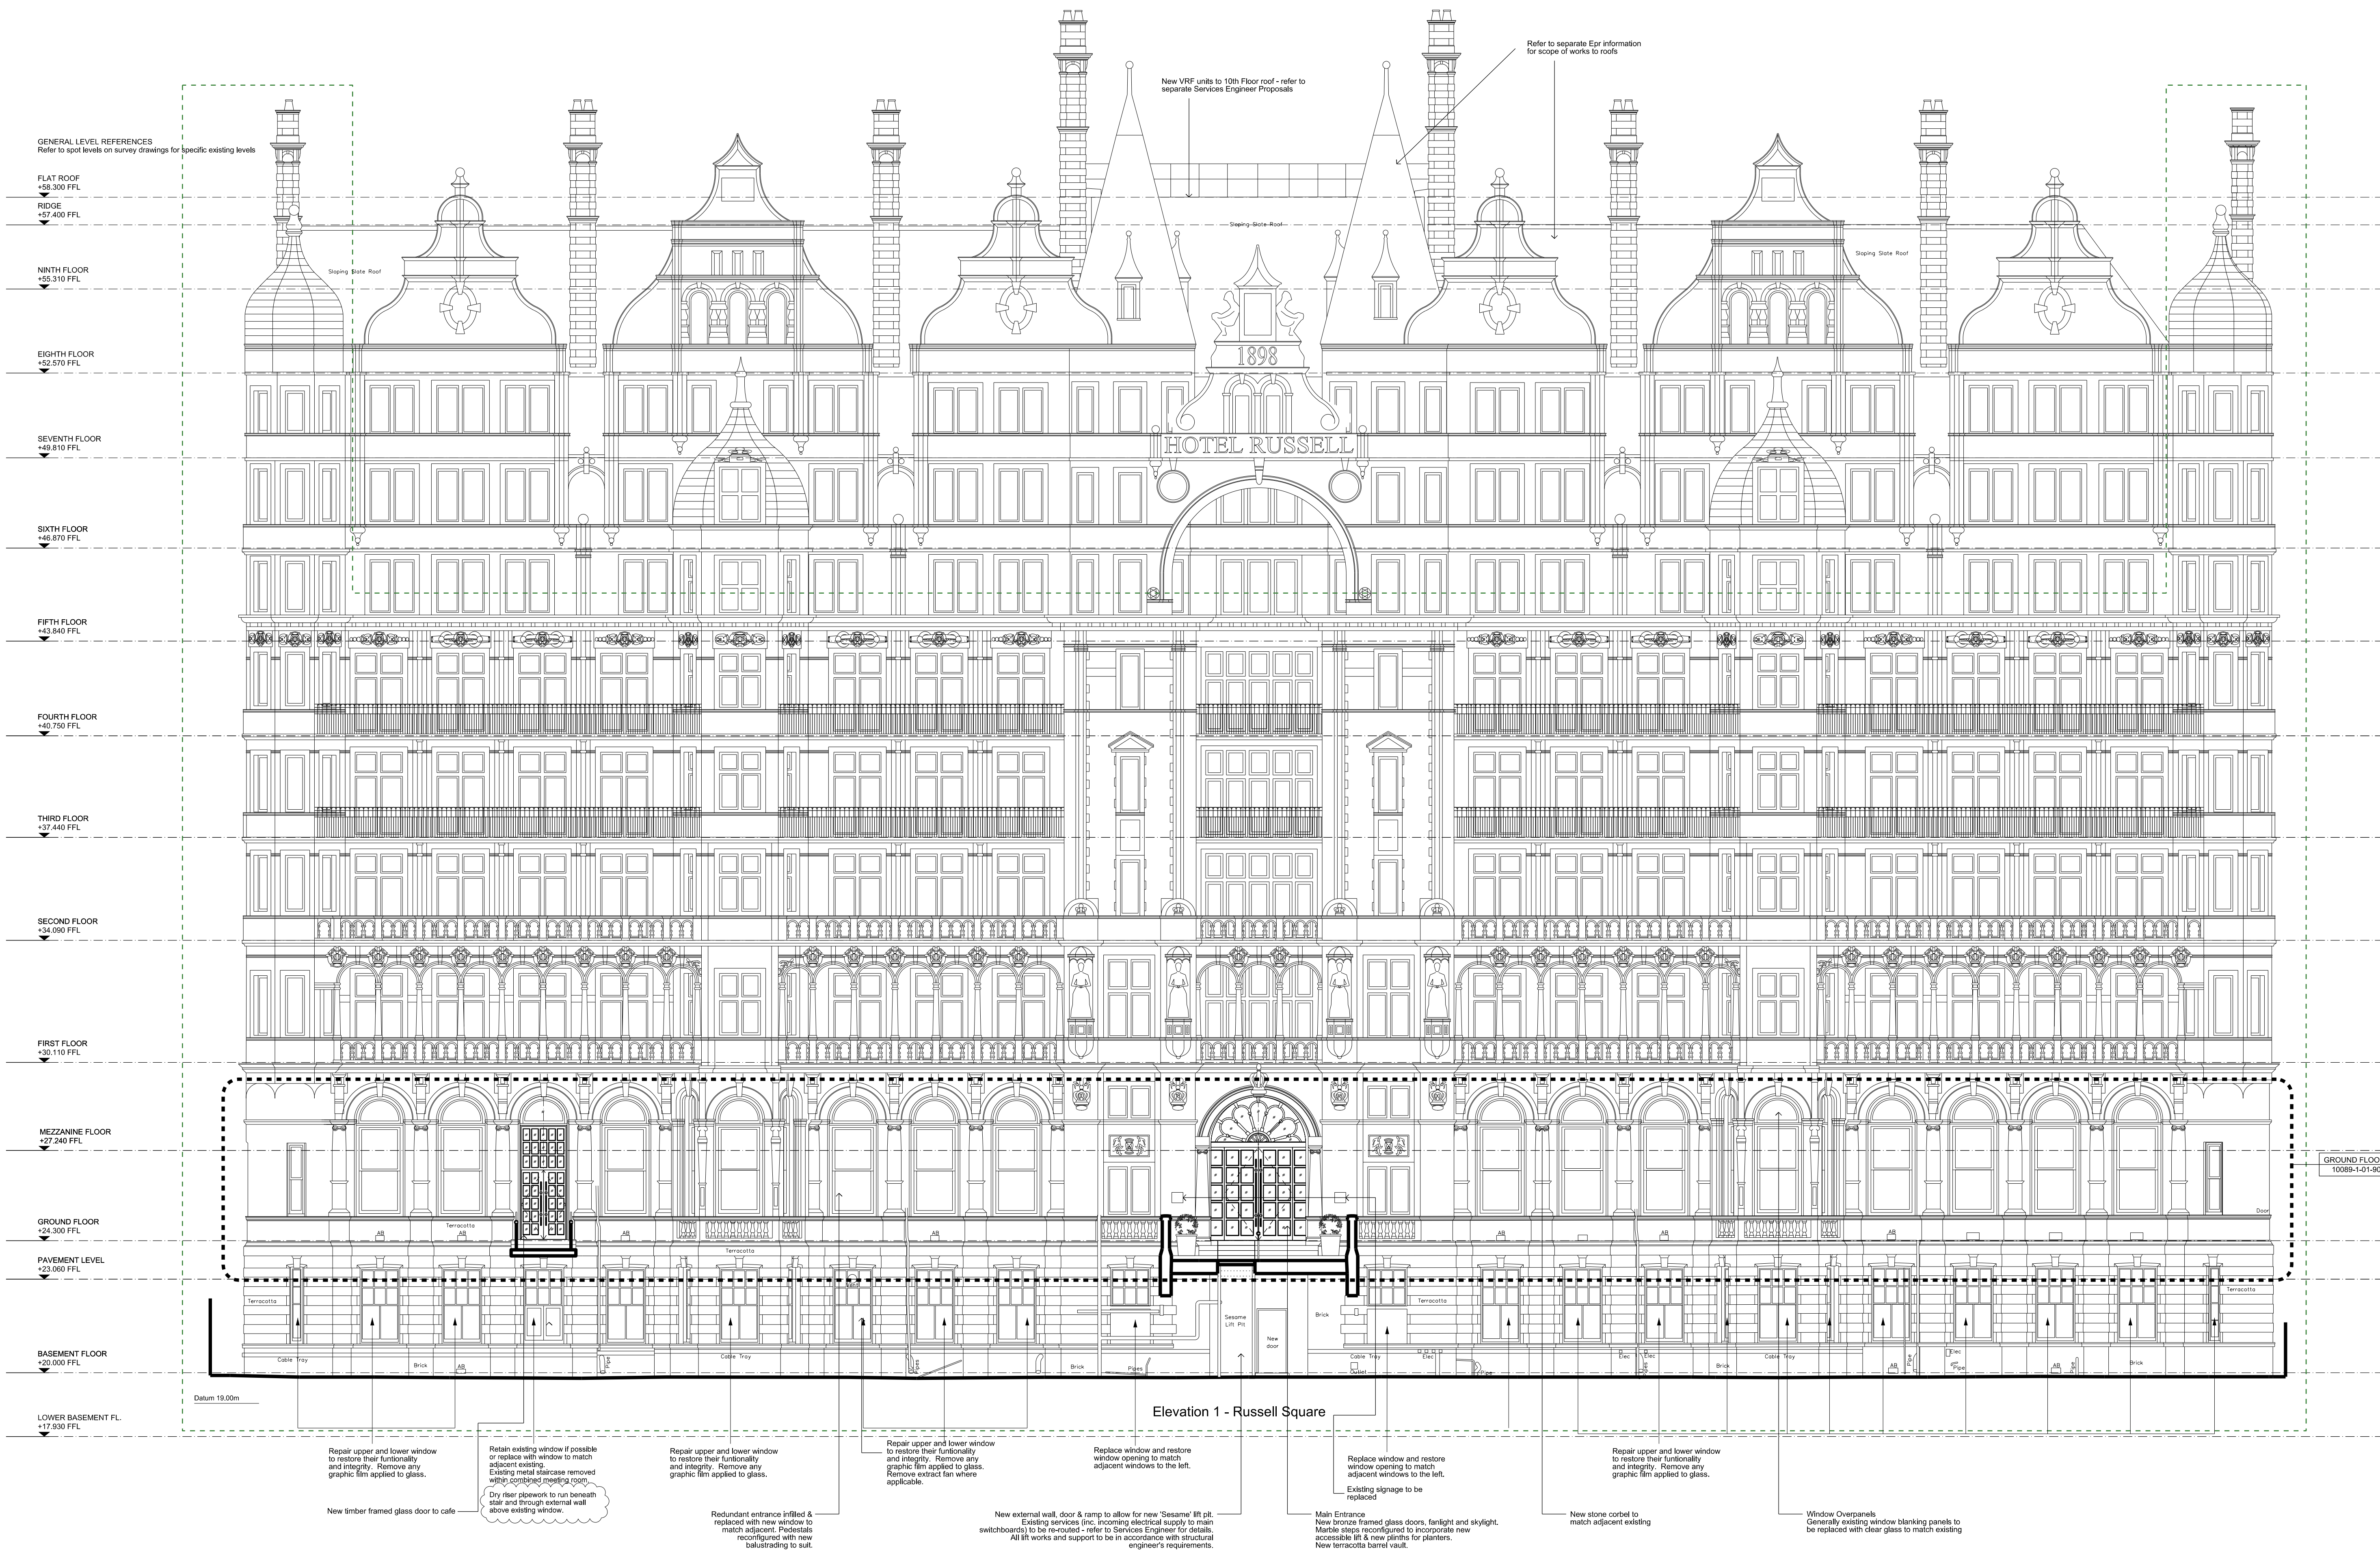
- Refer to Services Engineer information for extent of cabling, pipework & ductwork to be retained or stripped out and all new services proposals, General scope:

- All redundant services to be stripped out in their entirety.
- All existing services to be retained are to be repaired & made good/replaced where necessary.

- All unruly cabling to be retained are to be tidied and clipped securely
- Existing damaged cast iron soil stacks, gutters and rainwater pipes are to be repaired incl. dents, holes, loose straps & removal of moss.

- Existing grilles to lower ground windows are to be removed where indicated on services engineer proposals and replaced with clear glass to match existing. Where grilles are retained they are to be redecorated to match window frame. New grilles & overpanels are to match existing.

- Existing high level window fans to be removed and replaced with clear glass to match existing.
- All access requirements to below ground drainage and ductwork are to be retained and refurbished. Refer to Structural Engineer for works to be retained, redundant and proposed manholes, inspection chambers, covers etc.

- 3 no. new dry riser risers to be incorporated.
- New gas pipework incorporated to service 10 no. new gas lamps.
- Existing irrigation pipework to be omitted. New pipework for new external landscaping tbc.

Refer to Facade Consultants information for restoration of existing external fabric and repair of stonework and plaster, soffits etc e.g. terracotta, replacement of replaced stone corbel, repair of render to underside of balcony.

- All stonework surfaces are generally repaired and cleaned where indicated.
- For all new stone related components to facade and lightwell, it will be necessary to employ a stonework specialist to match colour, profile and general appearance of existing with new. All abutments of old to new shall be scribed and pointed with differential movement sealant.

- Existing stonework and glazed bricks to lightwell to be cleaned down and bricks replaced where necessary i.e. missing or due to services penetrations (bricks to match existing)

- Existing external windows to be refurbished, including a rub down and making good of frames to permit new paint finish. Extent of refurbishment tbc following full window survey. Windows vary in condition and thorough overhaul is required to put into working order, renew rotten and damaged sections of timber, renew sash cords and rebalance weights. Repairs are likely to include splice repairs and possible new casements. Allow for primer, undercoat and 2 finishing coats of satin finish to match existing colours (black to lower levels & white to upper levels). All ironmongery and window putty to be replaced.

- All removed window fans, redundant services and solid infill removed to be replaced with clear float glass to match existing, including all necessary frames, trims, sills and putty.

- Stained glass window to receive specialist cleaning and redecoration of frames.
- All existing pedestals and plinths to be refurbished and redecorated with new plinths and pedestals to match existing (to specialist subcontractor design).

- Existing retained marble steps to be refurbished by specialist & repaired where damaged.
- Removed and made good existing steps, along with new steps, will require demolition and making good of all abutment materials, including profiled terracotta clad concrete pedestals, new stone clad steps.
