Project:
**EC HARRIS
 BACTON LOW RISE
 CAMDEN**

**BACTON LOW RISE REDEVELOPMENT
GOSPEL OAK, LONDON**

The present report summarises the findings of the Desk Study and presents the findings of Geo-environmental investigation works carried out at the site for the purposes of foundation and infrastructure design and to identify remediation or mitigation works required in respect of contamination presence. The report has been prepared to support a full planning application.

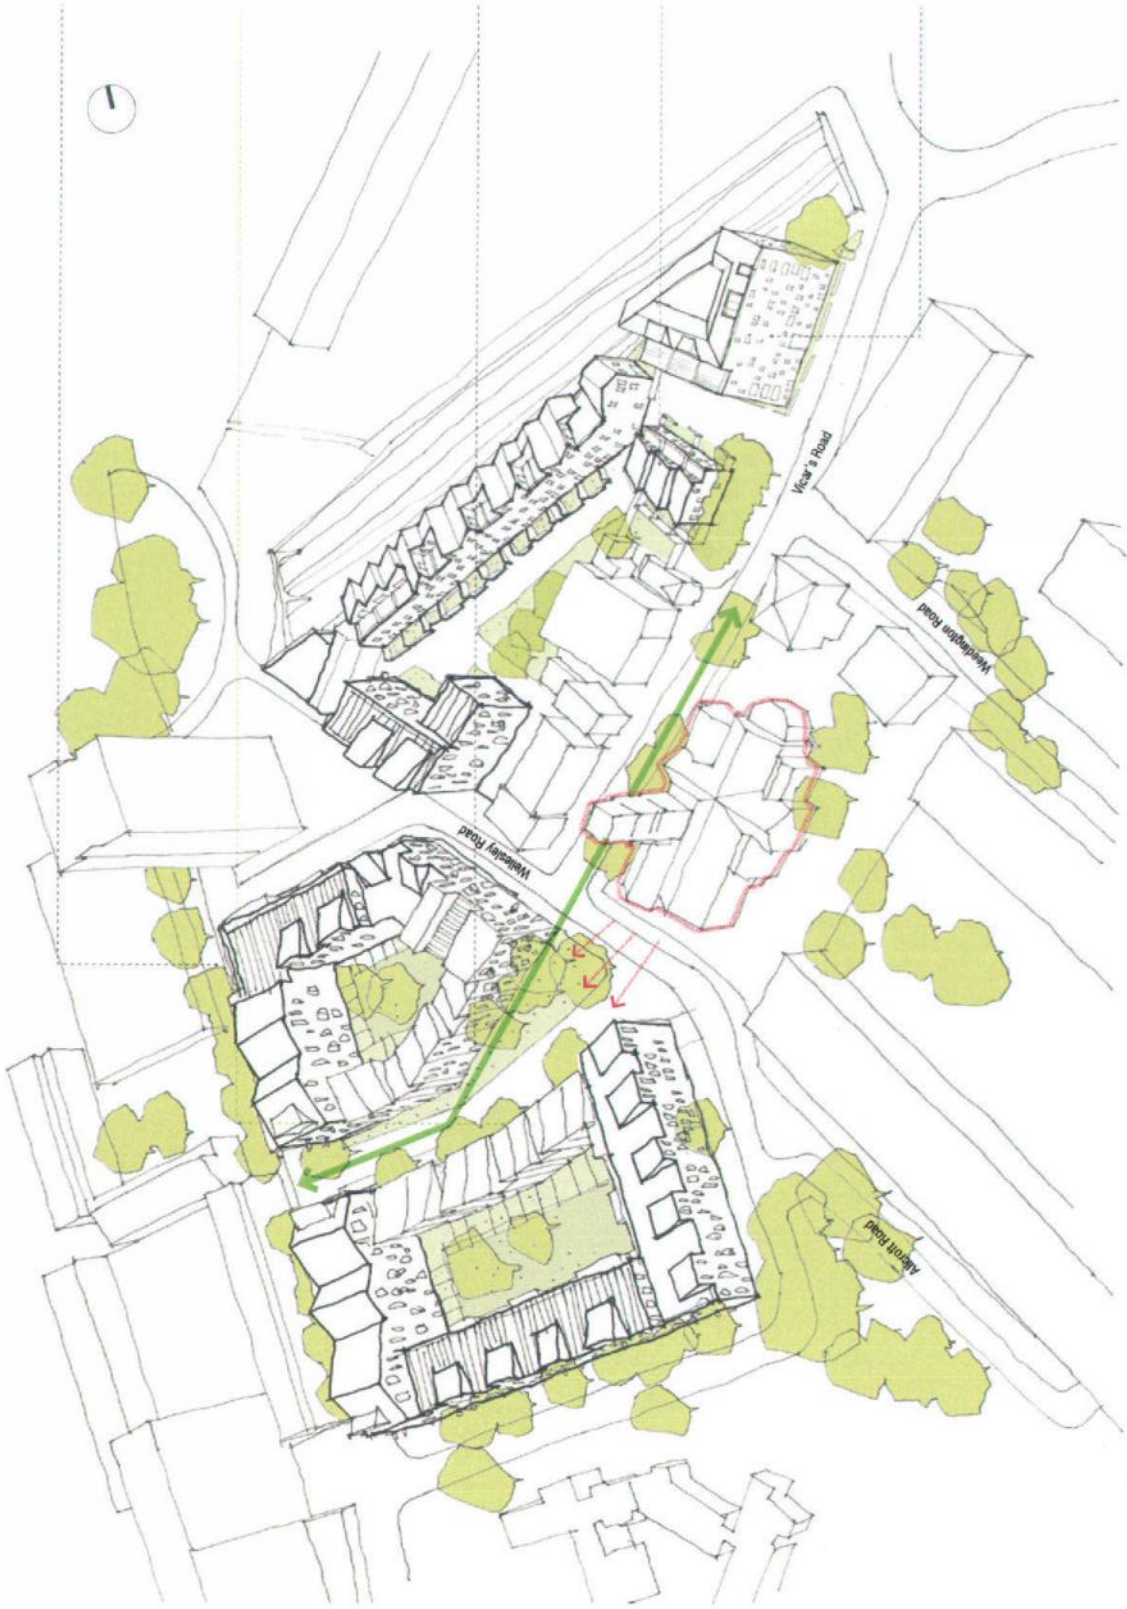
MASTERPLAN VIEW - PREFERRED OPTION

Mixed tenure housing

New landscaped street enhances the setting of St. Martin's Church, giving it a sense of place in the new townscape.
