7.8.15 ISSUED WITH NOTES.		FN
job NO.11 ROSSLYN HILL NW3		
title BASEMENT ADJACENT TO LYNDHURST HALL SECTION D-D		
drawn LPe	checked FN	
date JULY 15	scale (original - A1) 1:100	
<p>Alan Baxter</p> <p>75 Cowcross Street London EC1M 6EL tel 020 7250 1555 email aba@alanbaxter.co.uk www.alanbaxter.co.uk</p>		
drg. no. 1693/01/203	rev. -

-	7.8.15	ISSUED WITH NOTES.	FN
job No. 11 ROSSLYN HILL. NW3			
title SECTION THROUGH LYNDHURST HALL.			
drawn Rwa	checked FN	date Jul'15	
scale (original - A3) 1:50

Appendix K: Calculation for basement retaining wall adjacent to Lyndhurst hall.

DESIGN OF PILED WALL ADJACENT TO LYNDBURST HALL.

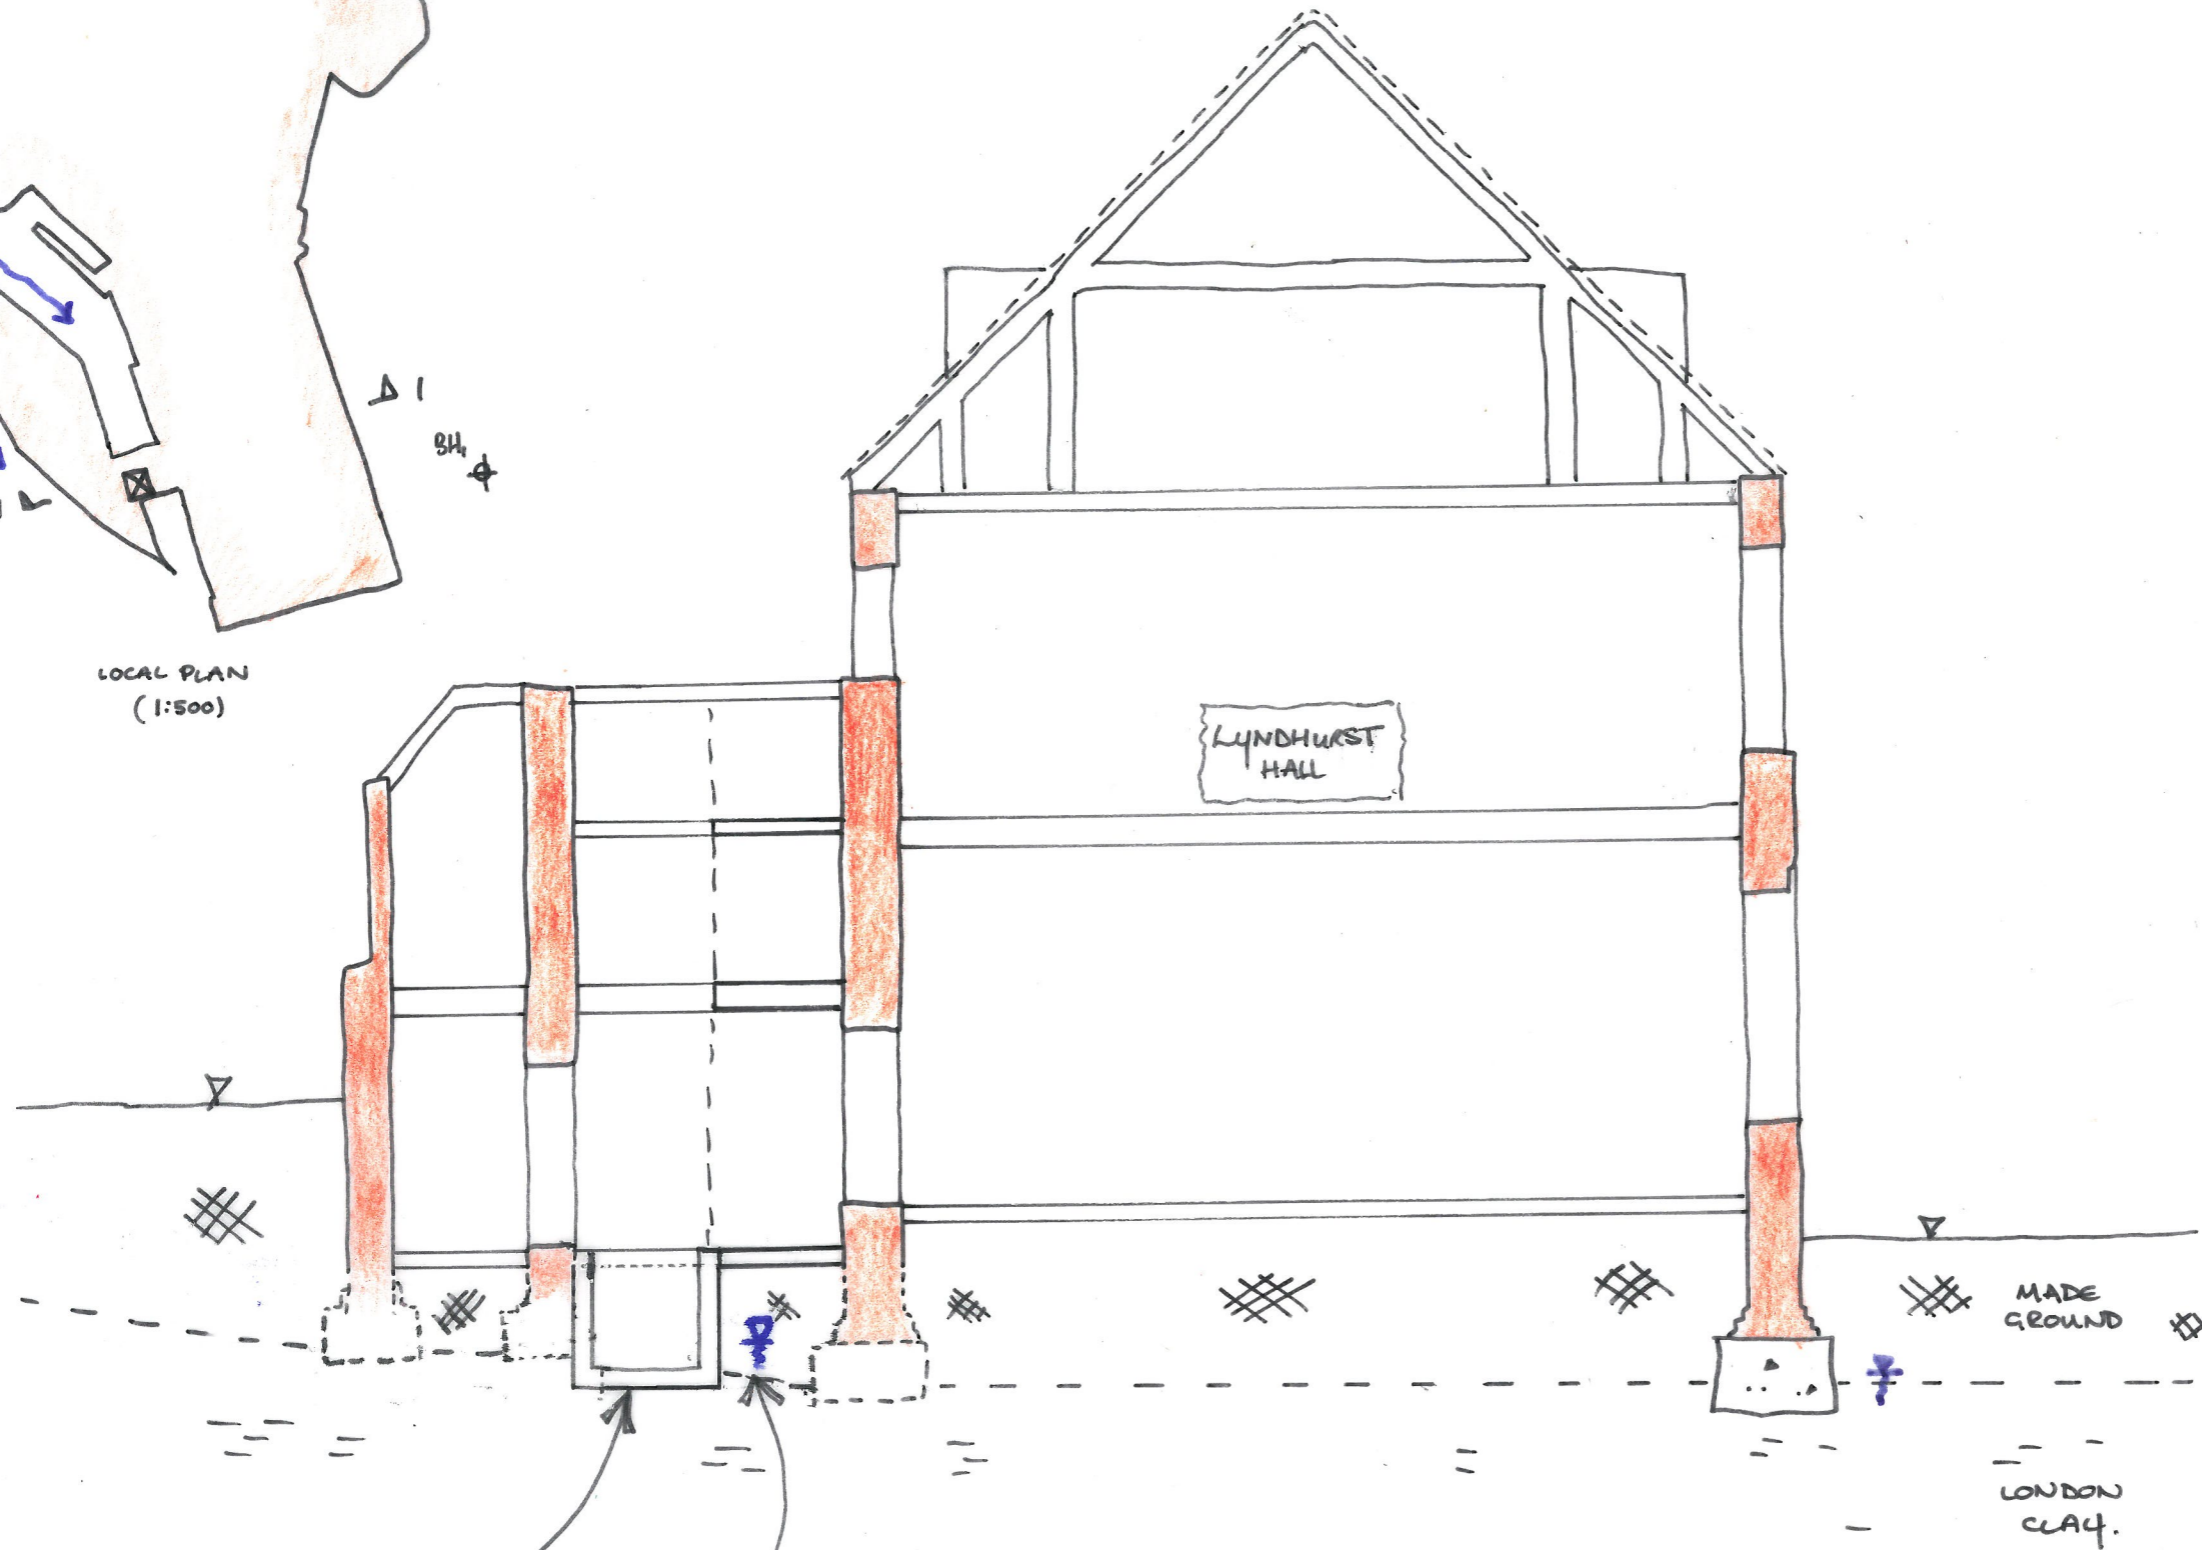
SECTION 1-1

LYNDHURST HALL

MADE GROUND

LONDON CLAY.

LOCATION OF LIFT BASED ON ARCHIVE DRAWINGS.

WATER TABLE (INDICATIVE) SHOWN IS BASED ON READINGS TAKEN FROM BH1

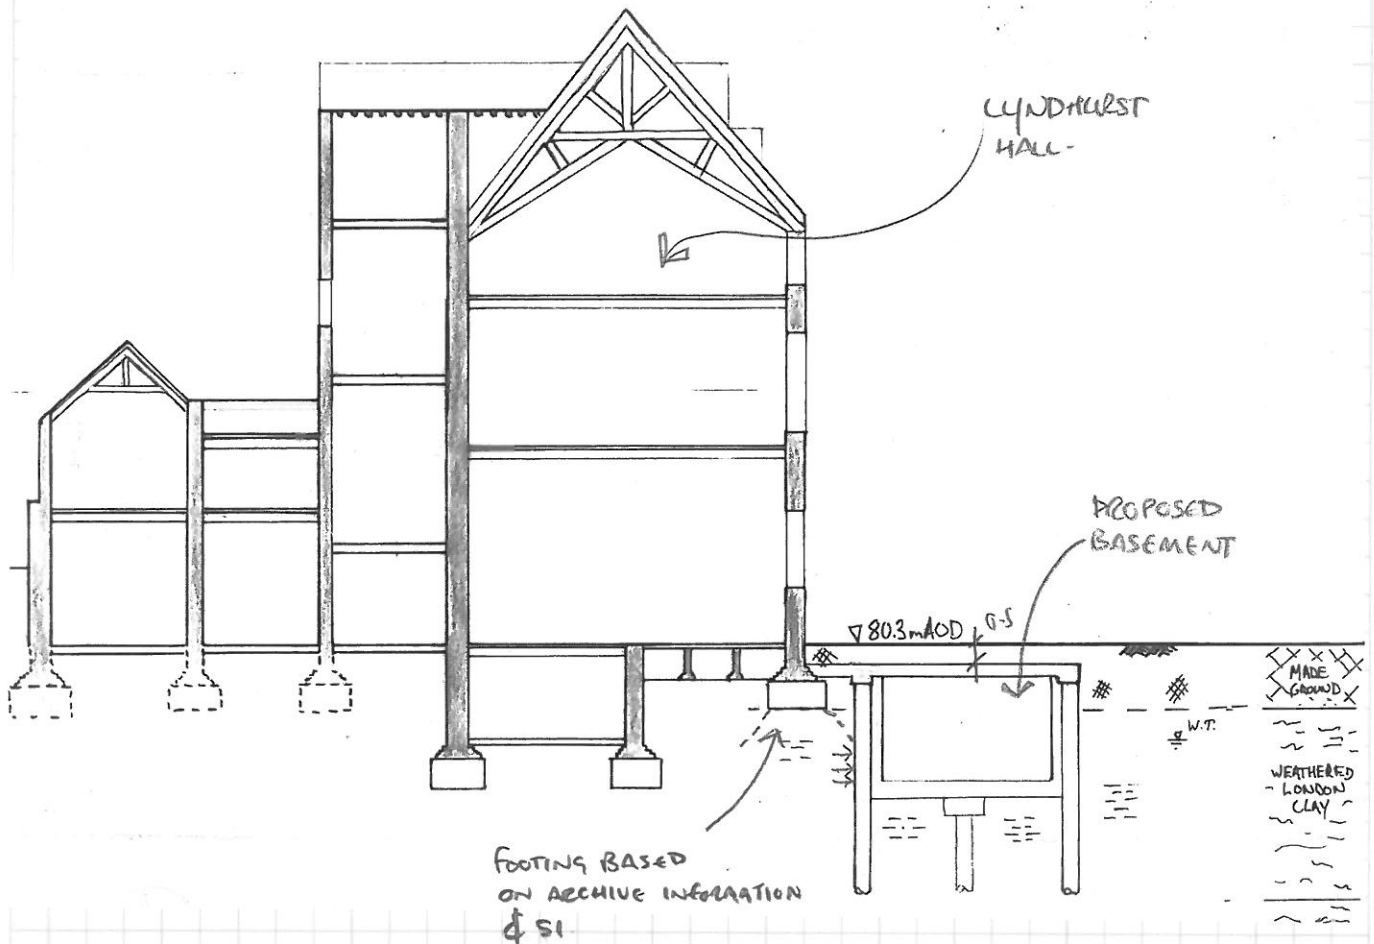
SECTION SHOWING PROPOSAL.

THE CALCULATIONS TAKE INTO CONSIDERATION THE SURCHARGE APPLIED TO THE RETAINING WALL. THE SURCHARGE LOADS ARE BASED ON THE AVAILABLE RECORD INFORMATION ON LYNDBURST HALL.

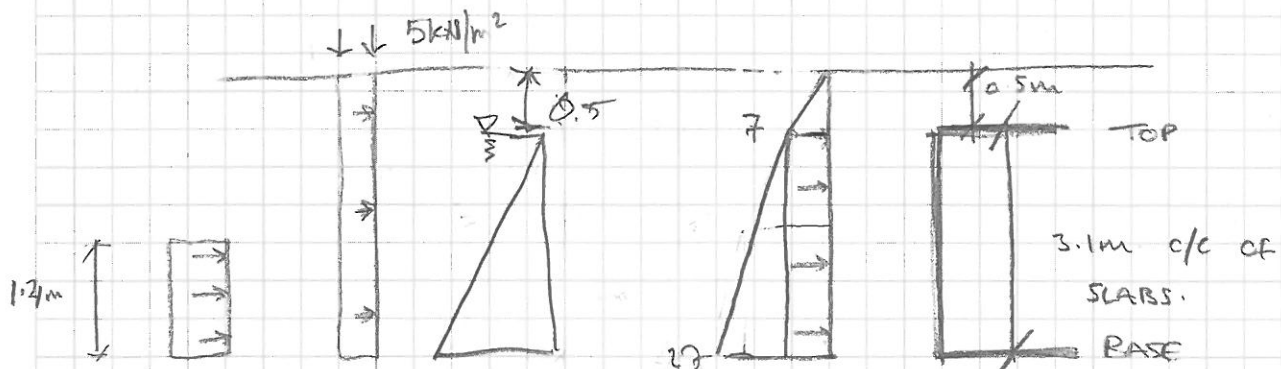
LOADS ON RETAINING WALL

SURCHARGE FROM LINDA REST HALL	IMPOSED SURCHARGE $P_0 K_0$	WATER $\gamma_w h$	SOIL (DRY)	(NTS)
AT TOP	—	3 kN/m²	0	7 kN/m²	TOTALS ↓ 10 kN/m²
AT BASE	55 kN/m²	3 kN/m²	32.5 kN/m²	27 kN/m²	123 kN/m²

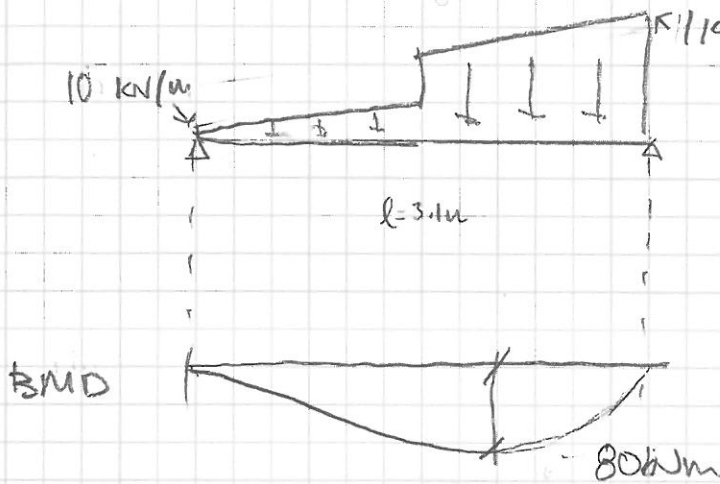
CONSIDER A 1m STRIP OF WALL IN ANALYSIS

BEAM ANALYSIS CARRIED OUT IN THE COMPUTED ANALYSIS SOFTWARE 'TEDDS'. BENDING MOMENTS SUMMARISED HERE.
