Ground floor

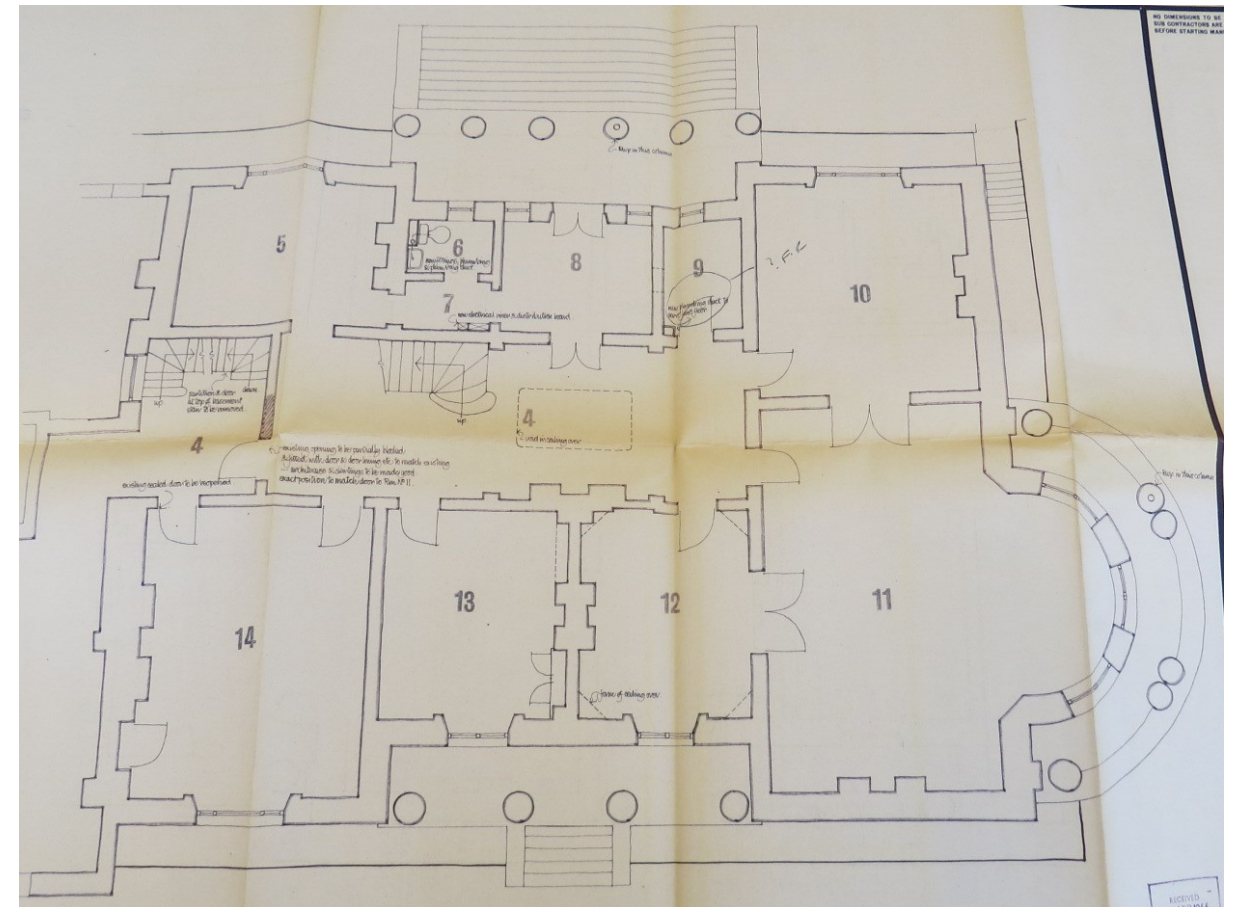
Figure 58. The Ground Floor general arrangement plan produced in 1966 by Casson Condor for the refurbishment works undertaken in the late 1960s.

- 3.78 Original plans for Kidderpore Hall have not been found. The earliest comprehensive general arrangement plans showing the layout of the property are provided in the set drawn up by Casson Condor Architects for the proposed refurbishment in 1966. The ground floor plan of the property is shown at Figure 58, which shows the layout of rooms at the ground floor level largely as they exist today. Six rooms lead off the entrance hallway, with the grandest reception room (Room 11) to the north west of the house, where the large bay window provides an aspect into the garden. It is known that this room was used as a student common room from the years 1905-12 when Westfield College occupied the site. A photograph of this room dating from c. 1905 is included at Figure 57, which shows the existing fireplace in situ.

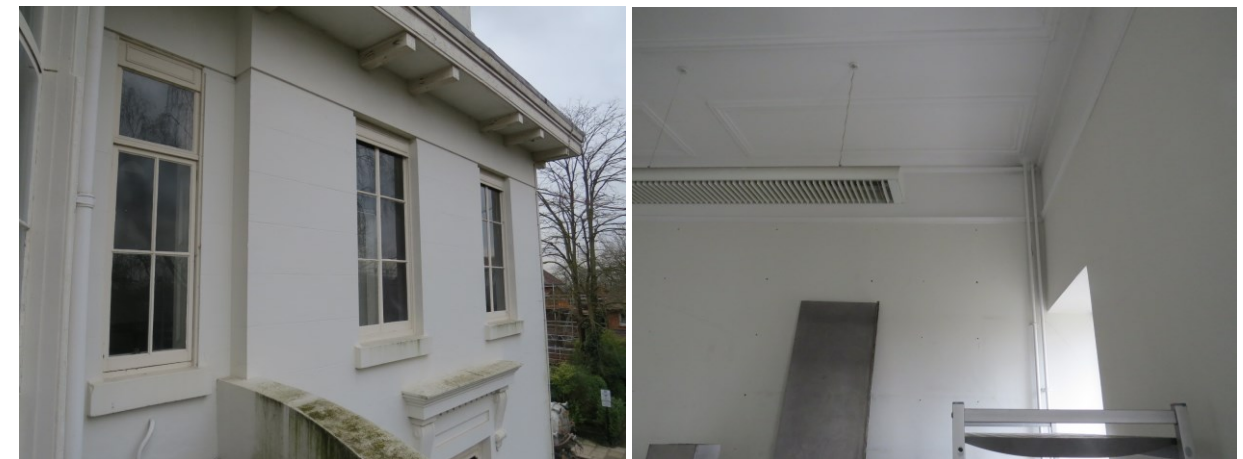
**Figure 62.** (Left) A photograph of the west elevation taken from a location on the balcony to the bay window. The central window is divided internally by the later partition. (Right) The internal partition which cuts the window internally.

- 3.82 Our investigation of the interiors at the property in conjunction with the exterior appearance of the west elevation has revealed that the partition at the first floor level which divides the two rooms must, in fact, be a later addition. This is owing to the position of the alignment of the window. This is discussed in more detail in the Kidderpore Hall Historic Building report prepared by Scott Brownrigg.

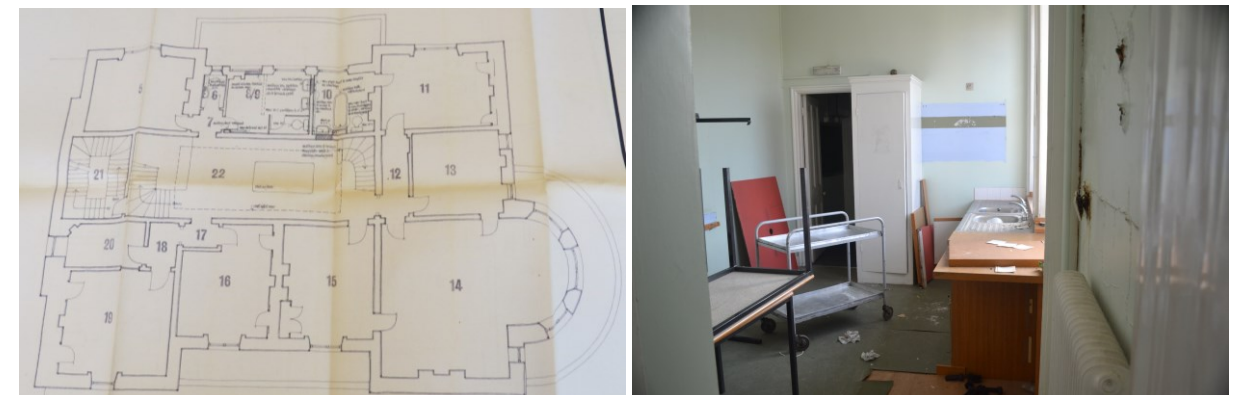
**Figure 63.** (left) The First Floor general arrangement plan produced in 1966 by Casson Condor for the refurbishment works undertaken in the late 1960s. (right) An image of the kitchenette in one of the former bedrooms at the first floor level.

- 3.80 The general layout of the planform at the first floor level largely reflects that of the ground floor. The central landing provides access to, what would once have been, bedroom accommodation for the family. One room at this floor level is now a converted kitchen.

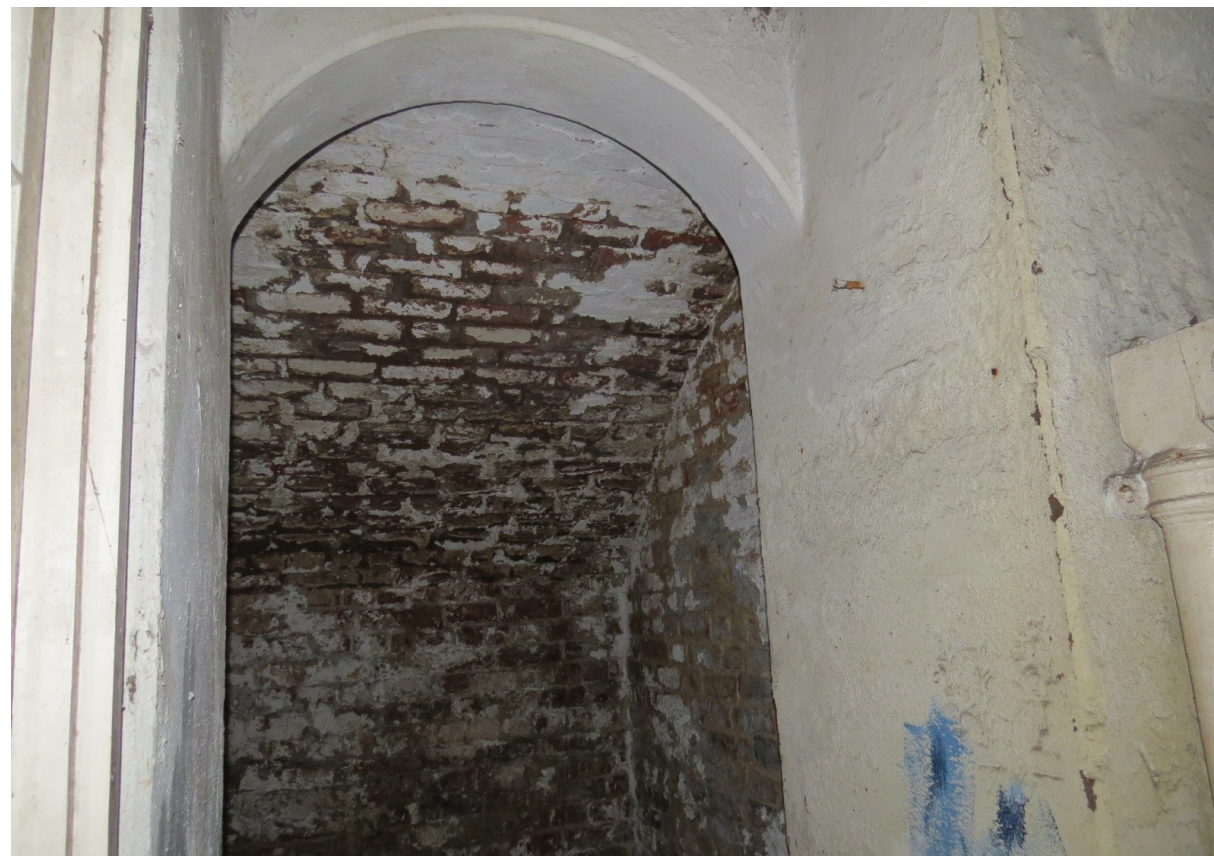
**Figure 64.** A photograph of one of the vaults at the basement level of Kidderpore Hall located underneath the pavement.

- 3.86 The basement areas of Kidderpore Hall are currently the location of storage rooms and toilet facilities and can only be accessed from Bay House, not from Kidderpore Hall. This floor level does not possess interior architectural features which contribute to the significance of the building, albeit the original vaults underneath the pavement to Kidderpore Avenue remain intact.

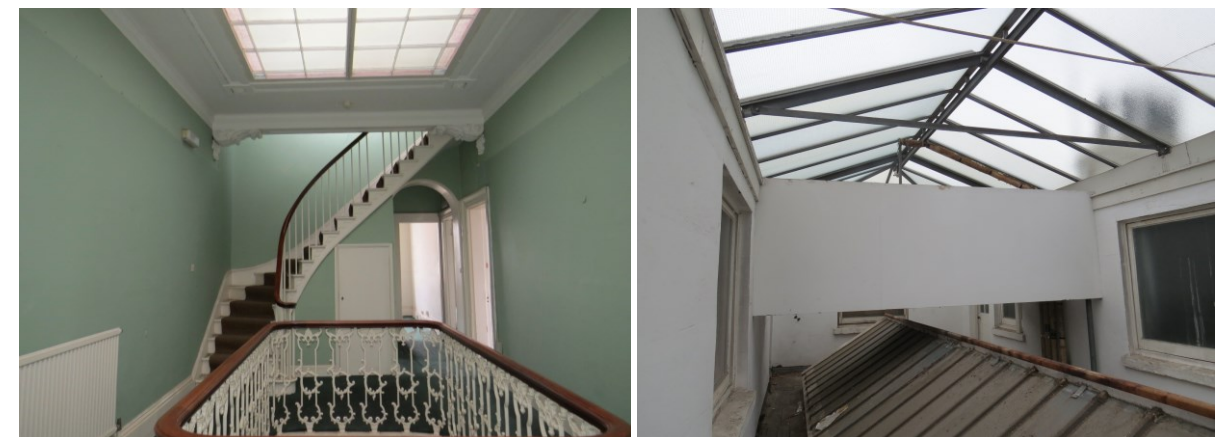
**Figure 66.** A photograph of the decorative skylight seen from a location on the first floor level landing, and the second floor level, and the structure located over the skylight at the second floor level.

- 3.83 The planform at the second floor was originally laid out for the occupation of the staff who served the family in Kidderpore Hall. Access is provided to this floor level by two staircases, both of which lead from the first floor level to the top of the building, one of which is enclosed adjacent to the principal staircase. The staircase leading from the first to the second floor level is shown in Figure 66.

- 3.85 The rooms at the second floor level are located around the central rooflight which allows light in from the A frame truss structure. This is a later, harmful addition which detracts from an appreciation of this central space. No original plans have been found for the detail of how this area was originally laid out at the second floor level.

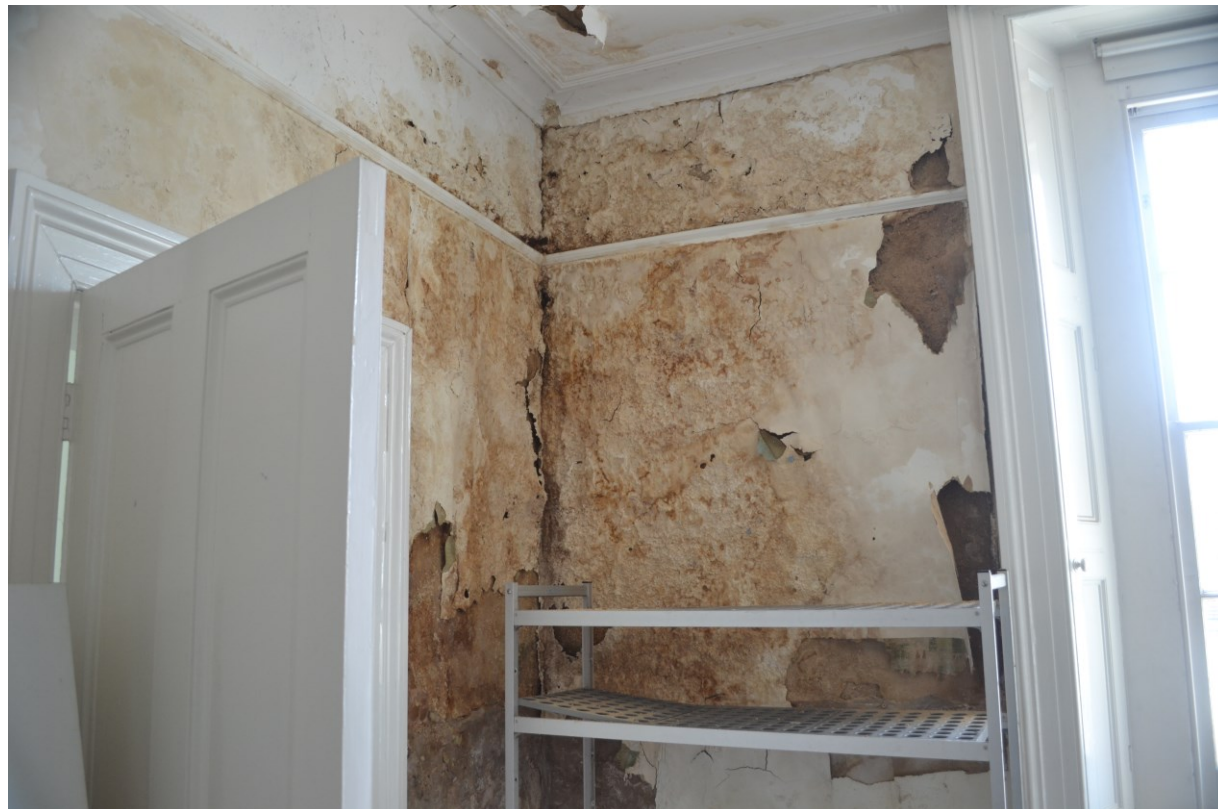
**Figure 68.** An image of the damage caused by water ingress at the first floor level.

- 3.87 Kidderpore Hall has not been in a sustained, active use for a period of ten years. The fabric of the building has suffered from lack of maintenance and in some rooms, the quality of some of the interiors has been thoroughly degraded by the effects of water ingress. Photographs of the degraded interiors are shown at Figure 68.

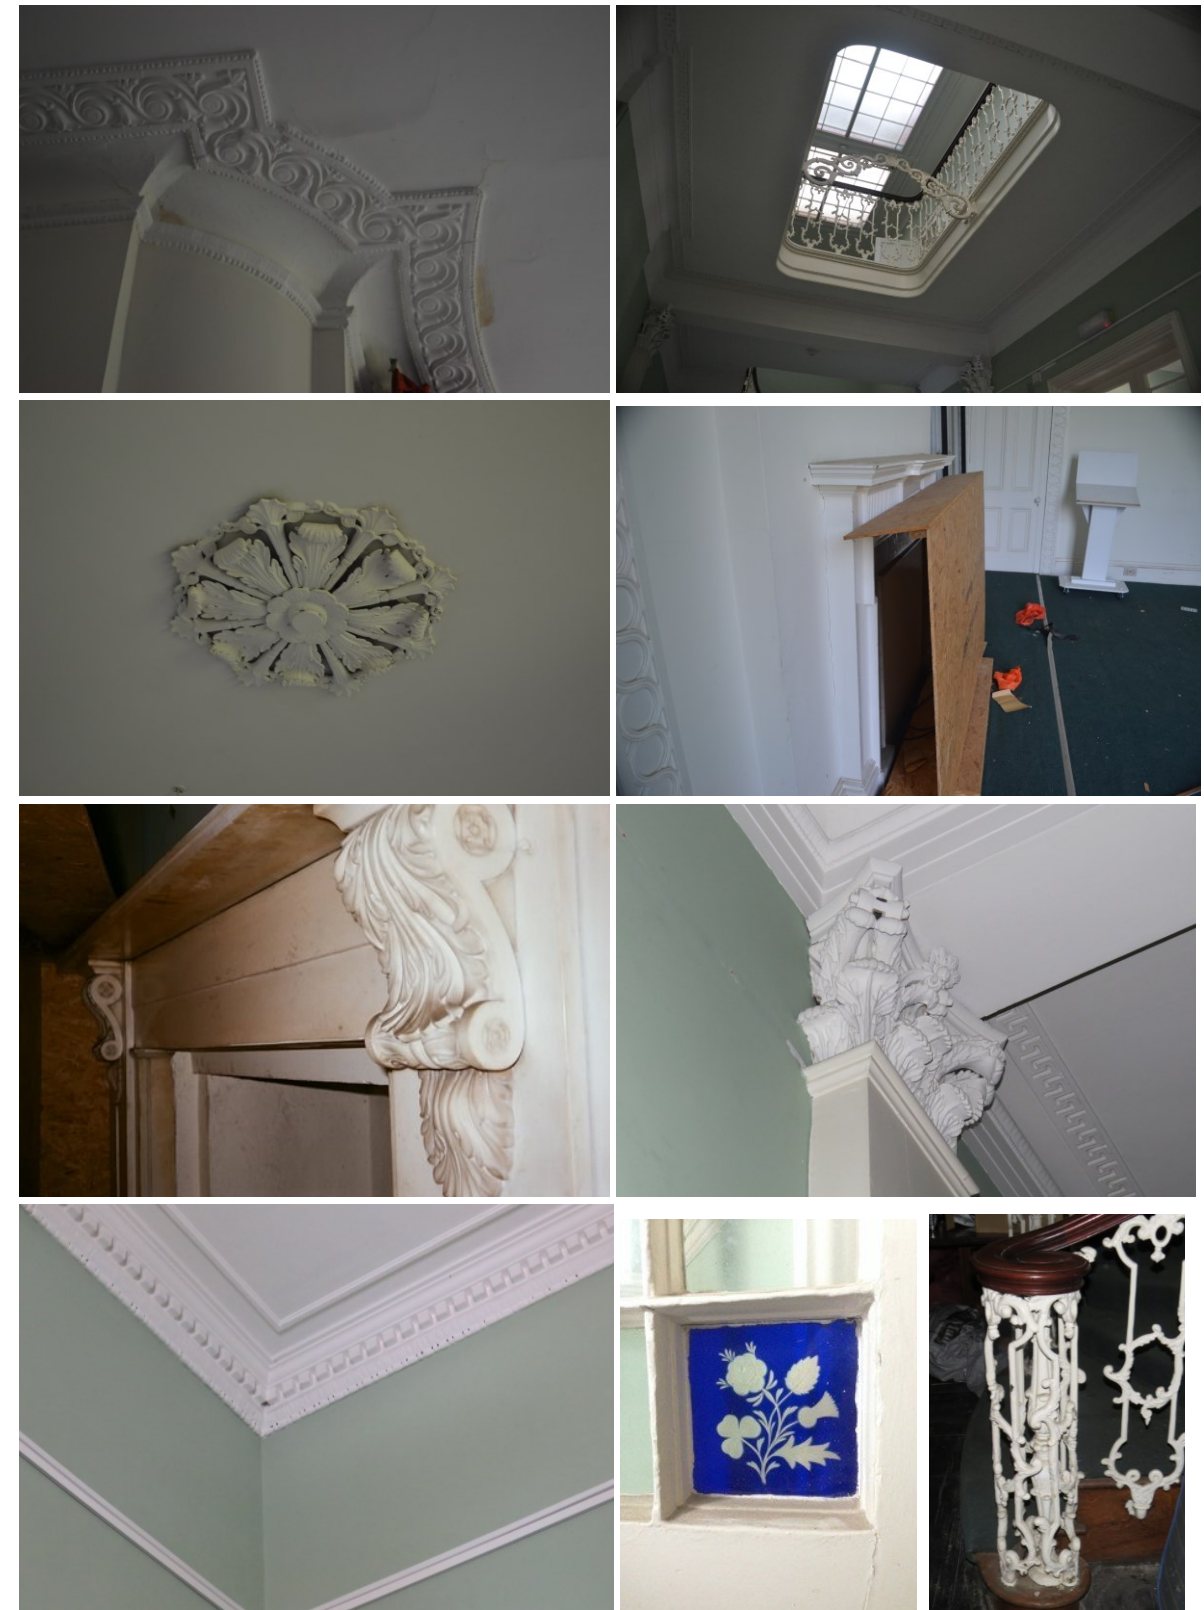
**Figure 69.** A palette of architectural features which are retained within Kidderpore Hall at the ground and first floor levels. Most of these features, including the balustrades to the principal staircase, the cornice and ceiling roses are original to the property.

- 3.89 Notwithstanding the poor condition of the interiors, a significant number of original and historic architectural features remain in the property. A palette of these architectural features is shown at Figure 69. Most of these features, including the balustrades to the principal staircase, the cornice and ceiling roses are original to the property.

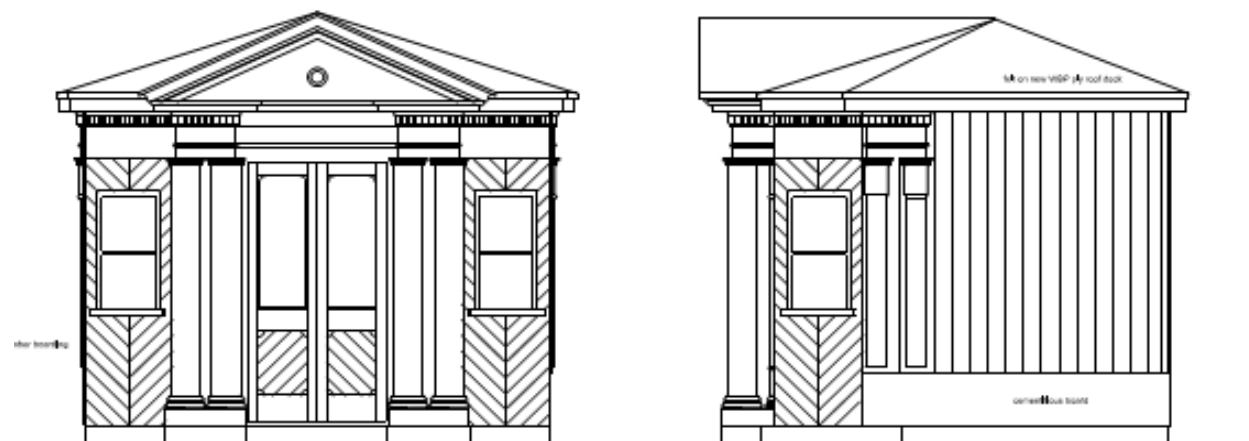
**Figure 70** Survey plans of the summerhouse prepared for the relocation of the Chapel consented as part of the 1997 Appeal scheme.

3.94 The surveyed elevations undertaken for the removal and relocation of the Summerhouse as part of the scheme approved at Appeal in 1997 are shown at Figure 70, courtesy of Paskin Kyriakides Sands Architects. The Summerhouse has windows in the front and side elevations and consists of one room only. It has not been possible to carry out an internal inspection for the purposes of this statement due to health and safety reasons. Photographs of the interior of the building taken in 2002 are included in the Historic Building report produced by Scott Brownrigg.

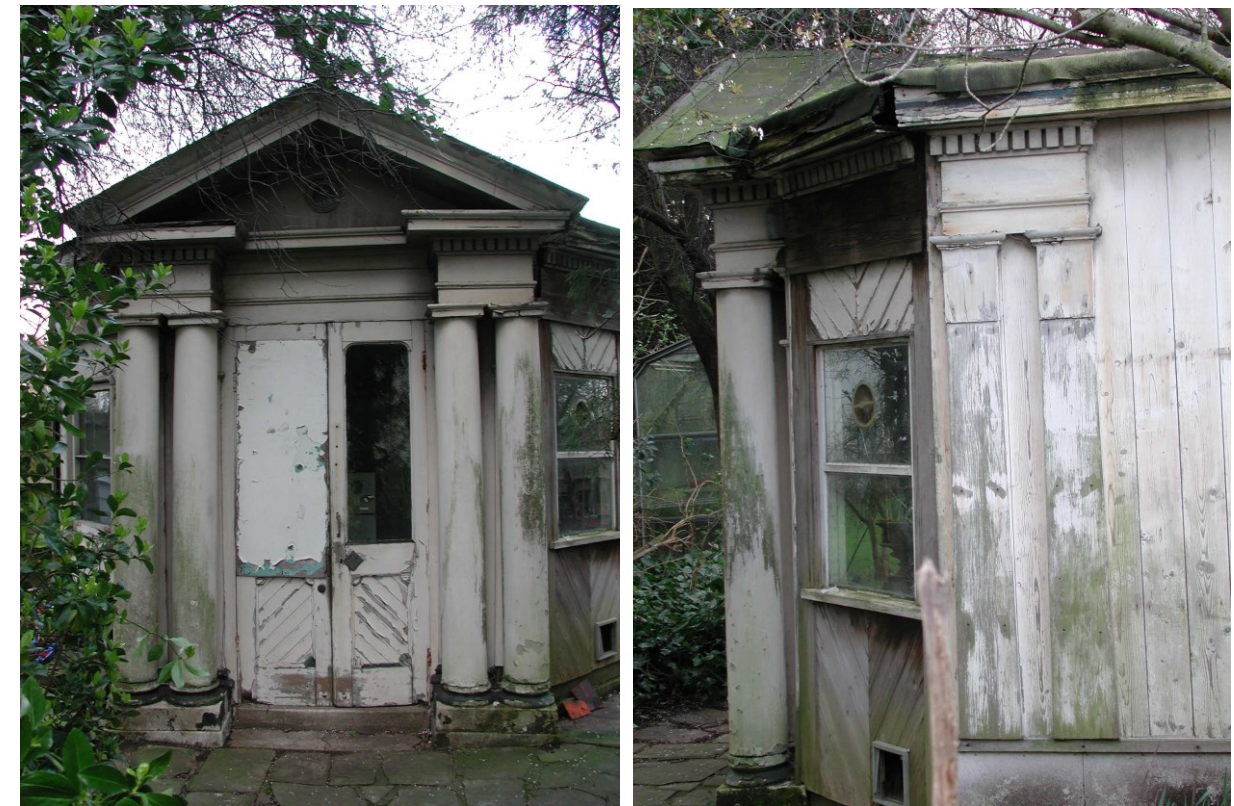
**Figure 71** A photograph of the Summerhouse taken in 2002. These give an indication of the physical state of the building 13 years ago.

3.95 The Summerhouse is currently supported by scaffolding and is in a state of disrepair. The structure is clearly unstable and entry is not possible. This is a listed building at risk of being lost as a result of decay and neglect. It is not included on Historic England At Risk Register.

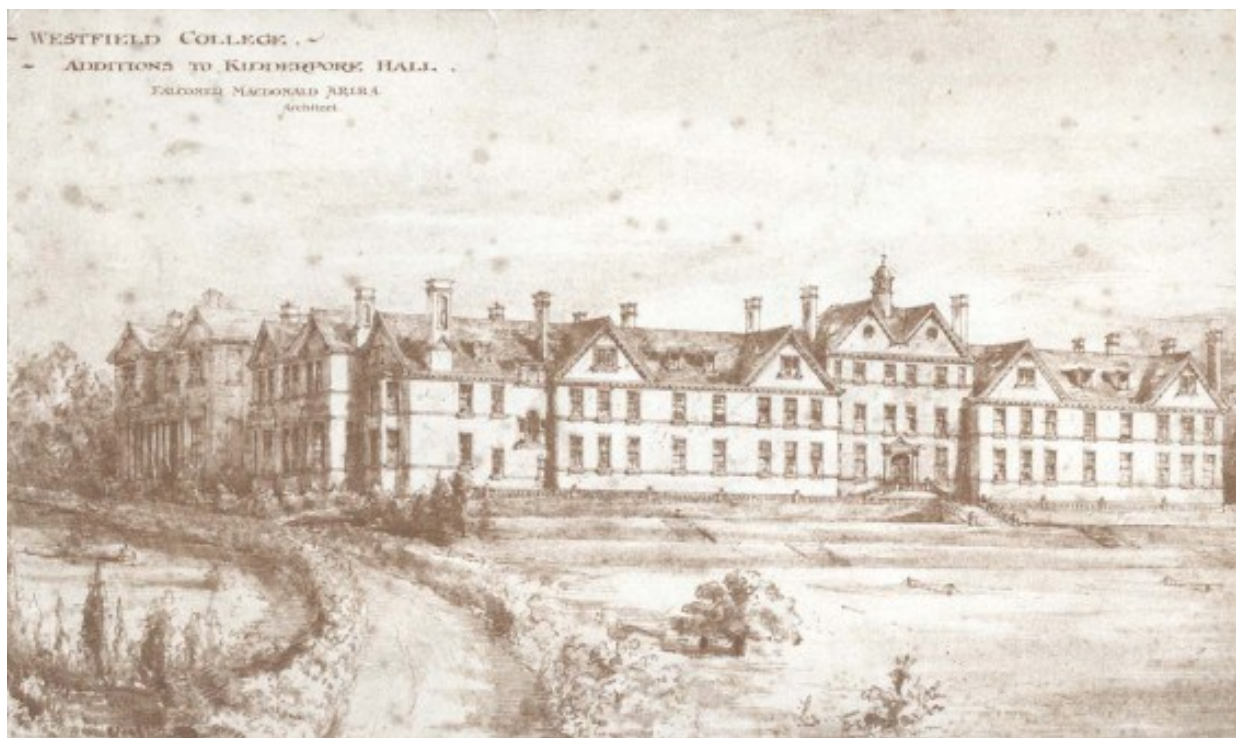
Figure 73 An architect's view of the additions to Kidderpore Hall, Falconer Macdonald c. 1891.

- 3.99 As one of his first commissions, and one for an institution on a tight budget, Robert employed, therefore, an economic approach to the Queen Anne style, with two long ranges of symmetrical elevations to the north and south. The south elevation faced onto open fields when it was first built, as shown in Figure 73.

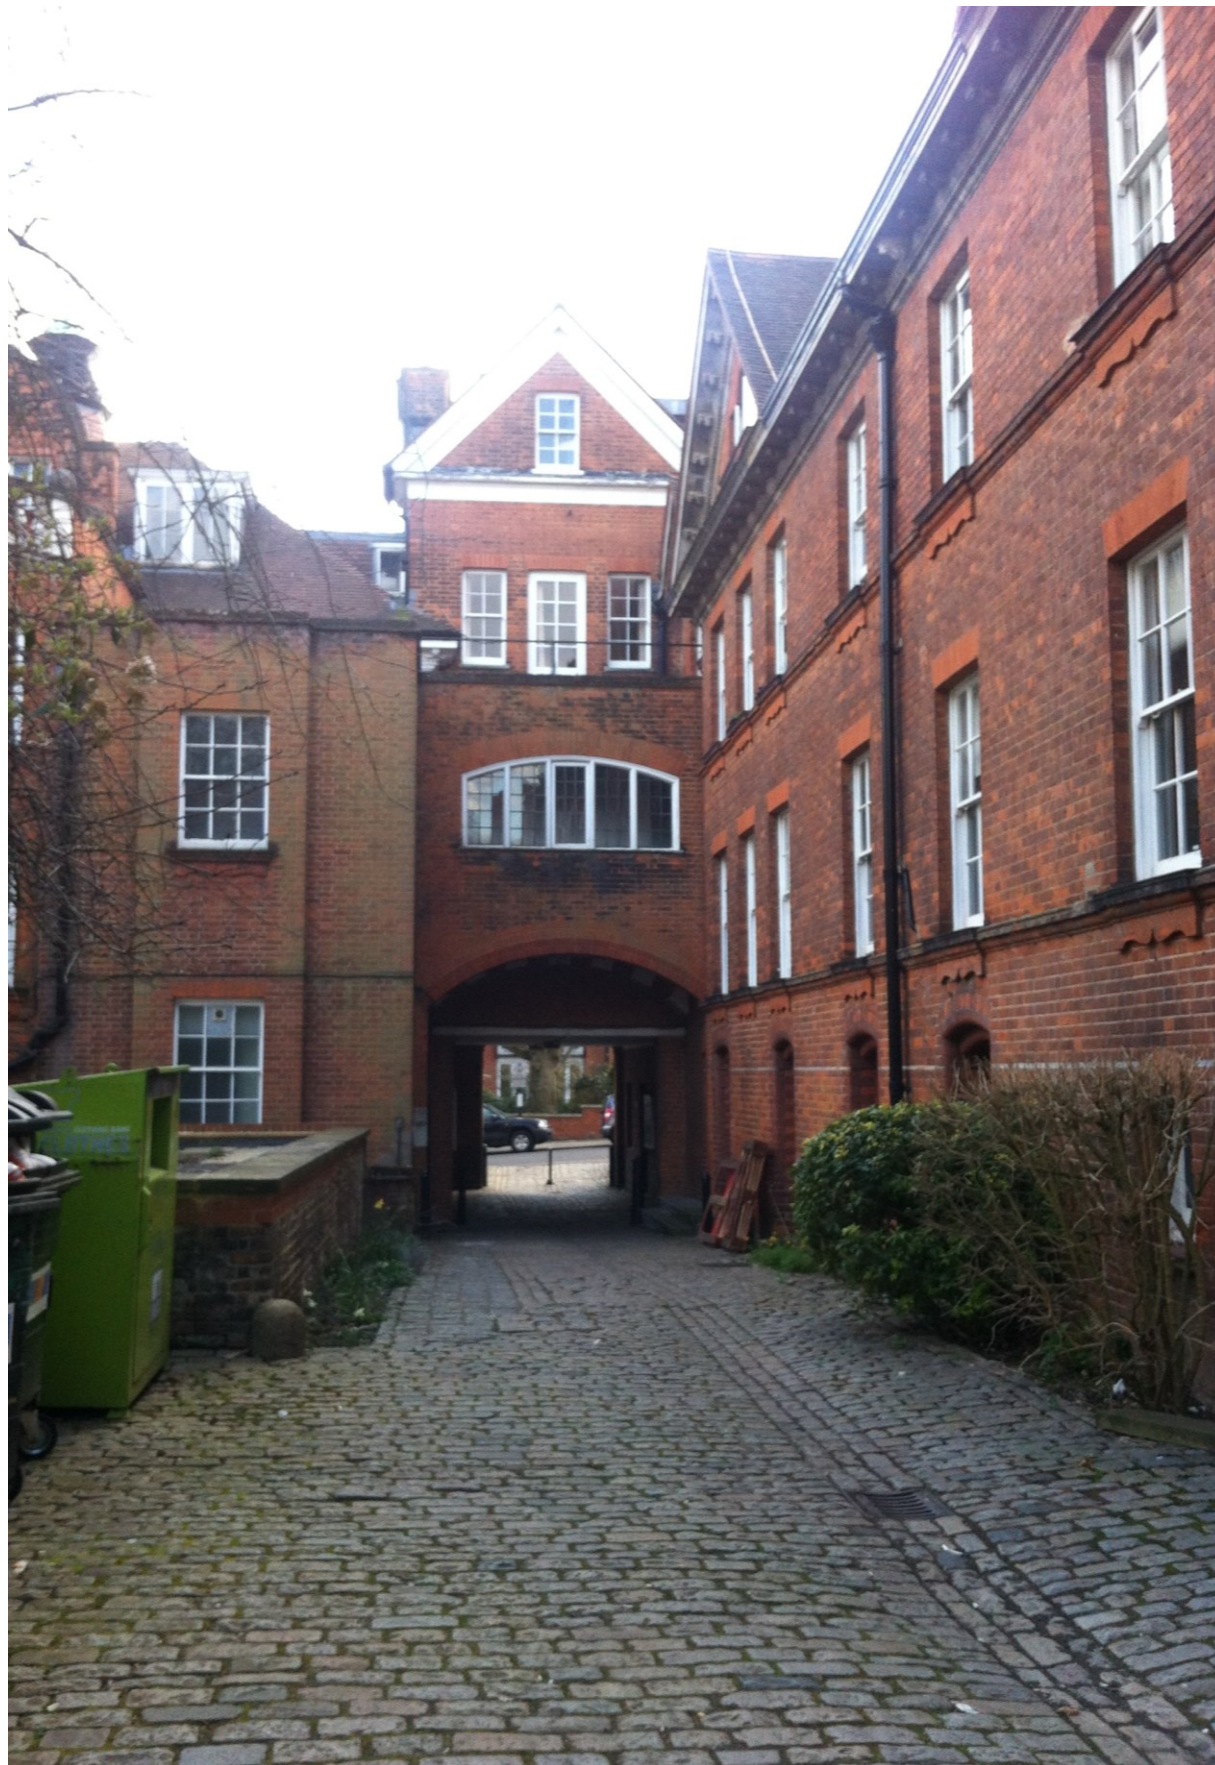
Figure 78 A photograph of the cobbled walkway to the east of Maynard wing looking towards Kidderpore Avenue.

3.107 The cobbled walkway outside the south elevation to Maynard can be seen in early photographs of the student wing c. 1905 and is shown currently at Figure 76. The original extent of the walkway has, however, been reduced by the later extension to the rear of Skeel Library which can be seen in Figure 78.

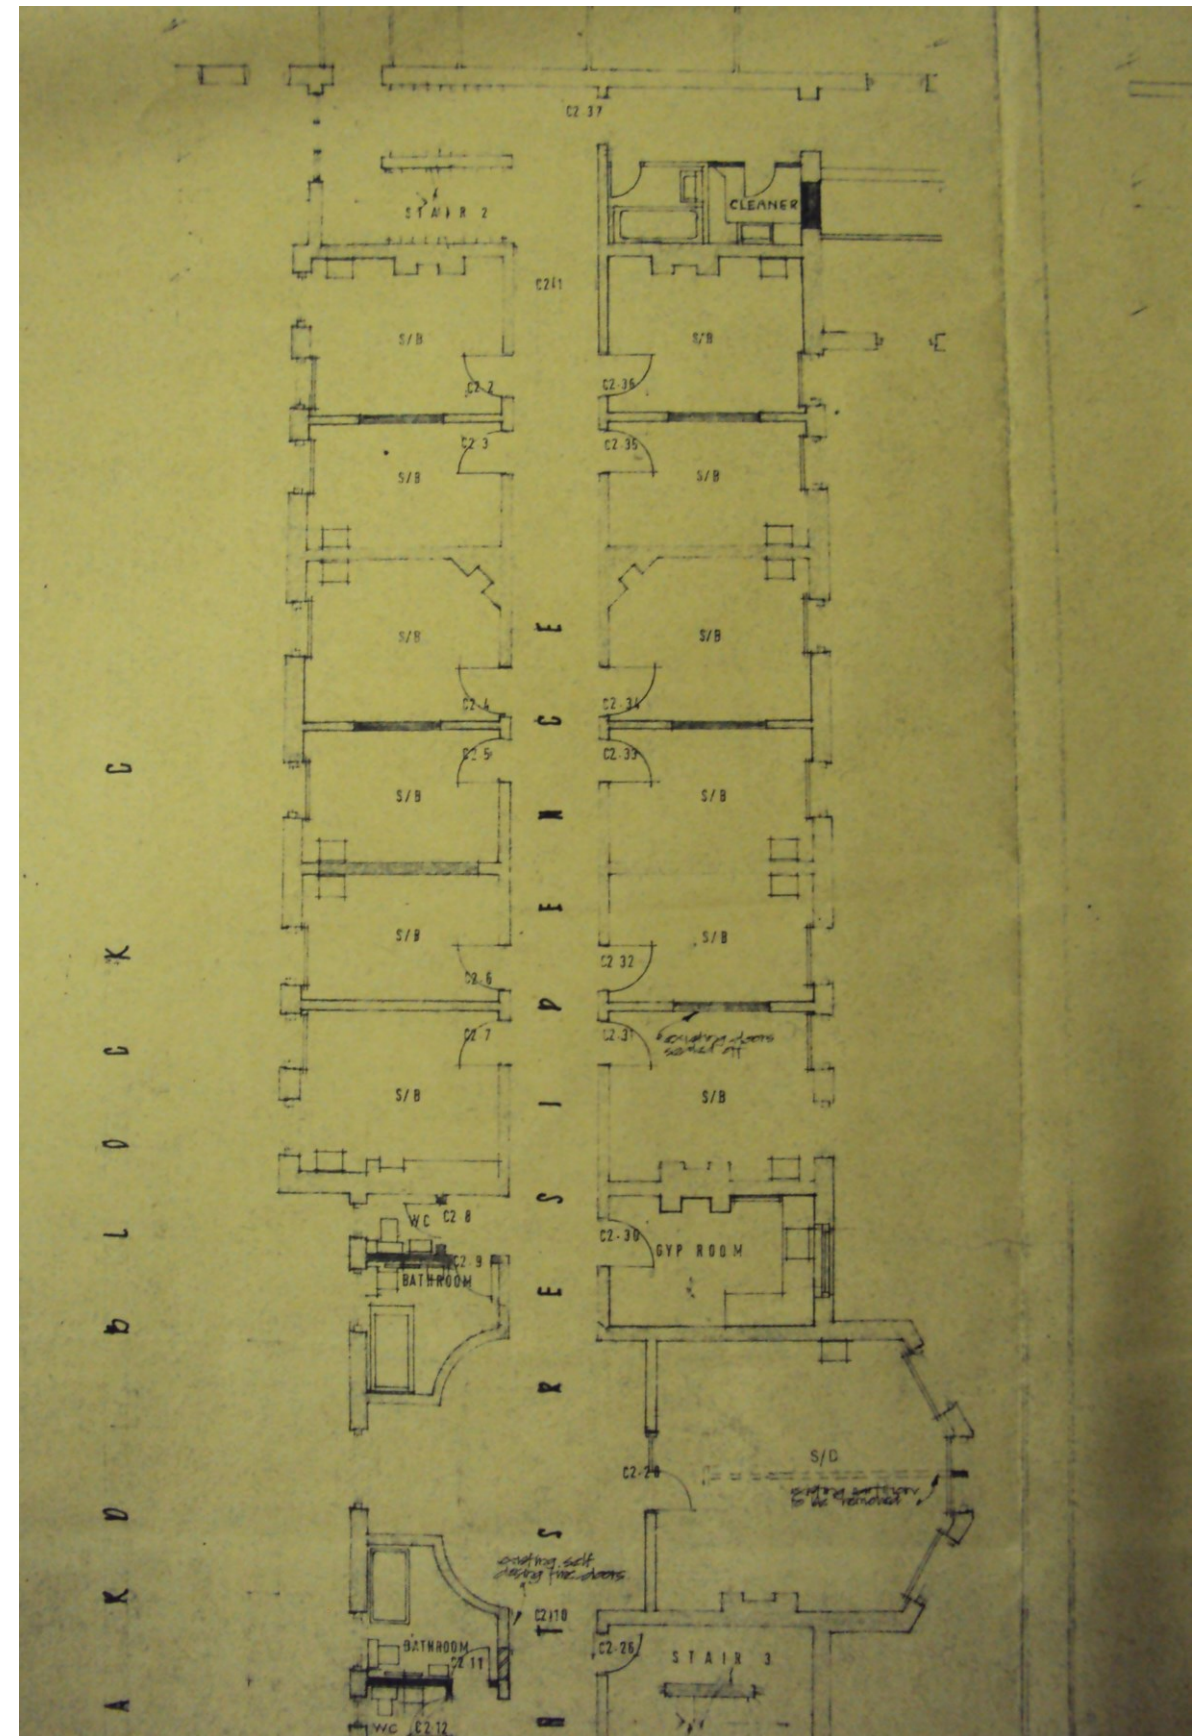
Figure 79. Image of the proposed alterations to be carried out in 1973 to increase the number of student bedrooms.
