29 New End, Hampstead

Structural Report : Reconstruction of Lawn House Buttresses

Ref No: 24397

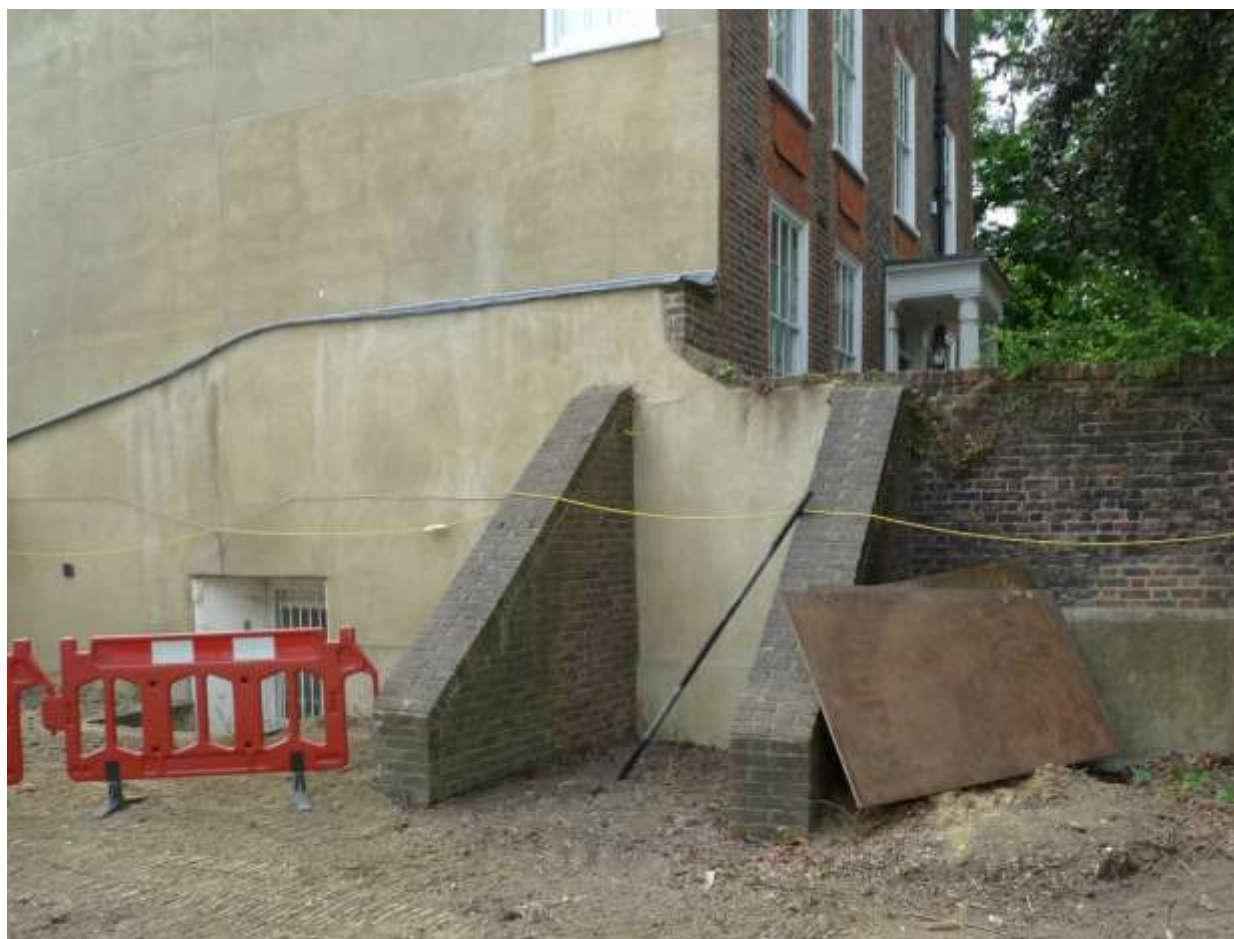
The buttresses are shown below, close to the Grade II Listed building of Lawn House which is adjacent to the site.

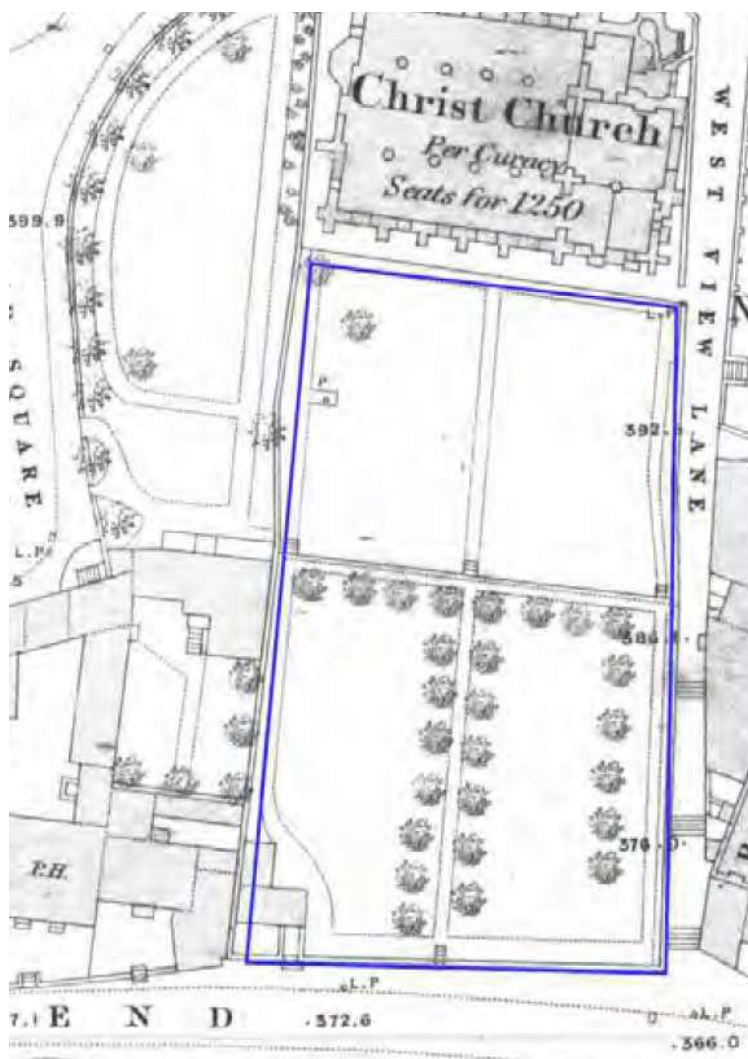
OS 1870, part, extracted from Desk Top Study

Soil Consultants have completed a desk top study which includes collation and review of historic OS mapping, The 1870 mapping shows the site to still be undeveloped, and also makes clearer the alignment of the East-West wall crossing the site and abutting the west boundary slightly north of Lawn House :

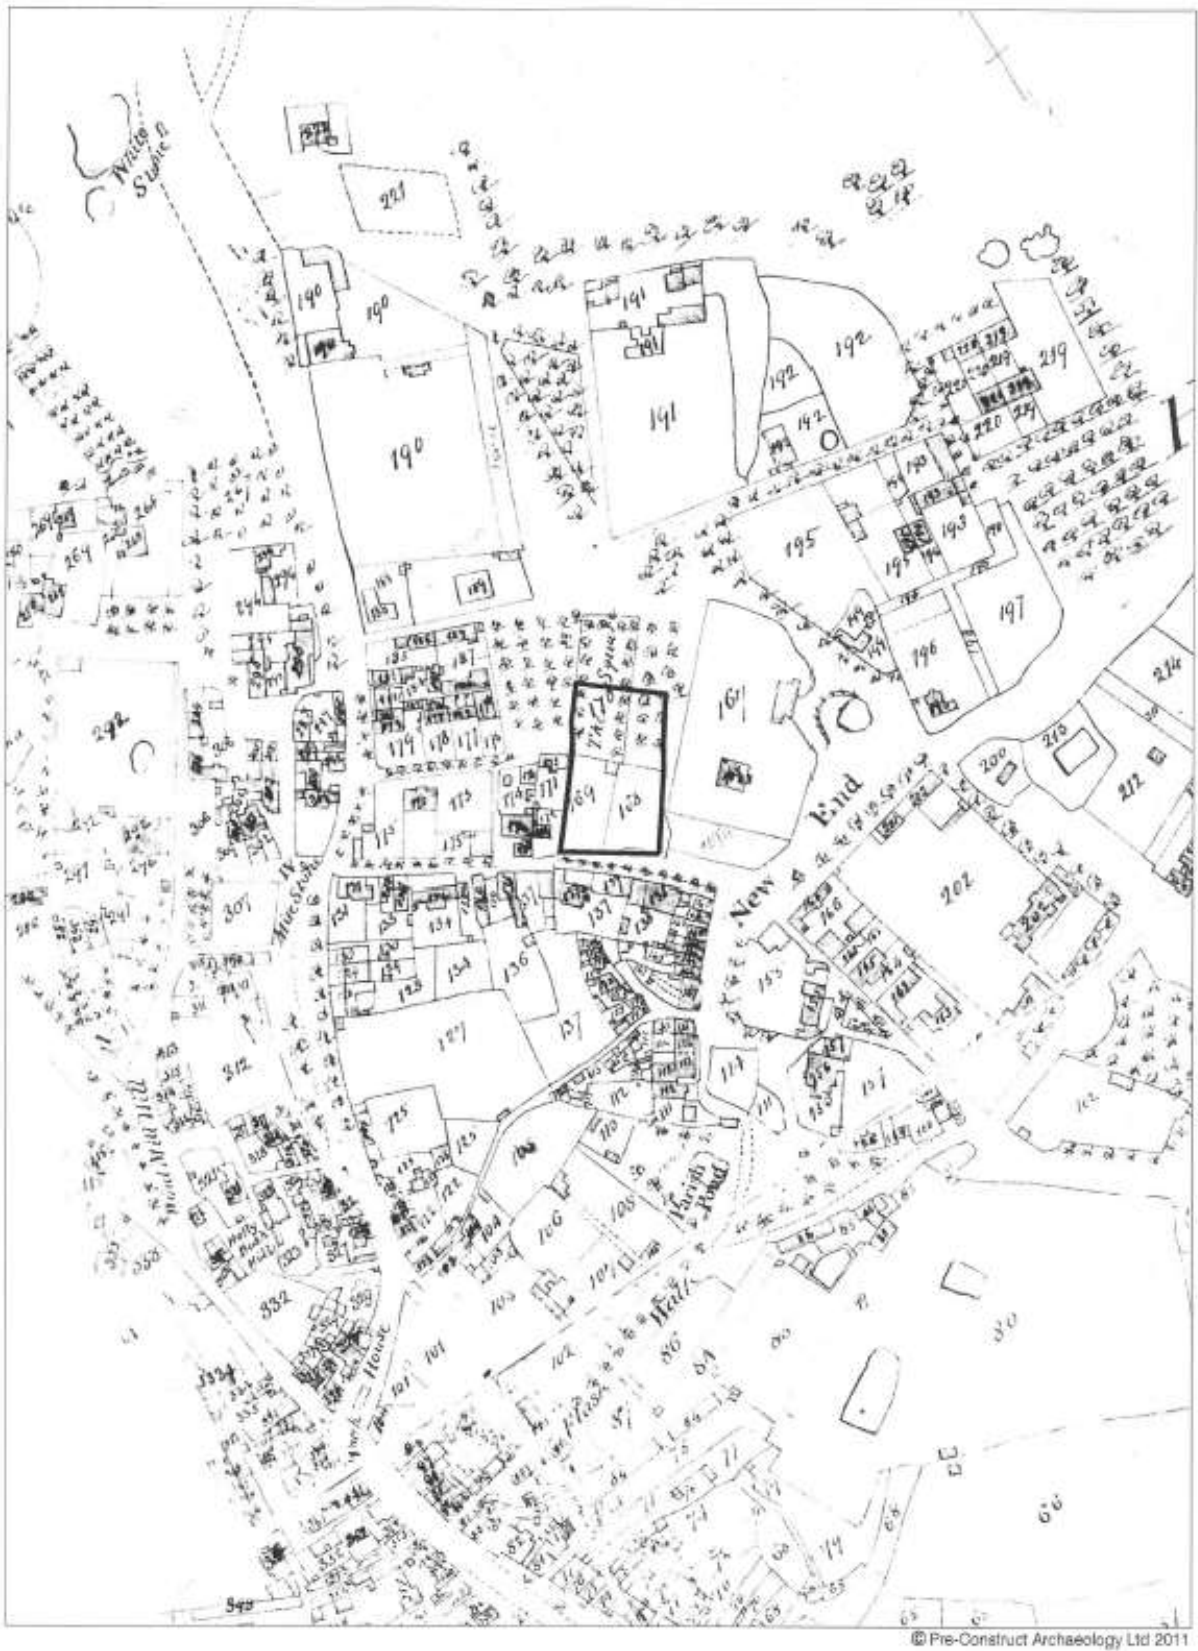
Figure 6
Belsize Manor and Lands: compiled for Lord Chesterfield, 1762

Pre-Construct have prepared an archaeological report in connection with the development. The 1762 map of Belsize Manor and Lands included therein indicates that the site of 29 New End was undeveloped open space, albeit with indications of garden walls crossing the site. The existence of these garden walls was confirmed during 2016 archaeological excavations.

Refer to 1762 plan overleaf.

Lawn House is shown as existing on the 1762 map therefore dates from prior to this. *Pre-Construct* note that the Victoria County History suggests that Lawn House was built “probably before 1709”

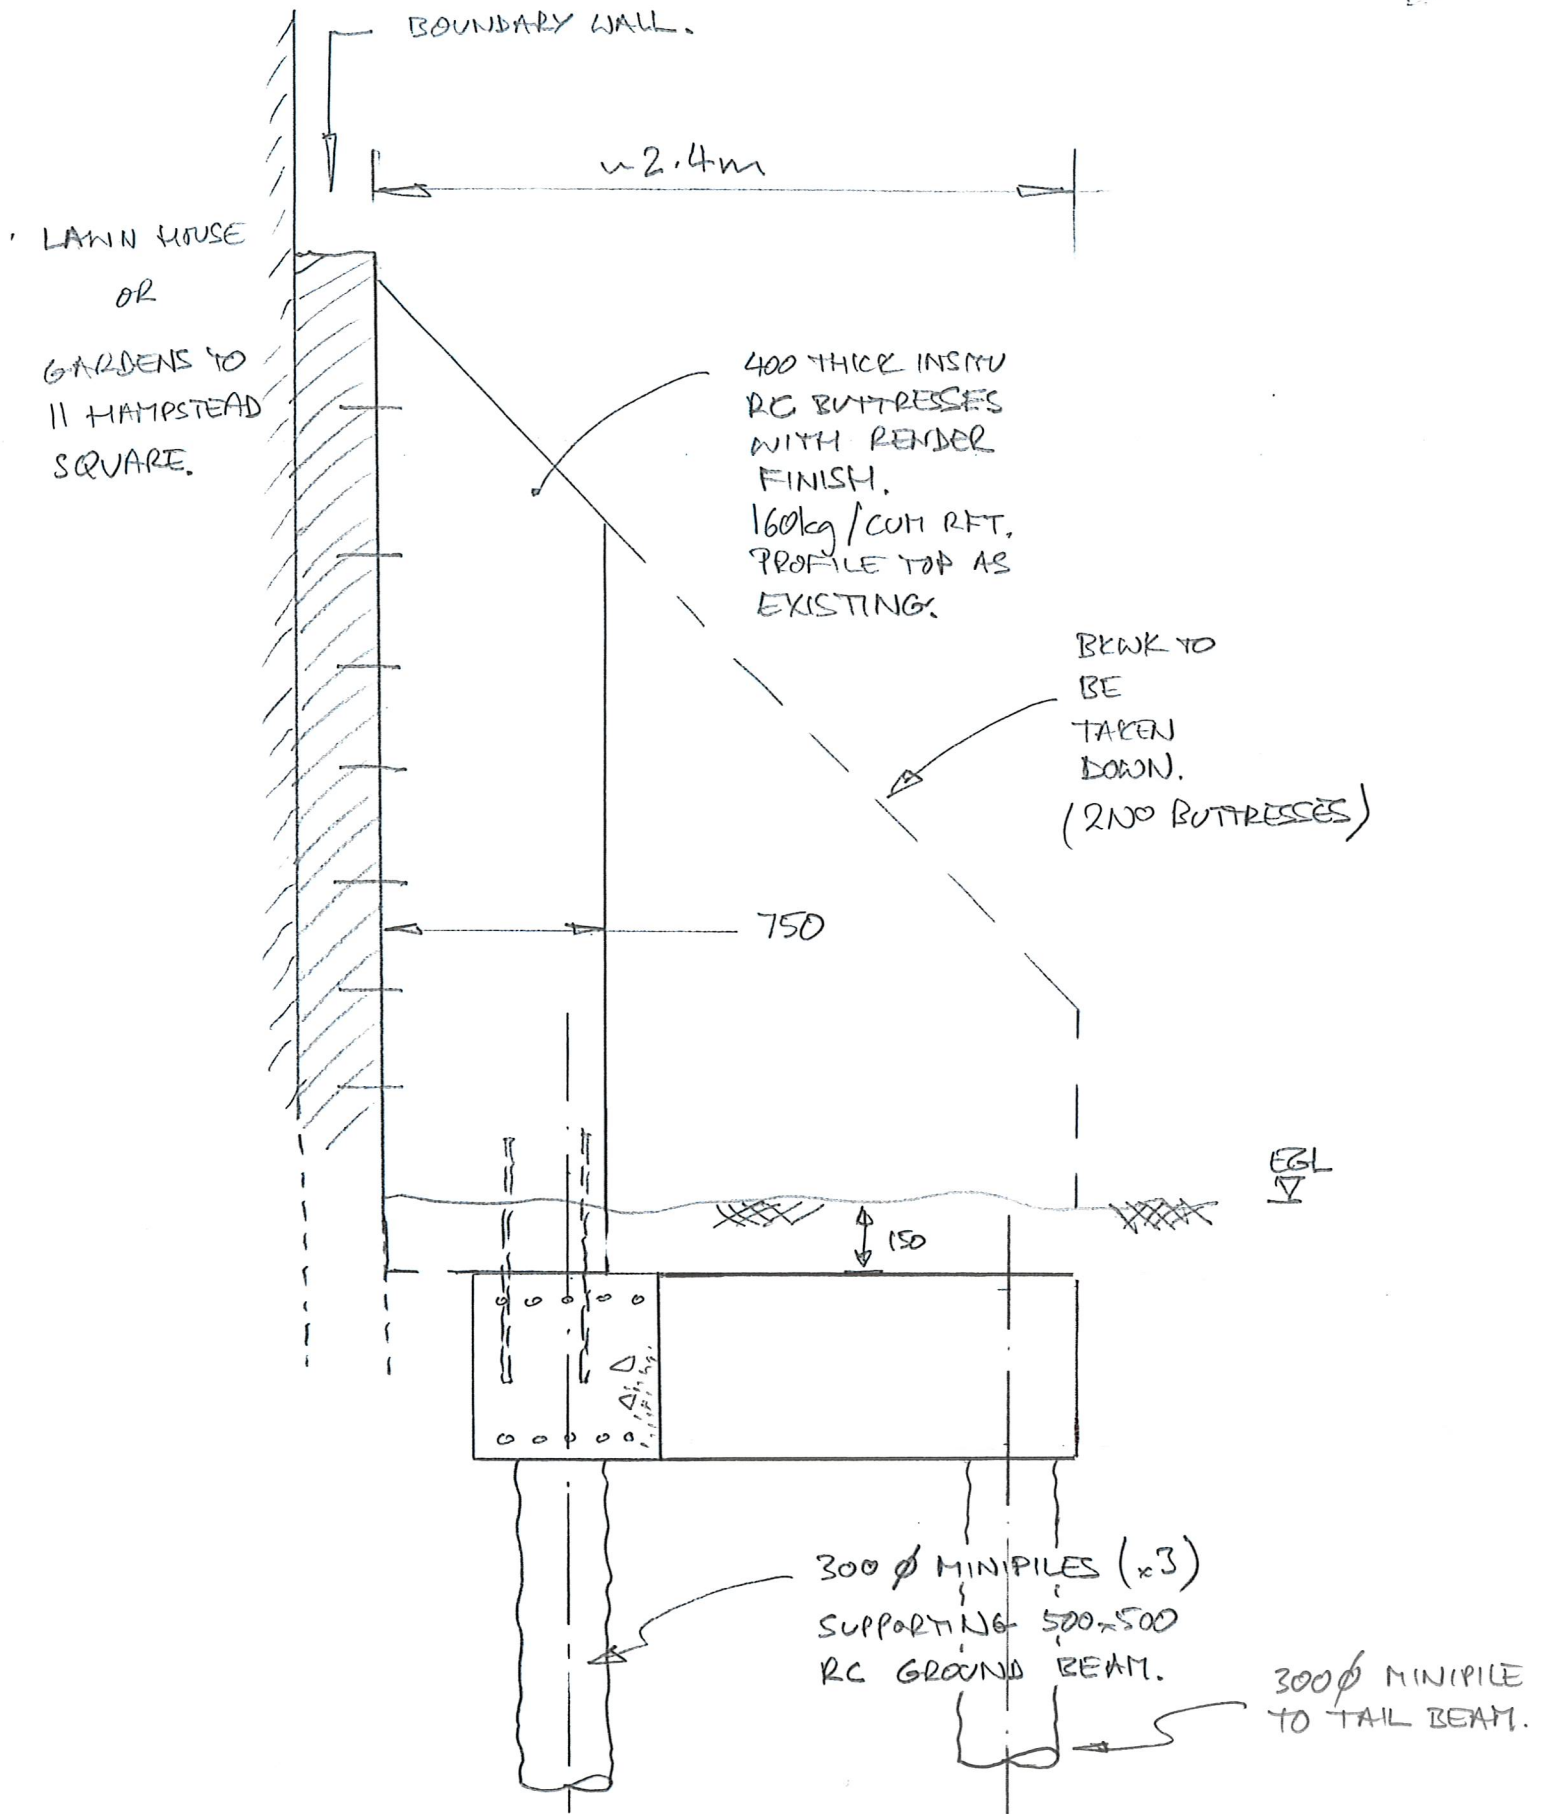
Project: 29 NEW END, NW3 1JD
 Title: BUTTRESS RECONSTRUCTION - SECTION
 Job No. 24397 Date: 7.6.16 Drn By: RWS
 Sheet No. SK/04 REV: T2 Chk By:

To be read in conjunction with KSR Architects drawing 15031-LB-001 and Fluid Structures drawings 24397/SK04T2 and SK06T2

The principle is to form a new permanent footing of RC on minipiled foundations, prop the wall with temporary steel posts, remove the old buttresses, then form the new pair of buttresses.

1. Prepare existing ground adjacent to Lawn House for a small mini-piling rig.
(Ground level is 119.8m AOD. Organic material will be removed and minimum 150mm layer of hardcore placed)
2. Bore minipiles. These will be augured cast in place reinforced concrete piles nominally 300mm diameter and expected to be around 8m deep.
3. Trim pile heads and expose the pile reinforcement
4. Excavate trench circa 750 deep and then shutter and cast the RC ground beam / pile cap adjacent to Lawn House, including forming the two necessary openings through the 2No existing buttresses. These openings will be approximately 750mm square and formed using hand tools. The RC ground beam will be T-shape on plan for stability.

5. Erect 3No bolted temporary steel 254x254 UC 89 posts onto the top of the RC ground beam/pile cap, with 4No M20 holding down bolts at their bases. Pack the gap between these posts and the garden wall with timber packing secured in position
6. Demolish the 2 buttress using hand tools
7. Shutter and cast the two new RC buttresses, now only 750mm in length
8. Take down temporary timber packing and 254x254 UC steel posts
