**Rear Elevation**  
 Following erection of scaffold inspect and schedule repairs to RW goods, copings, flashings and pointing. Known areas of concern are annotated.

**Poetry Society Offices and Poetry Café - Rear elevation**

**Mills Power**

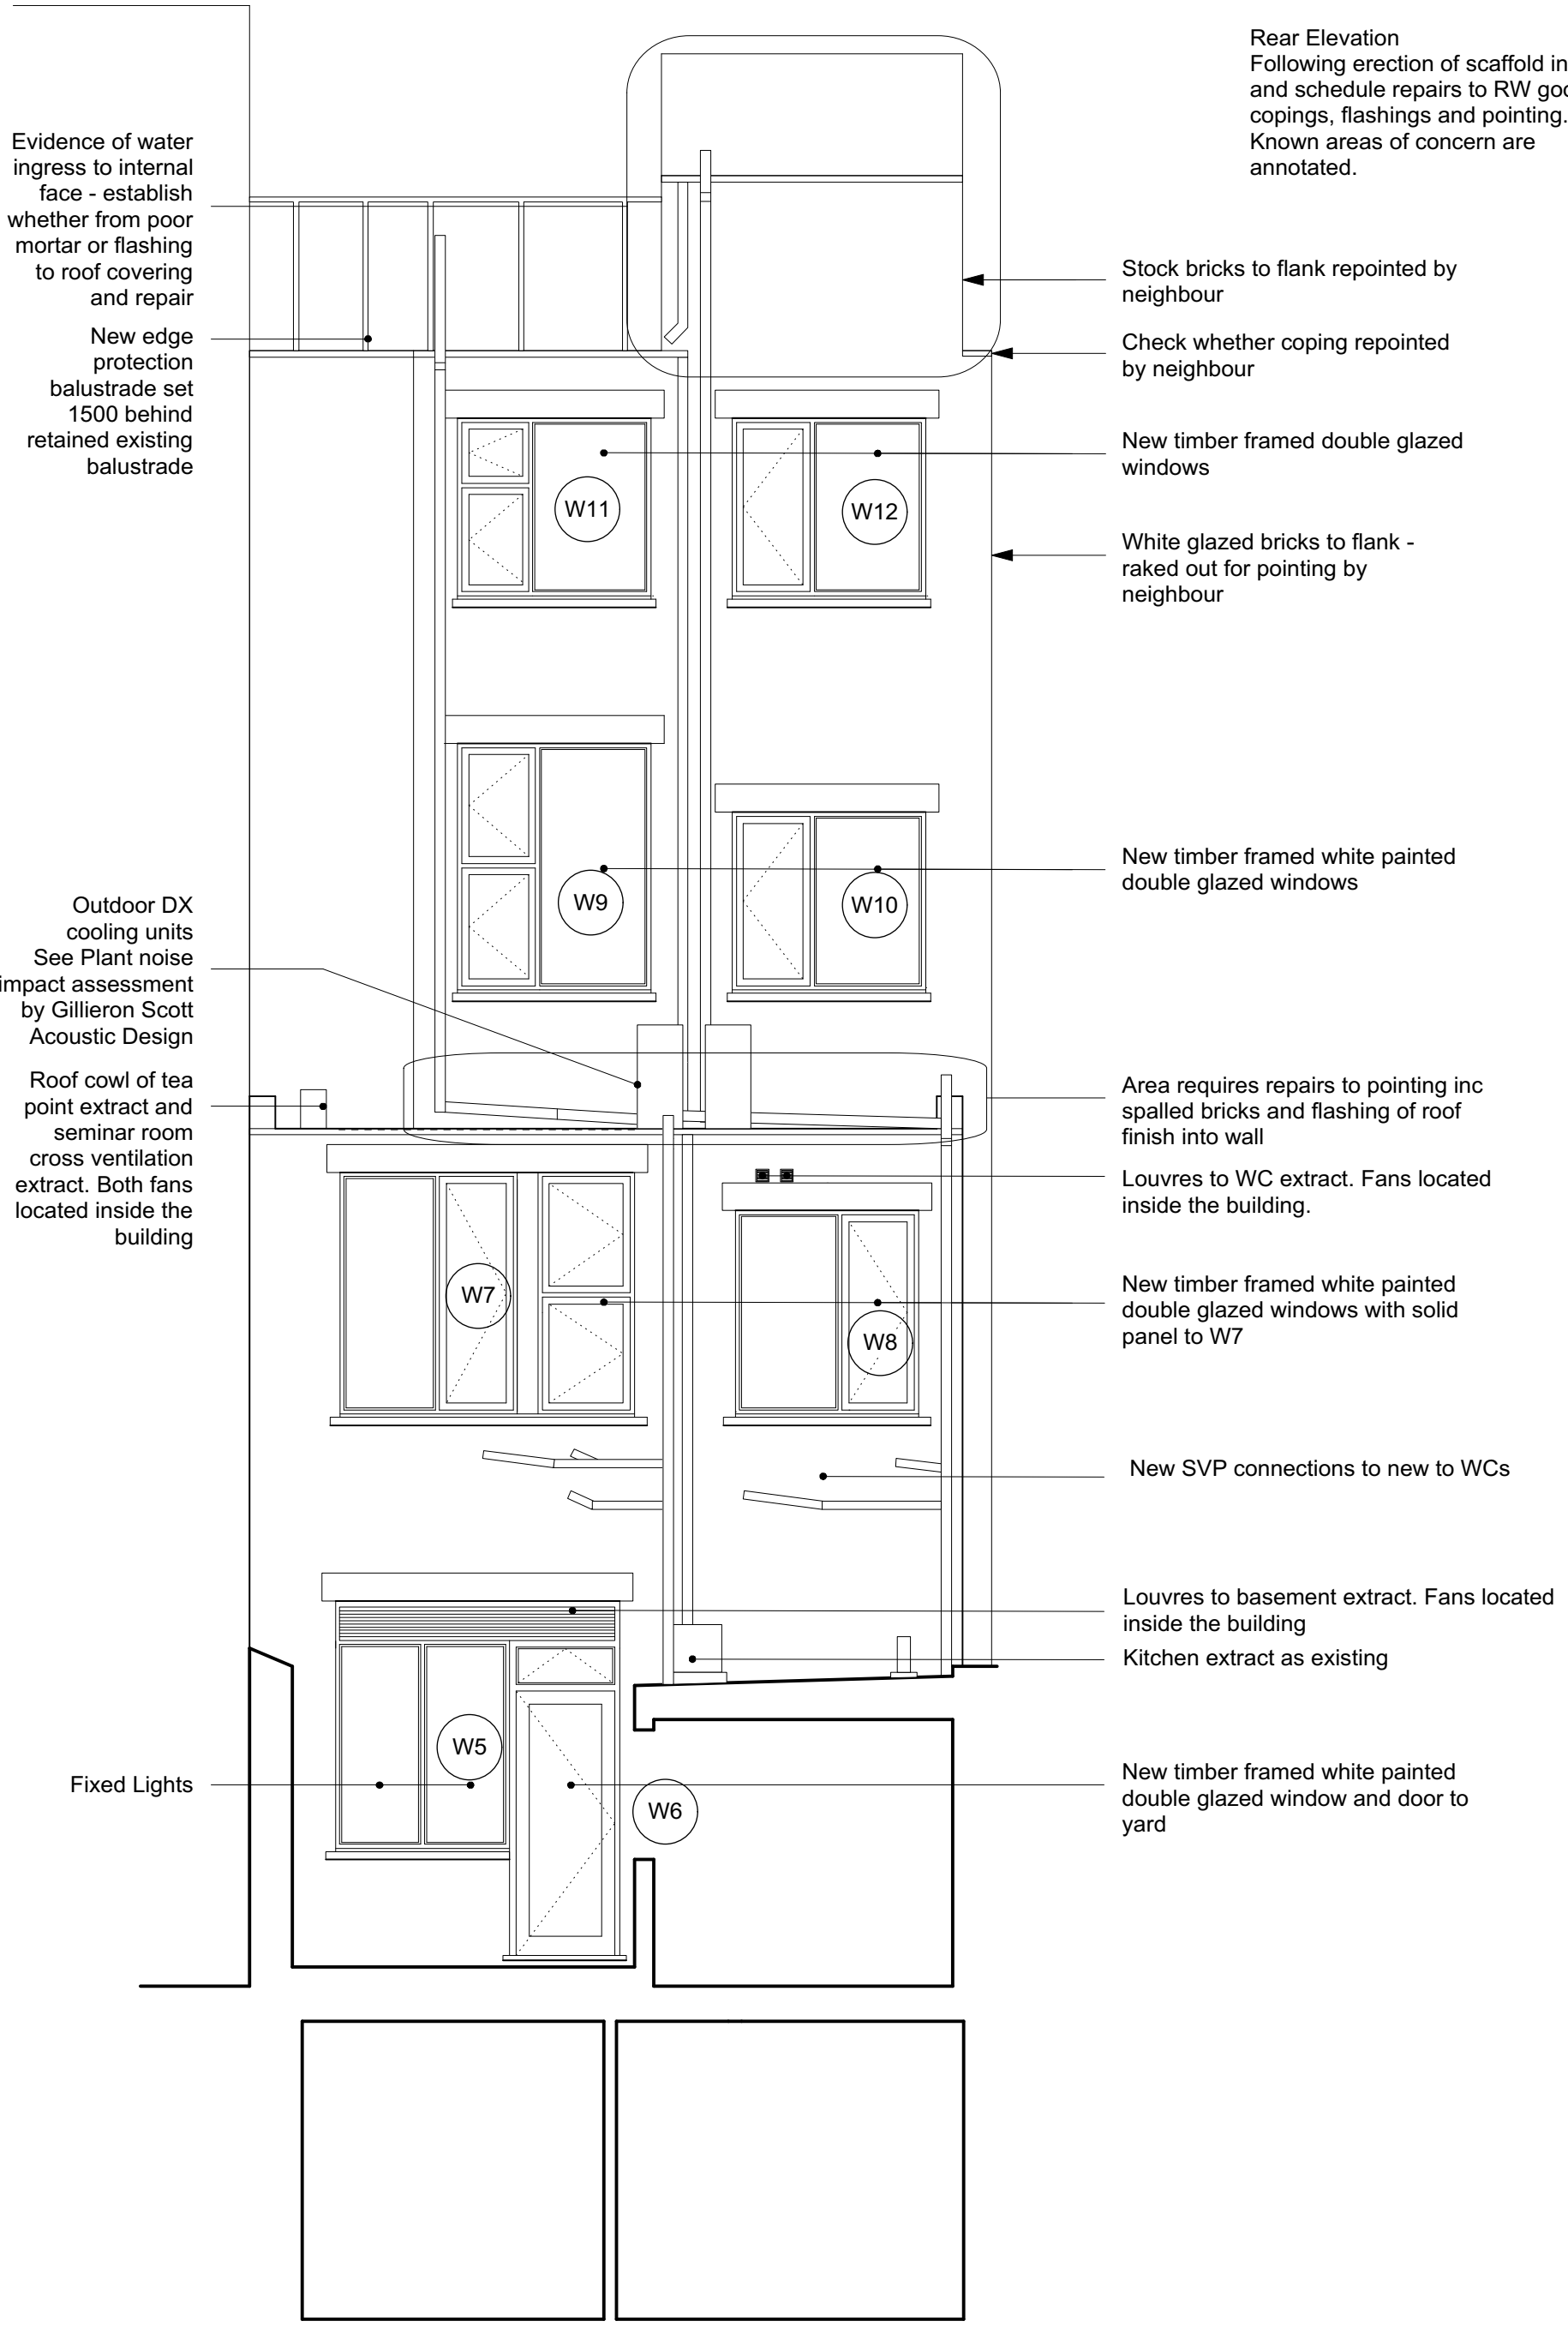
Evidence of water ingress to internal face - establish whether from poor mortar or flashing to roof covering and repair  
 New edge protection balustrade set 1500 behind retained existing balustrade

Outdoor DX cooling units  
 See Plant noise impact assessment by Gillieron Scott Acoustic Design

Roof cowl of tea point extract and seminar room cross ventilation extract. Both fans located inside the building

Fixed Lights

Stock bricks to flank repointed by neighbour  
 Check whether coping repointed by neighbour  
 New timber framed double glazed windows  
 White glazed bricks to flank - raked out for pointing by neighbour

New timber framed white painted double glazed windows

Area requires repairs to pointing inc spalled bricks and flashing of roof finish into wall

Louvres to WC extract. Fans located inside the building.

New timber framed white painted double glazed windows with solid panel to W7

New SVP connections to new to WCs

Louvres to basement extract. Fans located inside the building

Kitchen extract as existing

New timber framed white painted double glazed window and door to yard

**NOTE**  
 Window set flush with brickwork as existing. All existing stone sills refurbished and repainted.

No trickle vents in window frames
