2016/5975/L and 2016/5974/P 26 Christchurch Hill, London NW3 1LG

Construction of a basement extension under the modern wing of GII listed dwelling house (C3) and garden incl. demolition and rebuild of detached garden studio (C3).

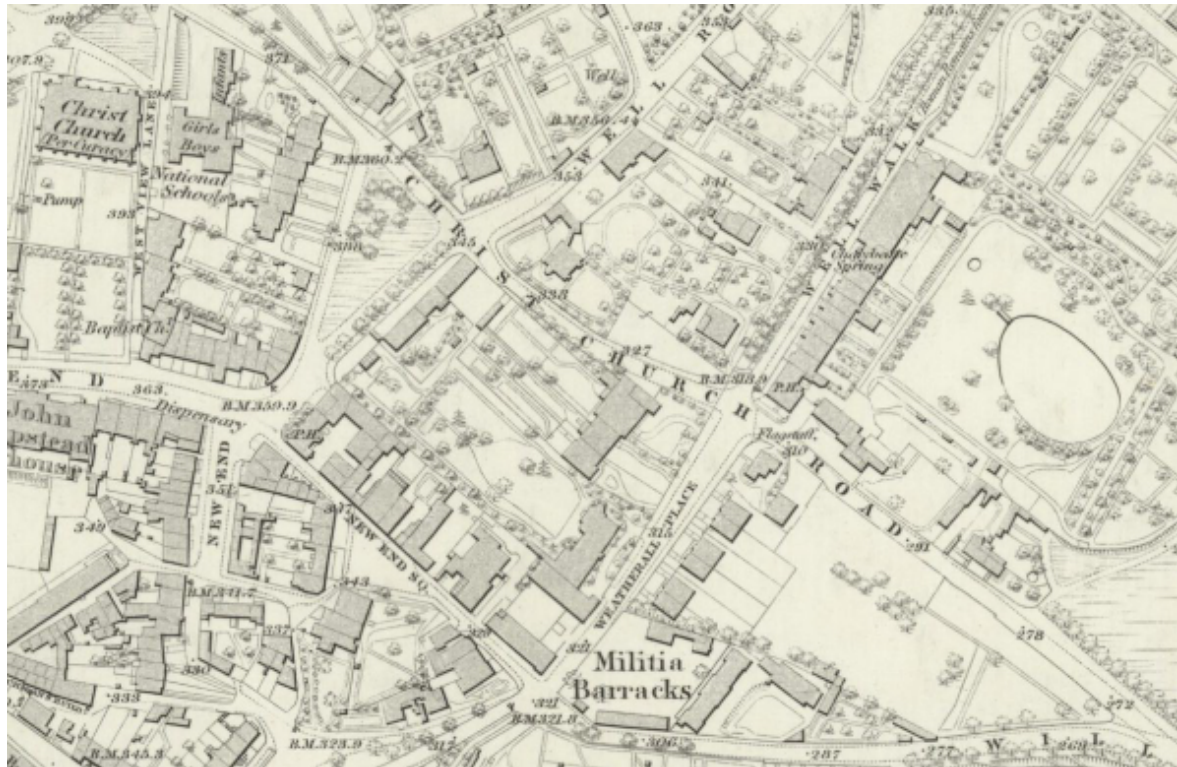
GEA in their Basement Impact Assessment report went back to the 1879 OS map but the 1866 OS map also shows the house as present in 1866. Not only this, but many wells and springs plotted around the area:

The modern OS map shows that Christchurch Hill runs at exactly right angles to the contour lines, indicating that groundwater is likely to follow this course. The stream that runs beneath the passageway from Well Road to Well Walk and in the past fed the public well here before flowing to the pond previously on the site of the central gardens of Gainsborough Gardens (see 1866 OS map) follows this same course to the east.

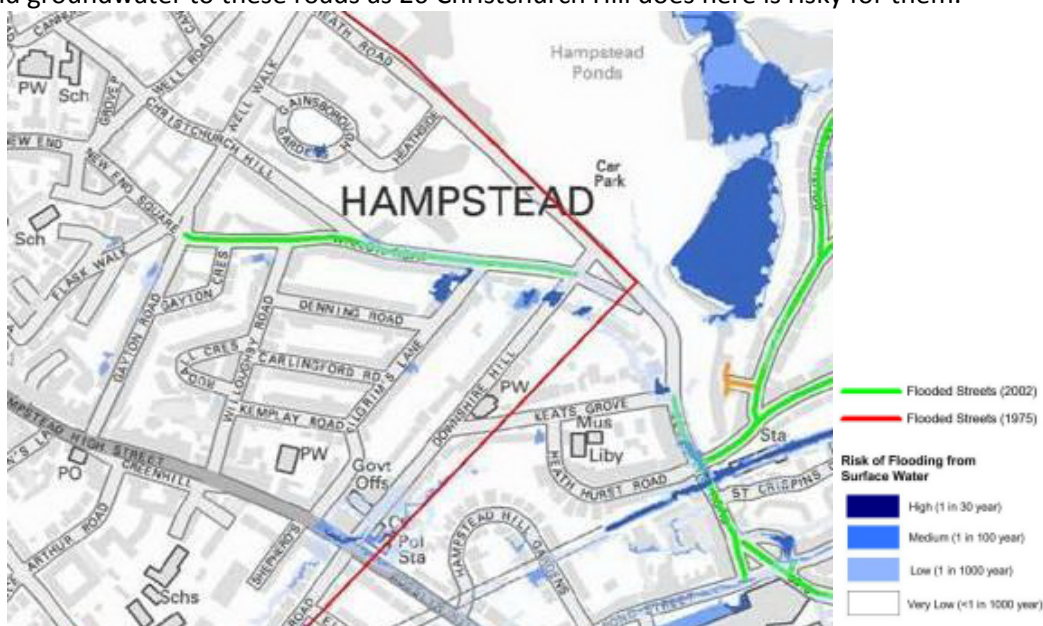
Coupled with evidence from the 'Flood map for surface water', this shows that while 26 Christchurch Hill might not be at high risk of flooding, many roads very nearby are. Any construction that affects the surface run-off and groundwater to these roads as 26 Christchurch Hill does here is risky for them.

Figure 3iii) Environment Agency updated Flood Map for Surface Water from 'London Borough of Camden Strategic Flood Risk Assessment 2014'.

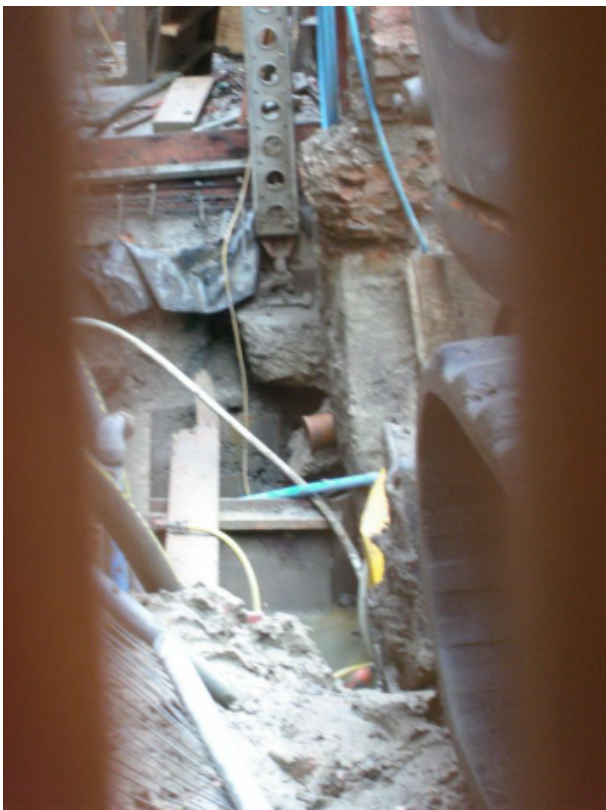
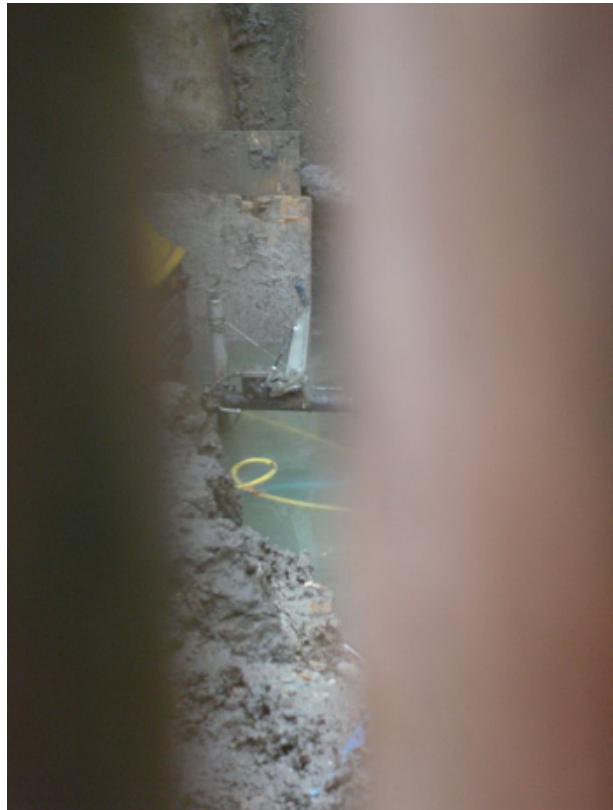
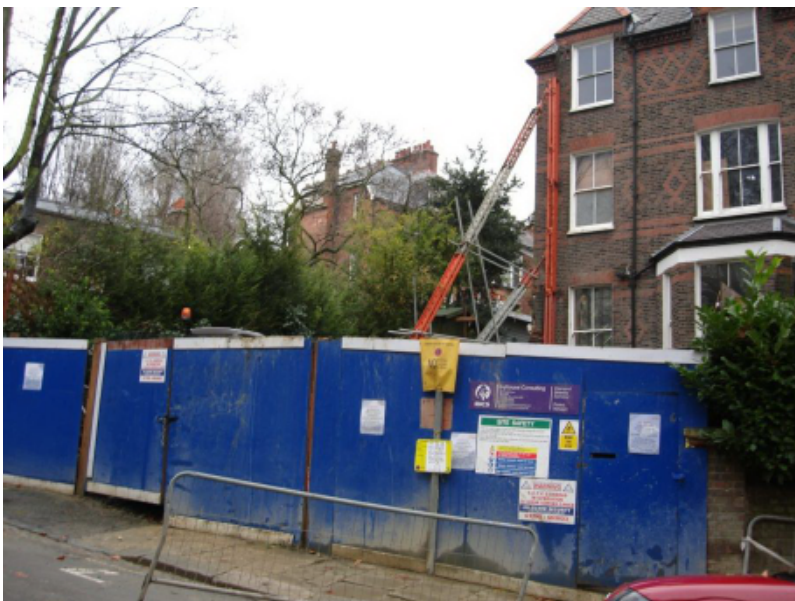
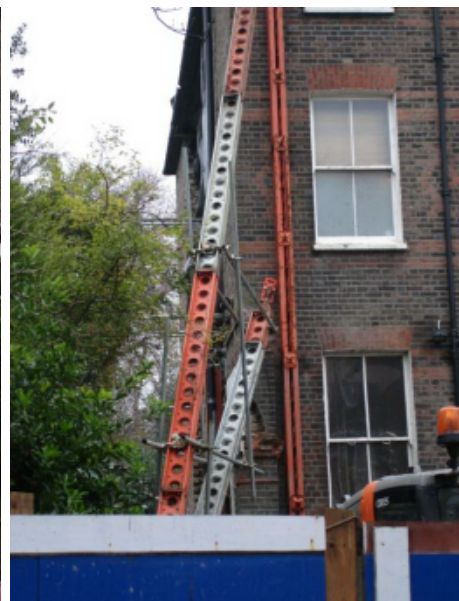
The BIA report notes that: 'The neighbouring No 22 to the southeast of the site was granted planning permission for the excavation of a single level basement in June 2007.' However it fails to report that the basement dig here broached water under pressure in a sand parting, a lake rapidly formed under the house and there was immediate settlement of the building and its semi-detached neighbour requiring shoring up. The pictures below were taken some time after (December 2008) *while* 24 hour pumping was on-going.

It took the developers here 18 months to solve this problem and stop the water gushing, while neighbours had to tolerate the noise of 18 months of 24 hour pumping of this water. The erosion that this water caused and subsequent settling of the buildings' foundations - not to mention that of the roadway - would have been very rapid and very expensive to put right. The delay of 18 months alone must have been very expensive.
