3.2 ORIGINAL 1858 DRAWINGS OF 44A GLOUCESTER AVENUE

4.0 DESIGN STRATEGY

4.2 DESIGN PRINCIPLES

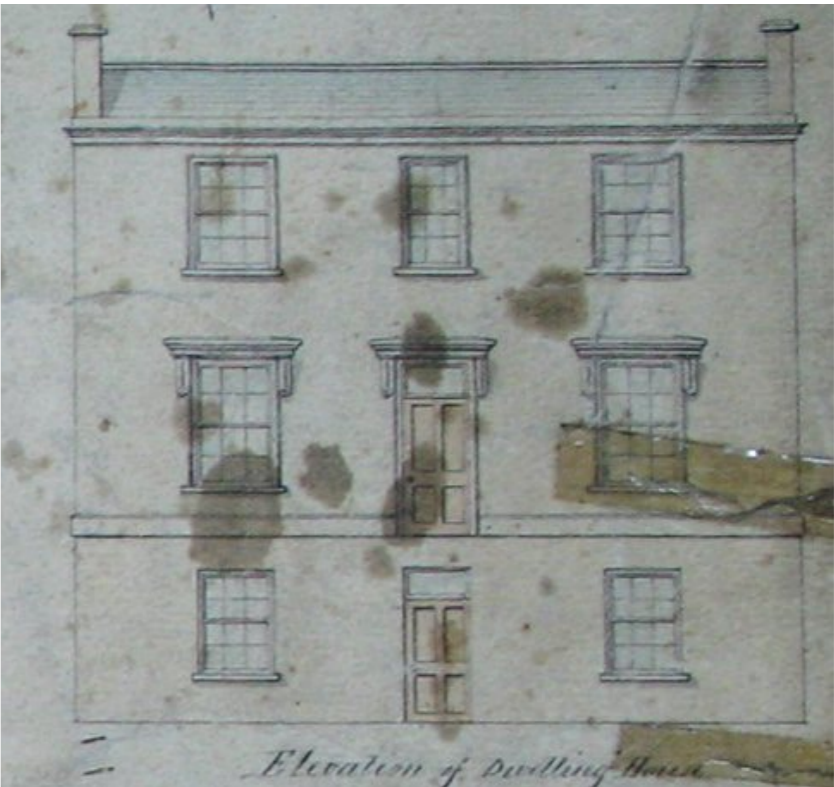
The original 1858 plans and elevations of the house are reproduced on page 17; these illustrate the original form and design of the building.

ELEVATION

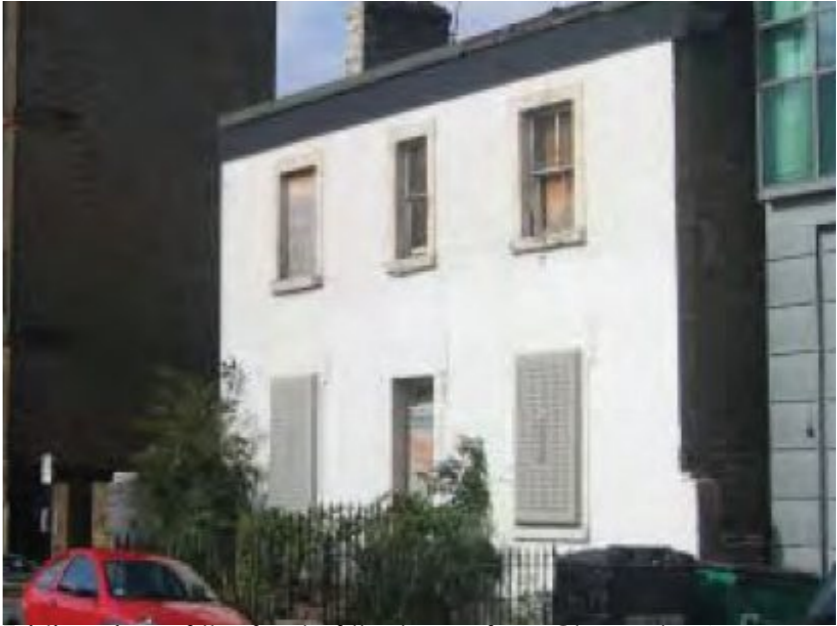
1 Existing view of the front of the house from Gloucester Avenue

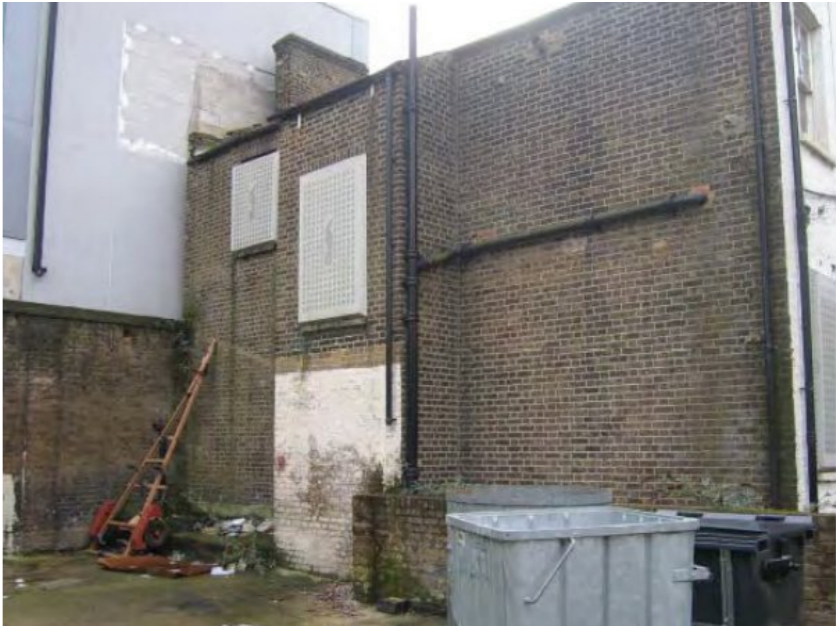
2 Existing view of the house at the rear elevation

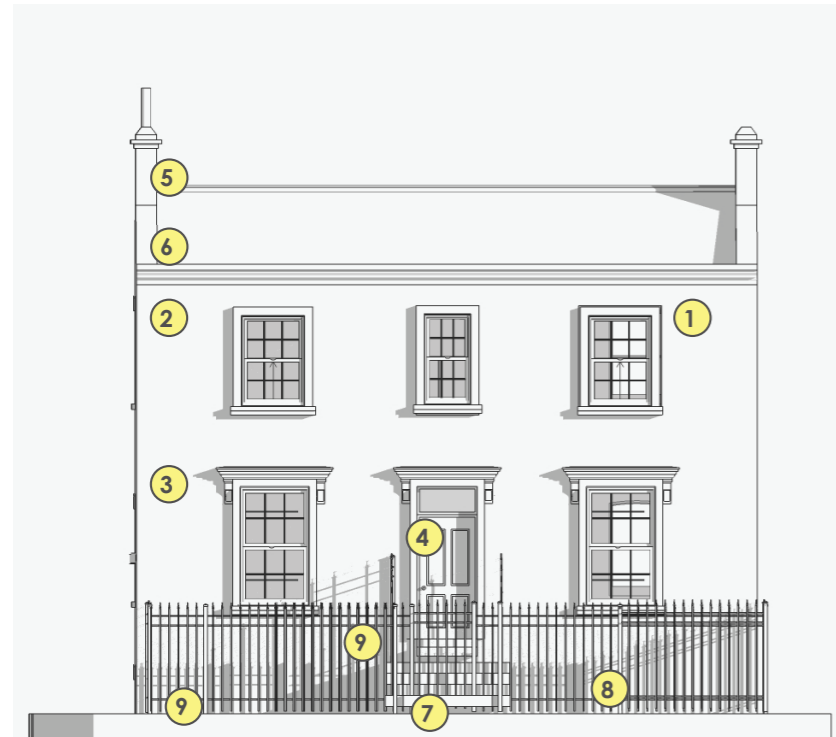
ORIGINAL DESIGN INTENSION - AS PER DISCOVERED DRAWING

- 1 Simple 3 bay façade originally built of stock brick.
- 2 Sash windows with glazing bars, 6 over 6 panes. Stone architrave and cill details
- 3 Stone architraves, scrolled consoles and entablatures to upper ground floor windows and door.
- 4 Timber panel Georgian style front door. Colour unknown.
- 5 Low pitched end-gabled Welsh slate roof, with a verge parapet and flanking chimneys.
- 6 Cornice at Eaves Level. Short return to Gables only.
- 7 York Stone steps lead to the front door. A second set of stone steps lead down to a basement level entrance.
- 8 Metal railings with spire finials.
- 9 Gate to basement steps. Metal Boot Cleaner to Entrance.

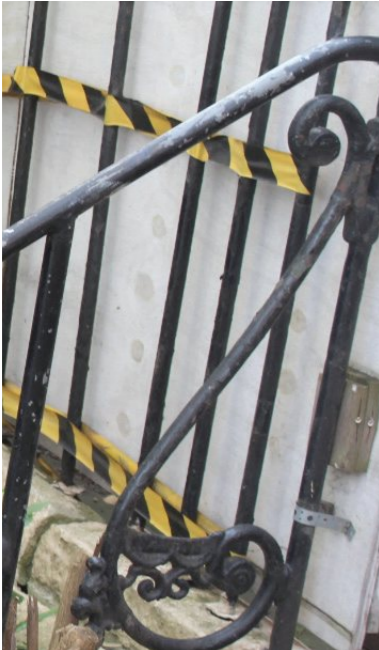
9 Restore Existing Boot Cleaner detail to both Entrances.

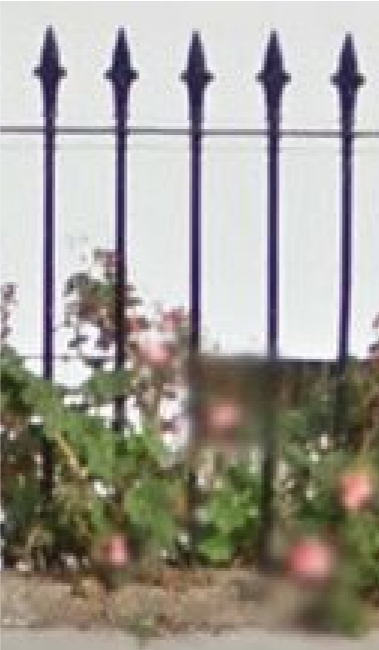
8 Restore and Repair Existing Railings.

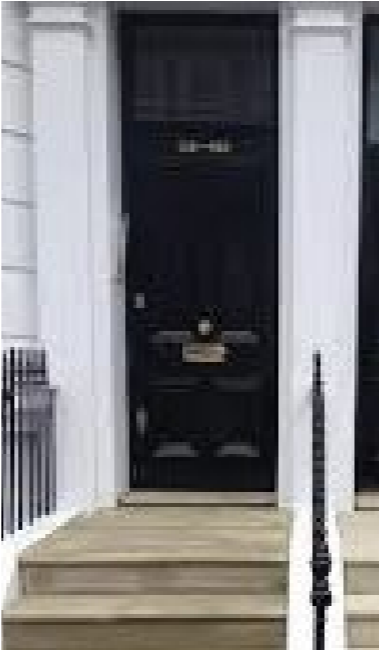
4 Restore and Repair Existing York Stone Steps.

Entrance Door to be painted Black and to receive new Bronze Ironmongery.

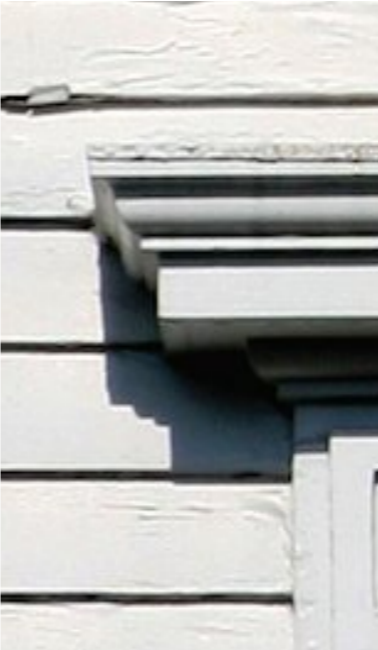
3 Restore original Stone Front Elevation Windows.

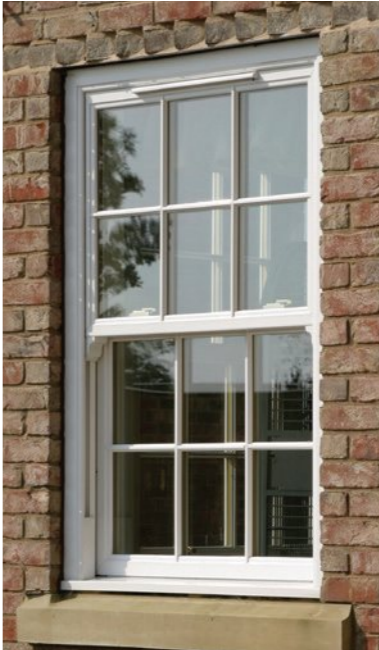
2 Replace removed and damaged windows with New Timber Sliding Sash with double glazing.

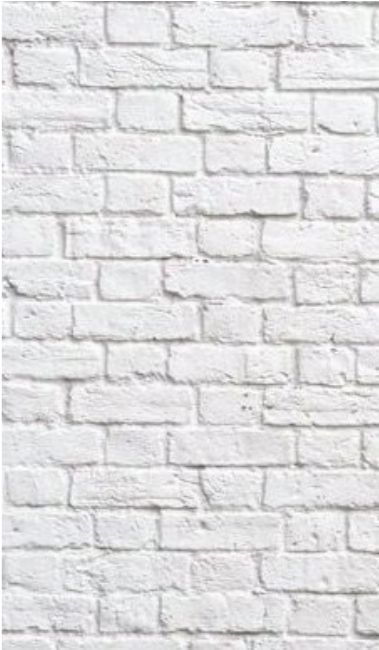
1 Existing Brickwork to be cleaned, existing white wash removed. Brickwork to be re-pointed where necessary and a new White Wash applied.

- 1 Original brickwork re-pointed and repaired where necessary. The brickwork will be cleaned, removing the existing white wash, with a new white wash finish proposed.

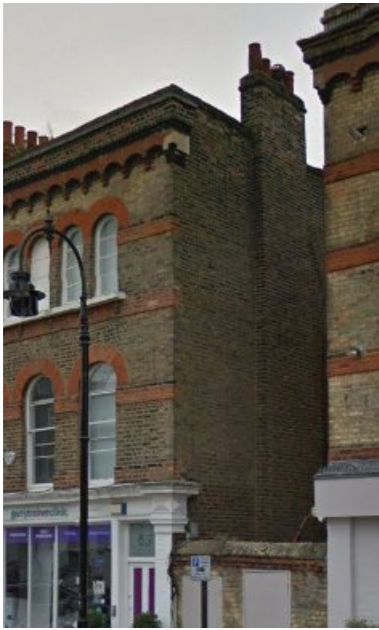
A Chimney Stack to be expressed on the Gable Facade - as per the example above at 65 Princess Street adjacent to the site.

- A** The chimney is located to the rear of the building. The chimney breast is expressed in a similar fashion to buildings in the locale - e.g. 65 Princess Street. The expressed chimney breast will give structural integrity to the flank wall and be used to disguise the change in brickwork.

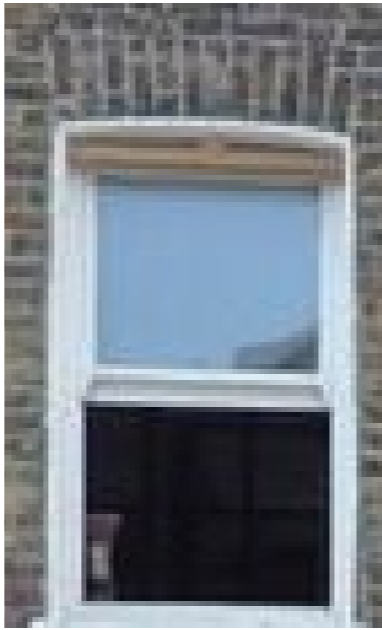
F New Windows to be Gable and Rear Elevation to have a Arched Brickwork Window Head. This detail is currently used to the windows at the rear of the existing elevation we intend on removing.

- F** Existing Windows to be replaced with Timber Sliding Sash windows with double glazing. Stone Cill details to be repaired or replaced where necessary. The window head detail is to a arced Solider course as existing.

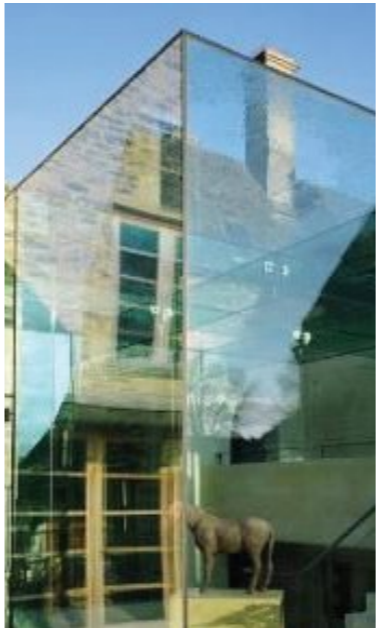
G New Glass Box to have minimum detailing. The neutral design will highlight the character of the existing building.

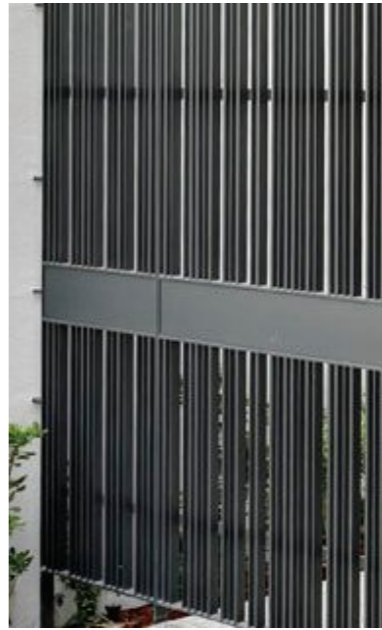
H Garden Gates to be designed in a similar style to the Main Entrance Gates.

The slender vertical rails provide a light, delicate style to respect the existing building. They also have a neutral style to extenuate the historical merit of the existing buildings.

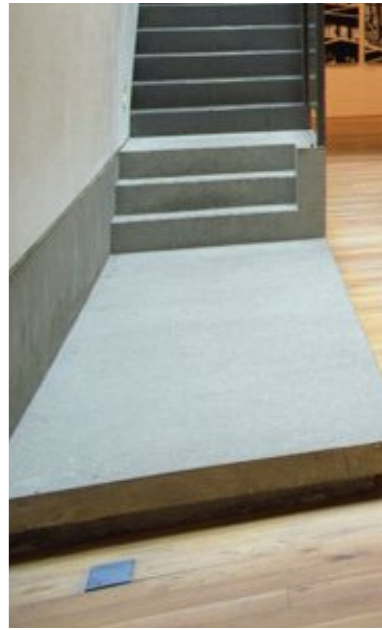
L Modern Access Steps to be Black Metal.

- J** Private garden with car parking.
- K** Roof Light in Landscaping to provide daylight into the Basement Areas.
- L** Entrance Steps.
