Flat A 15 Well Walk 2016/6491/P

I am commenting on aspects of this application as they relate to trees and to groundwater.

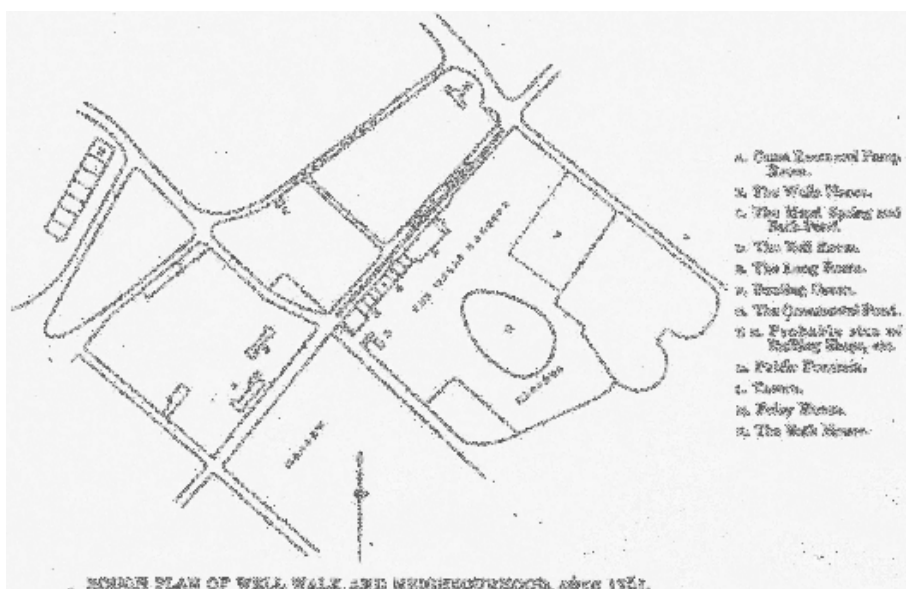
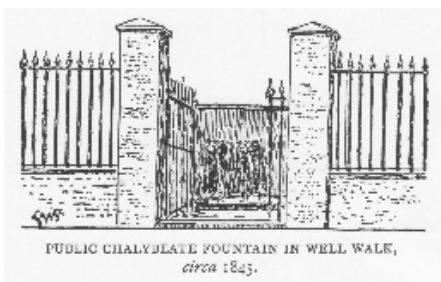
This c1761 map of the immediate area demonstrates the practical use being made of the local springs in the past. While some of this water was piped then and is now, there is still evidence of other groundwater and springs.

The 1761 map and 1866 OS map of the area show the large pond where Gainsborough Gardens now are, originally fed by a spring originating in Well Road, later directed via a conduit running below Wells passage (that

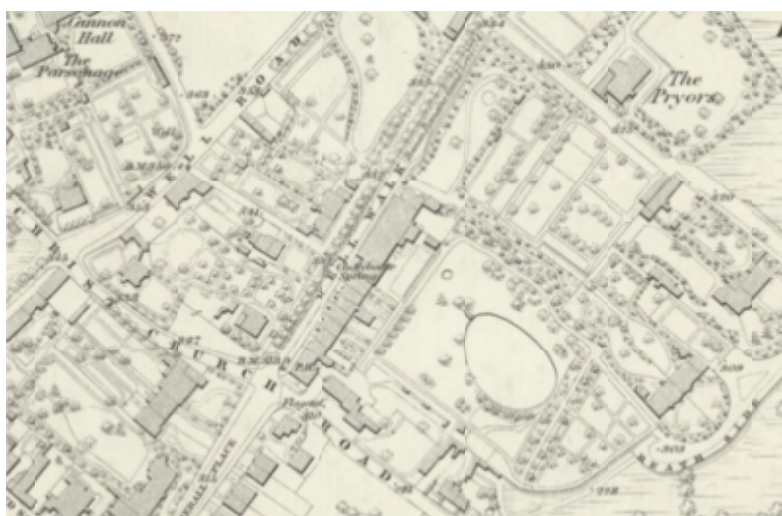
1866 OS map showing large pond downstream of 15 Well Walk

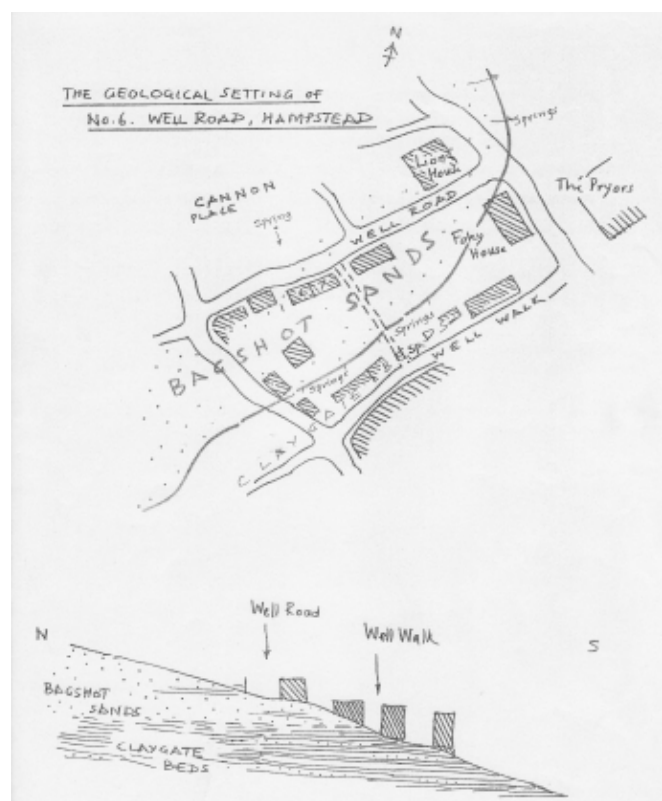
Dr Eric Robinson of University College London has drawn a geological map of the area (originally for another address in the locality), which indicates the springs and the spring line and should be of concern for 15 Well Walk:

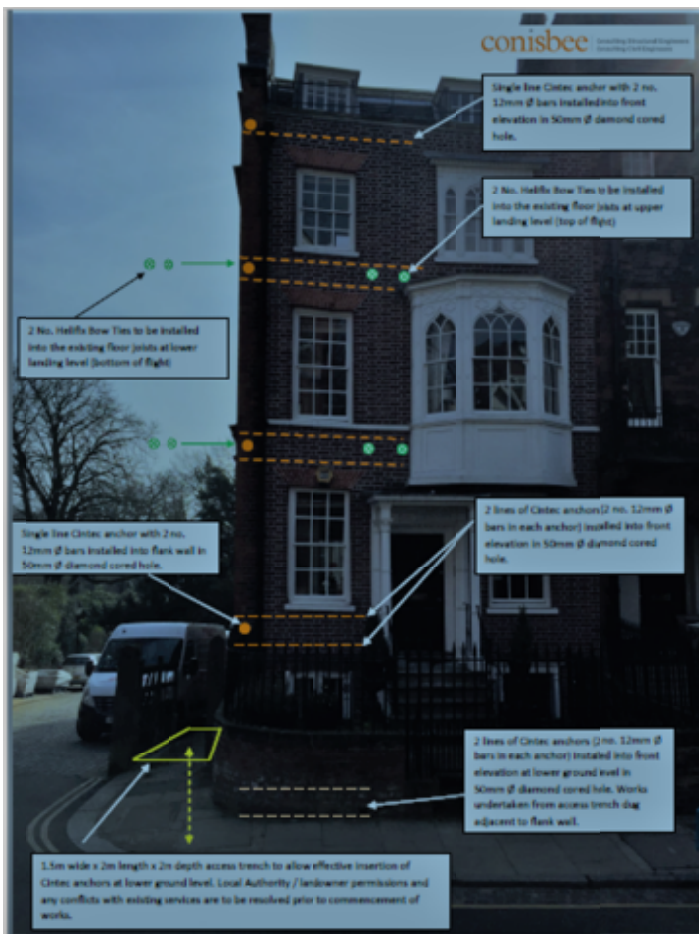
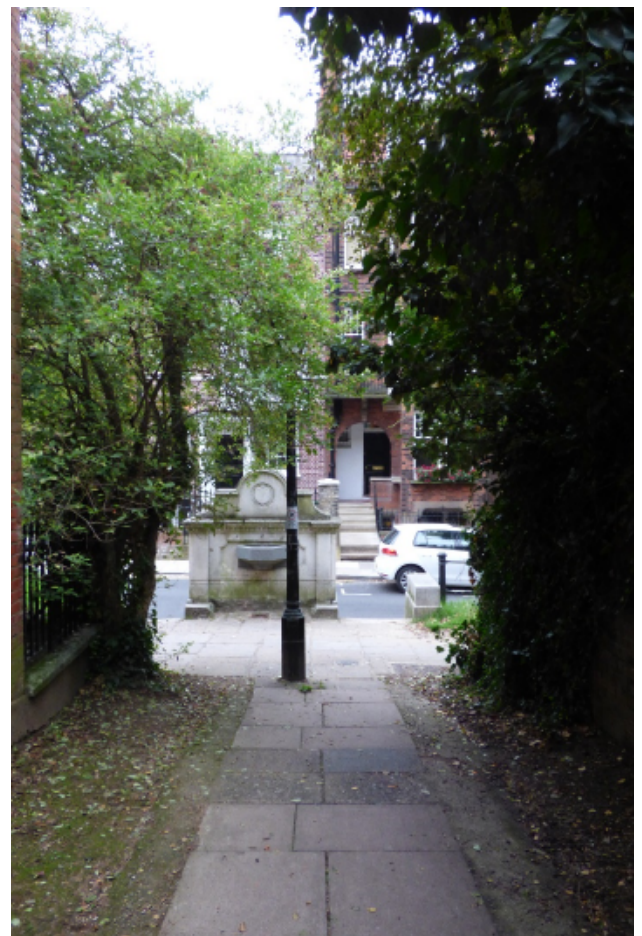
Some of the groundwater still running below houses on even moderate slopes can affect them by contributing to ground slip, but its main action is erosion of the significant proportion of silt within the Claygate Beds causing subsidence. Number 46 Well Walk for example – almost directly opposite 15 Well Walk – is having underpinning work to strengthen it and withstand the sub-foundation volume loss from silt erosion by groundwater action. Movement monitoring from 2013 presented in 2016/0242/P showed that ongoing movement *was active*. Looking at 46 Well Walk from the road it can be seen that the main groundwater flow is below the house, west of the front door. This is in line with the eastern side of Wells Passage and thus closely associated with 15 Well Walk.
